# Validation Report

51, 53 and 55 Headfort Street, Greenslopes Queensland

Department of Veteran Affairs

Reference: 784-BNEEN282781 Validation Report

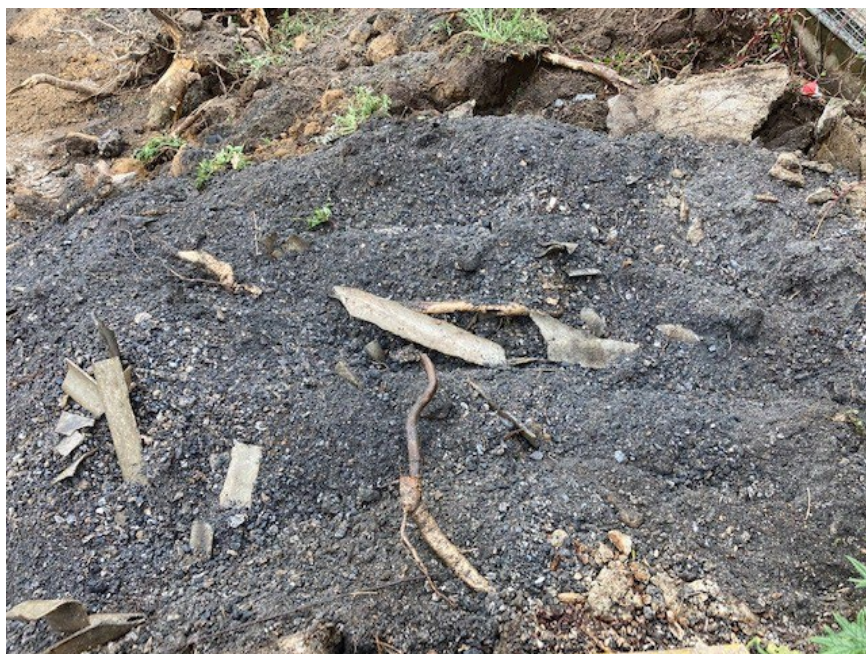
Plate 1: Example ash fill material with ACM

During remediation ACM comprising broken sheets of cement sheeting were frequently encountered in fill materials on the Site. All fill materials were removed from the Site during remediation (refer to Section 6).

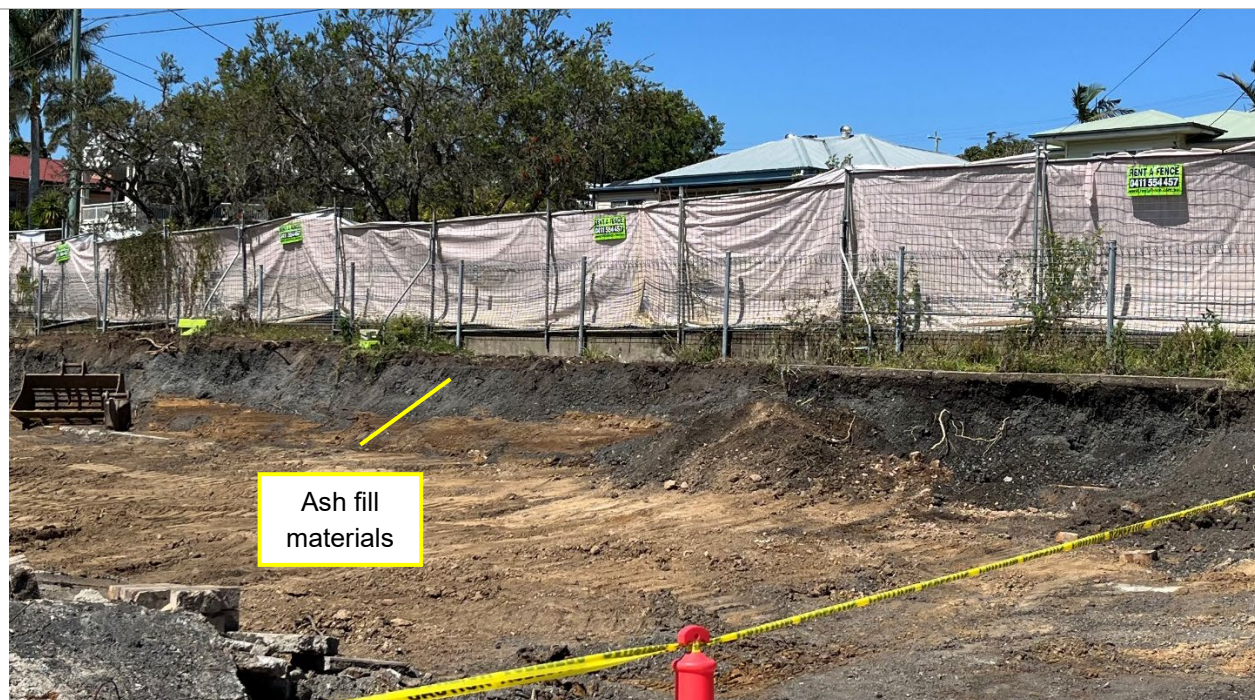
Fill materials were variable in depth and composition over the Site. Fill was identified to a maximum depth of 0.6 m, and were deepest along the southern and south-western boundary of the Site.

Plate 2: Excavation of ash fill materials during remediation along the southern boundary of the Site during remediation

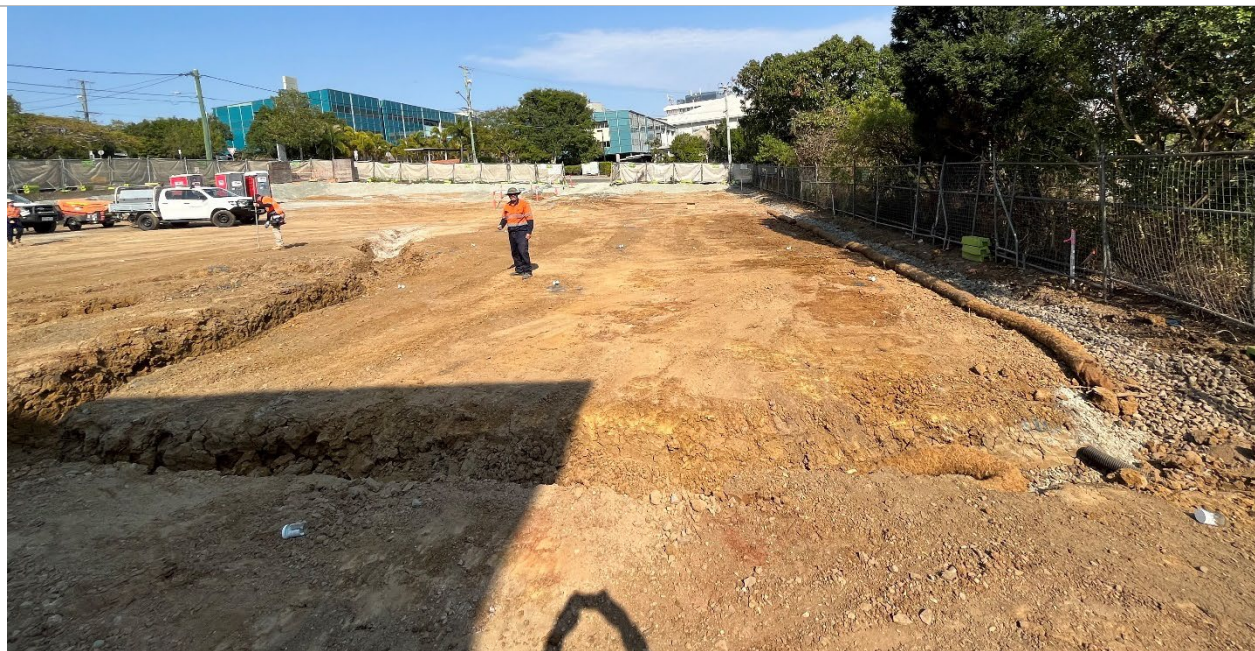
Plate 3: Natural soil materials comprising red/brown silty clays

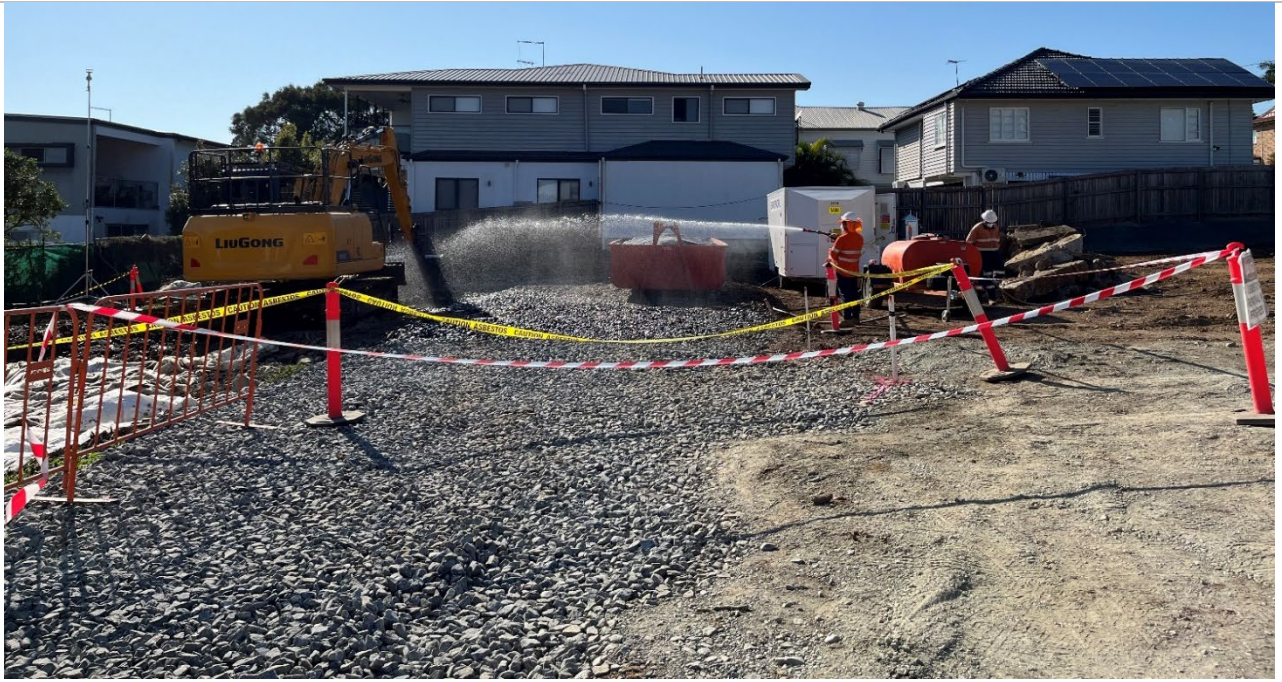
Plate 4: Active dust suppression during site excavation works along the eastern boundary

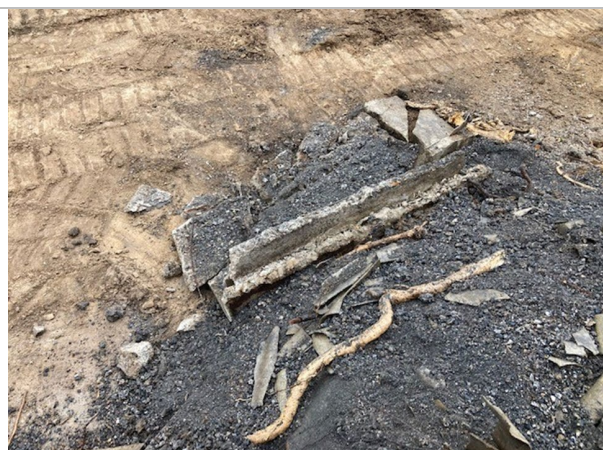
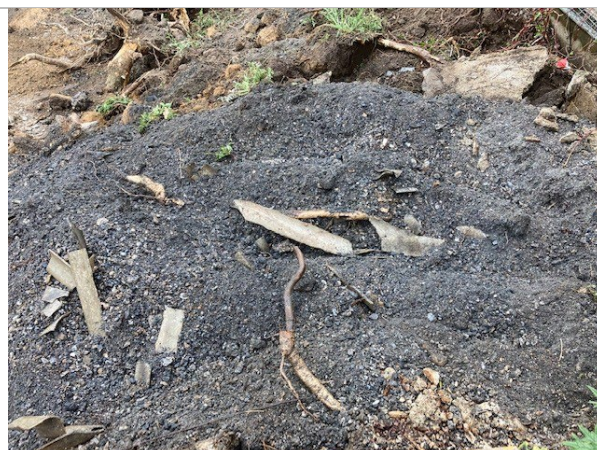
As excavation commenced, frequent occurrence of ACM were reported in fill materials on the Site. ACM were also observed in the bedding material surrounding services and/or in the service material (e.g. pipe). Examples of ACM fragments found in ash fill materials during excavation are provided in the photographs presented in Plate 5 below.

Plate 5: Examples of ACM in fill material

The finding of ACM in fill materials was considered to be **unforeseen contamination** and managed under Section 8.5 of the RAP included in Appendix L.3.

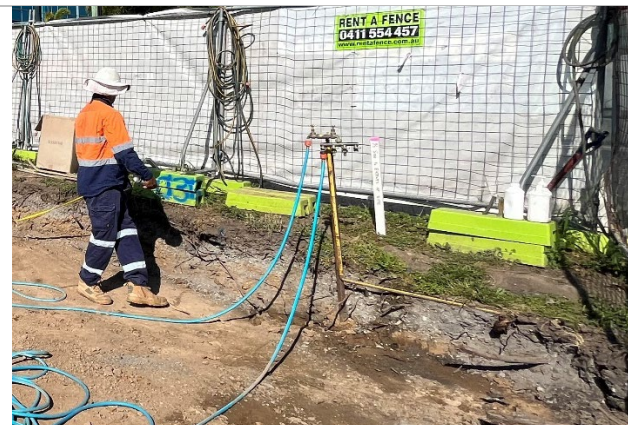
Photograph showing water main connection and materials being removed around this service.

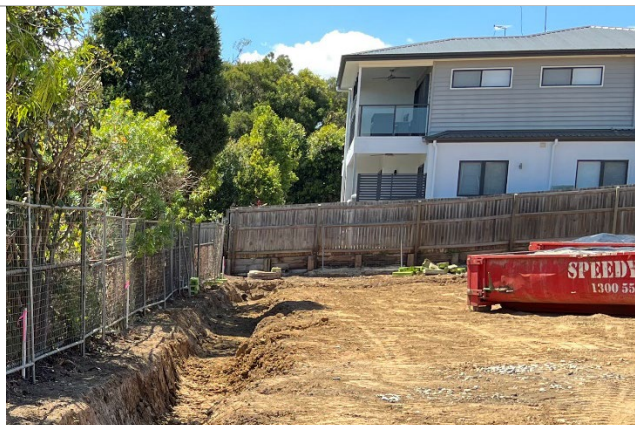
Photograph showing excavated service trench along the northern boundary and the exposed sewer main at the end of the trench. A gravel drain was installed by EPS in the service trench shown (refer to Figure 12, Appendix A).

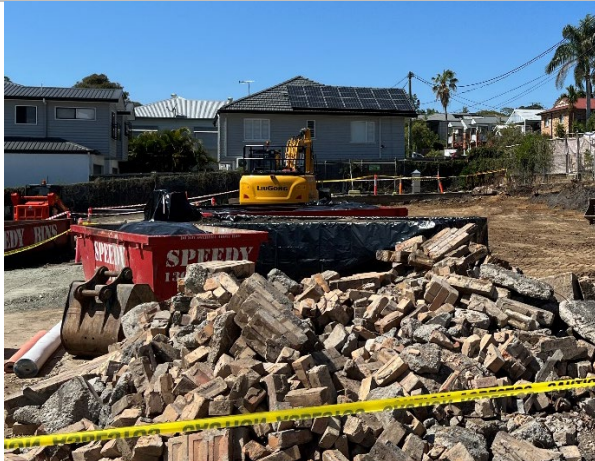
Example of covered skip bin 5/9/23

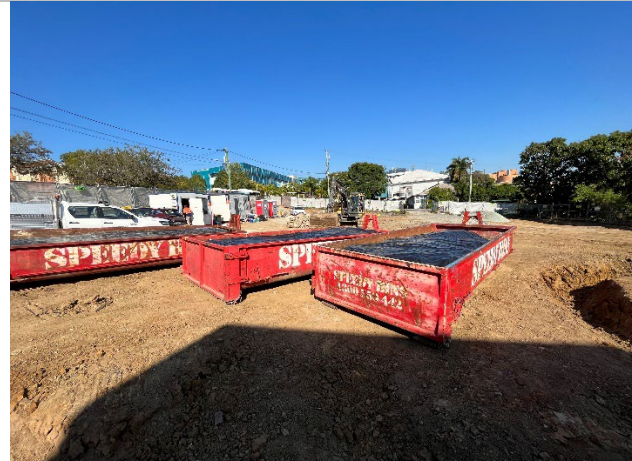
Example of covered skip bin 16/10/23

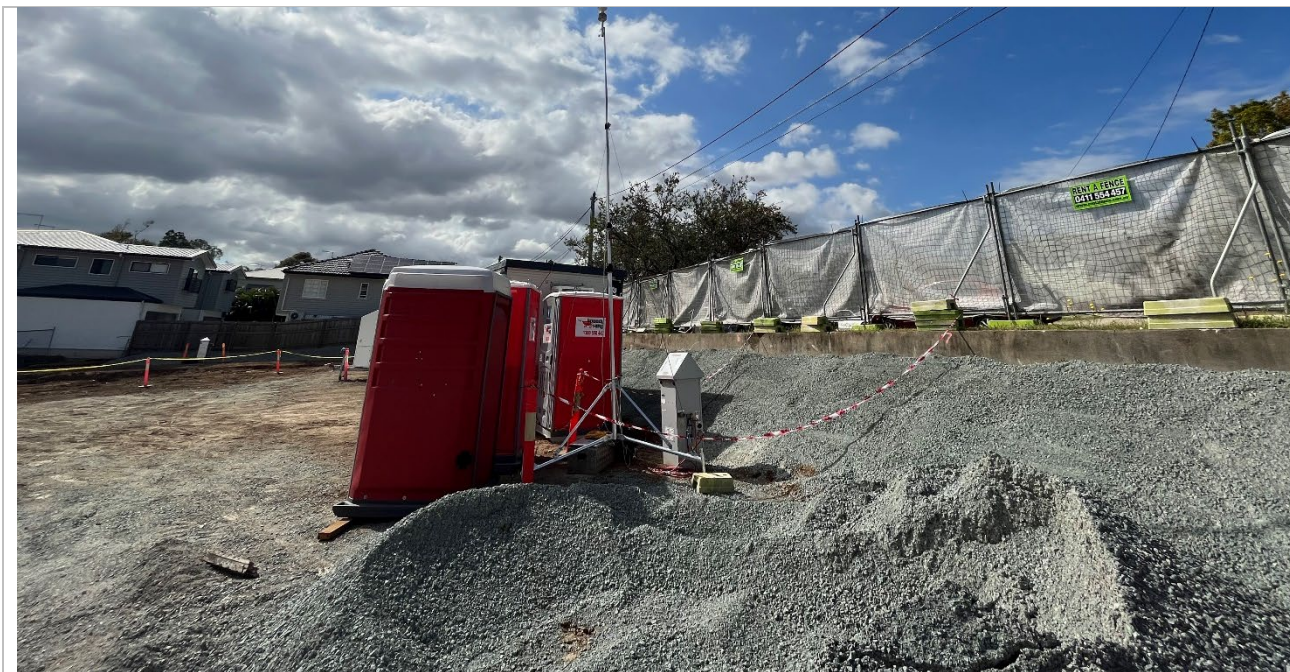
**Plate 5: Imported materials used in the shoring of boundary walls**

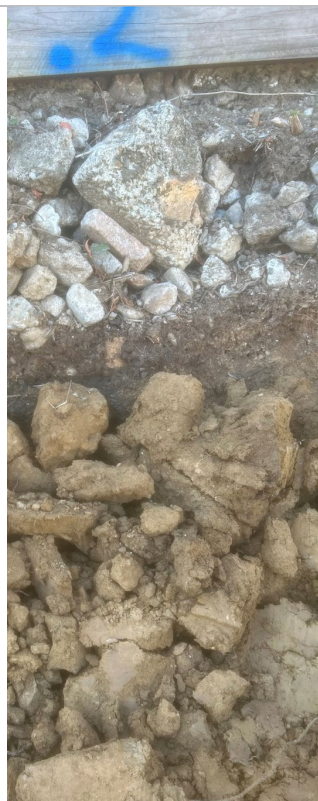
Example of excavation to Eastern Boundary Fence

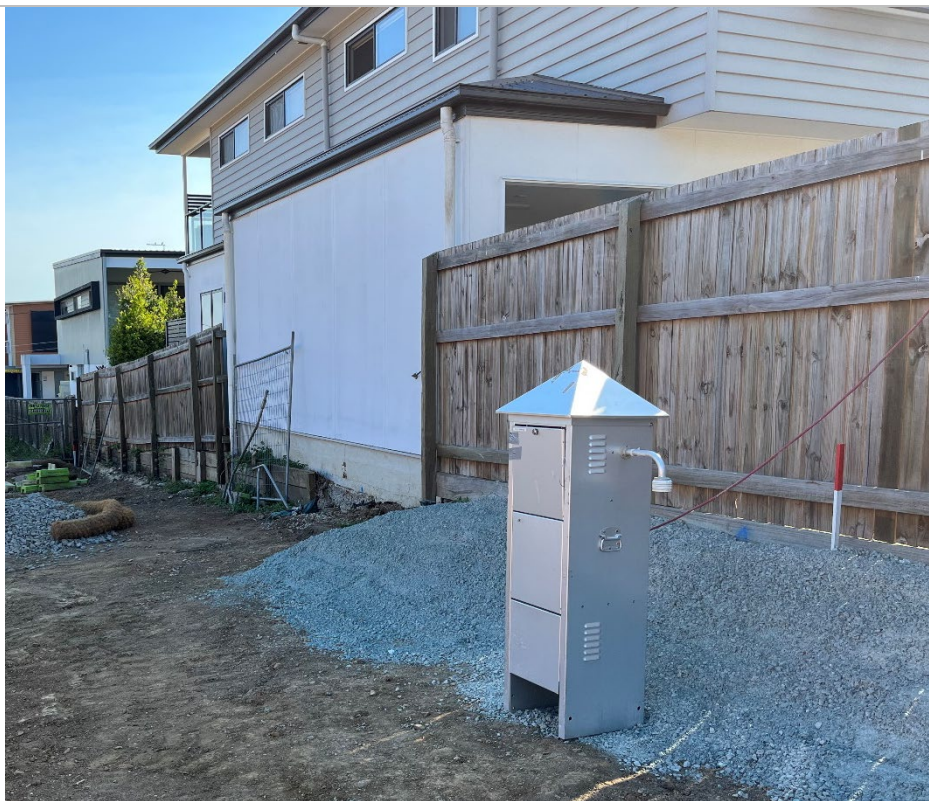
Eastern Boundary Fence with boundary fence. Imported material was place along the boundary fence following excavation and validation.

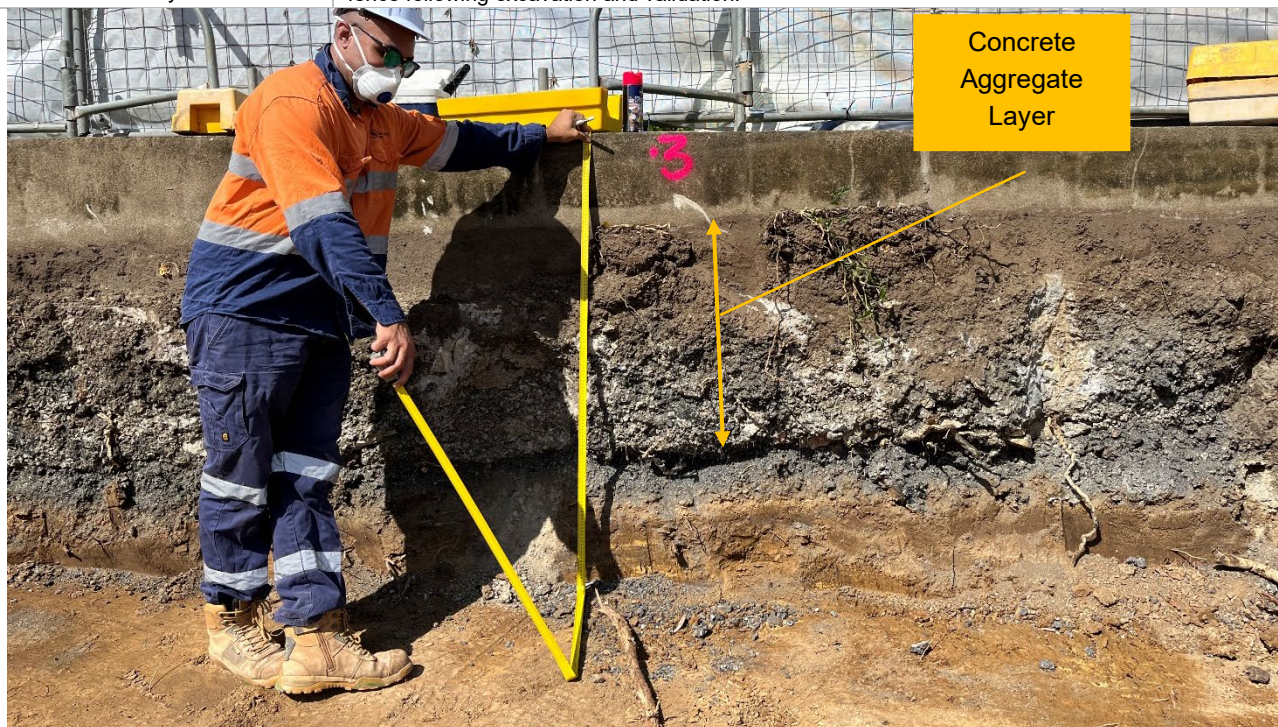
Excavation along the southern boundary was undertaken to the retaining wall which was the practicable limit of excavation.

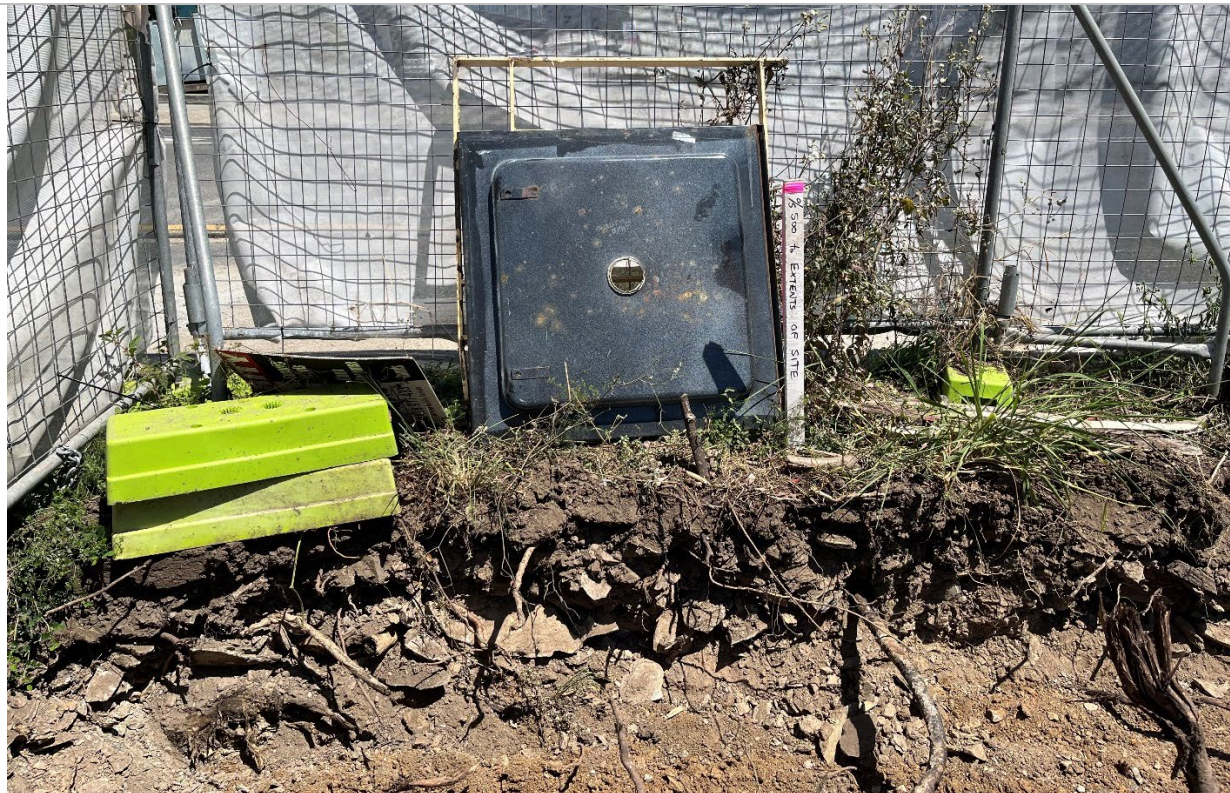
Excavation along the western boundary of the Site. The survey peg shown is offset 0.5 m west off the Site boundary.

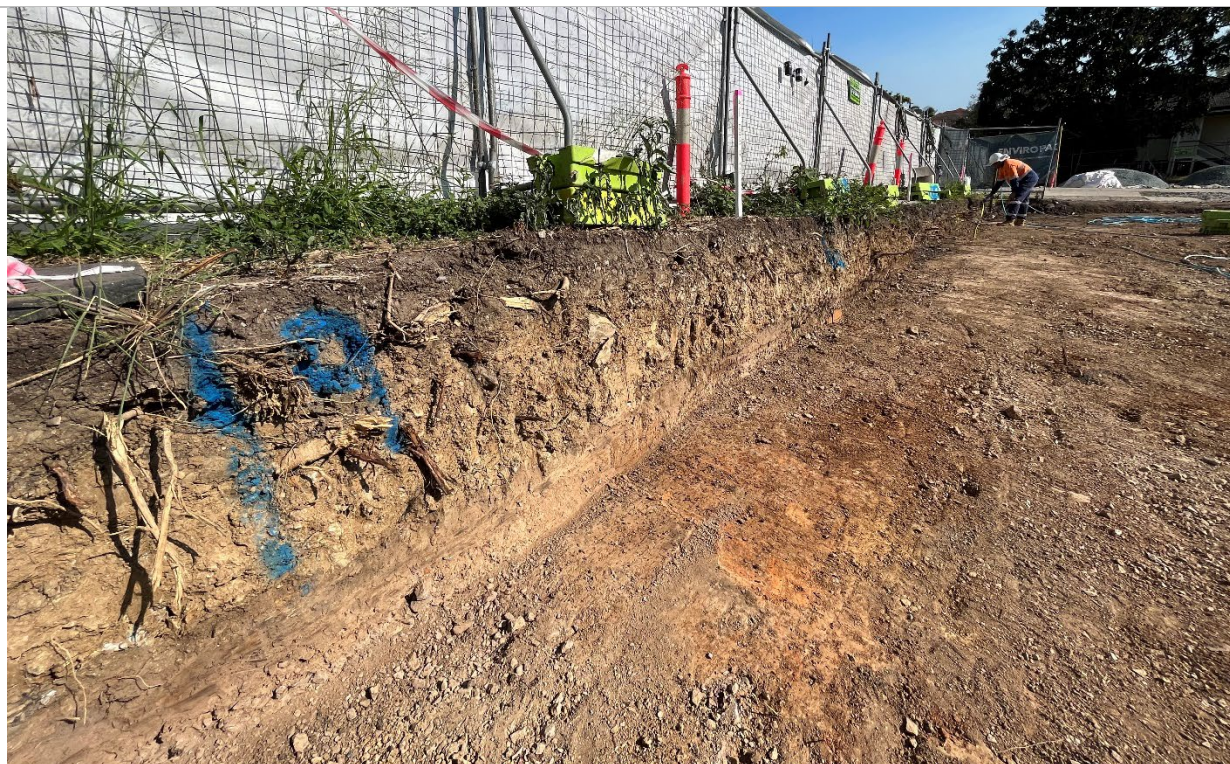
Excavation along the western boundary of the Site. The survey peg shown is offset 0.5 m west off the Site boundary.

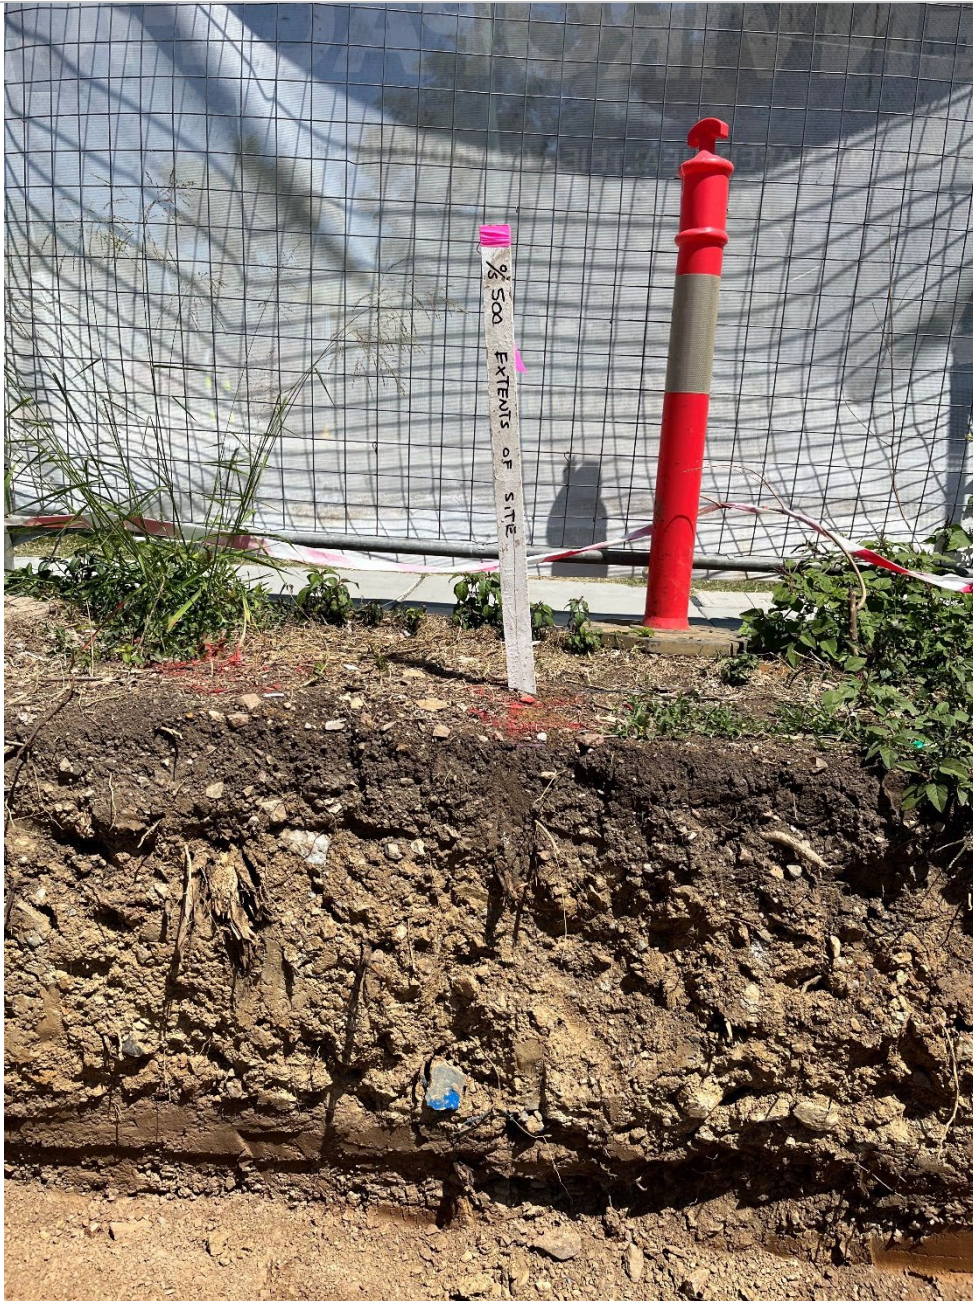
Excavation along the western boundary of the Site. The survey peg shown is offset 0.5 m west off the Site boundary.

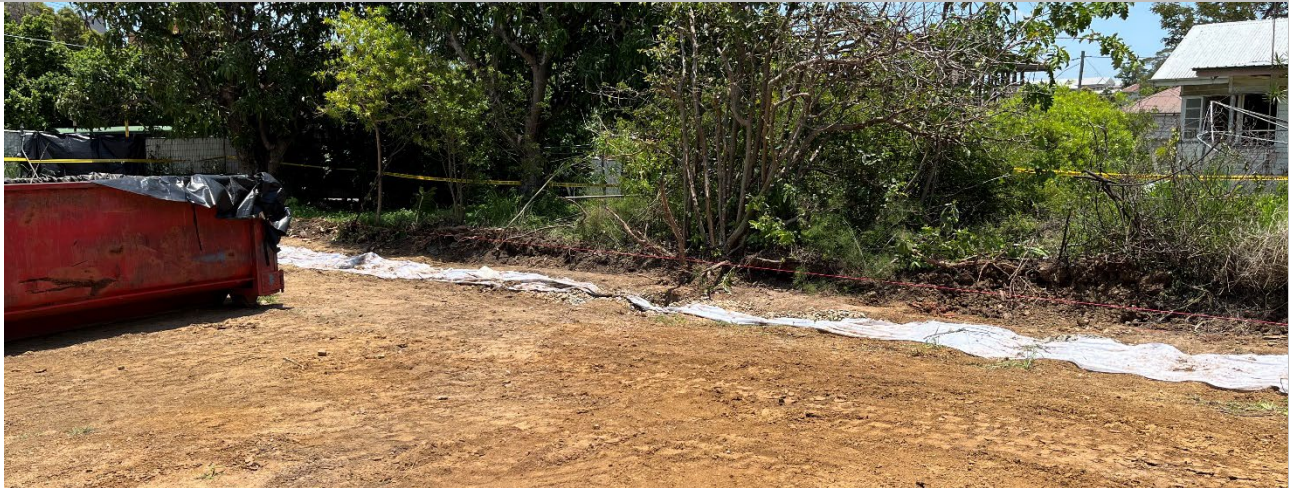
Excavation along the northern boundary required the removal of the boundary fence. Surface materials to natural ground were scrapped to approximately 0.1 m north of the Site boundary marked by the red tape.

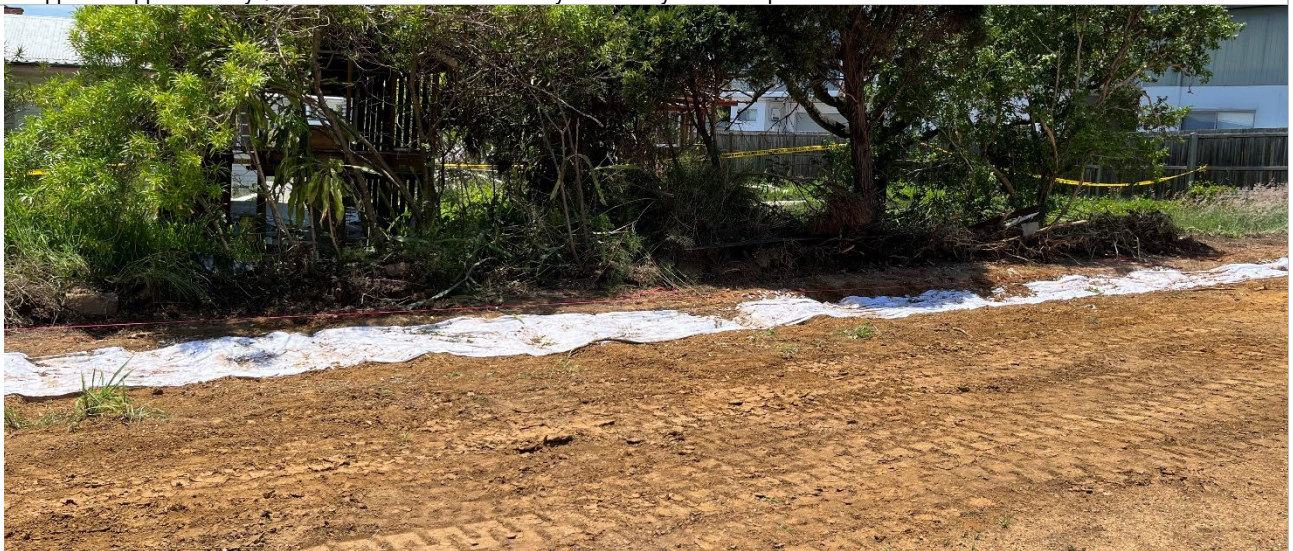
Excavation along the northern boundary required the removal of the boundary fence. Surface materials to natural ground were scrapped to approximately 0.1 m north of the Site boundary marked by the red tape.

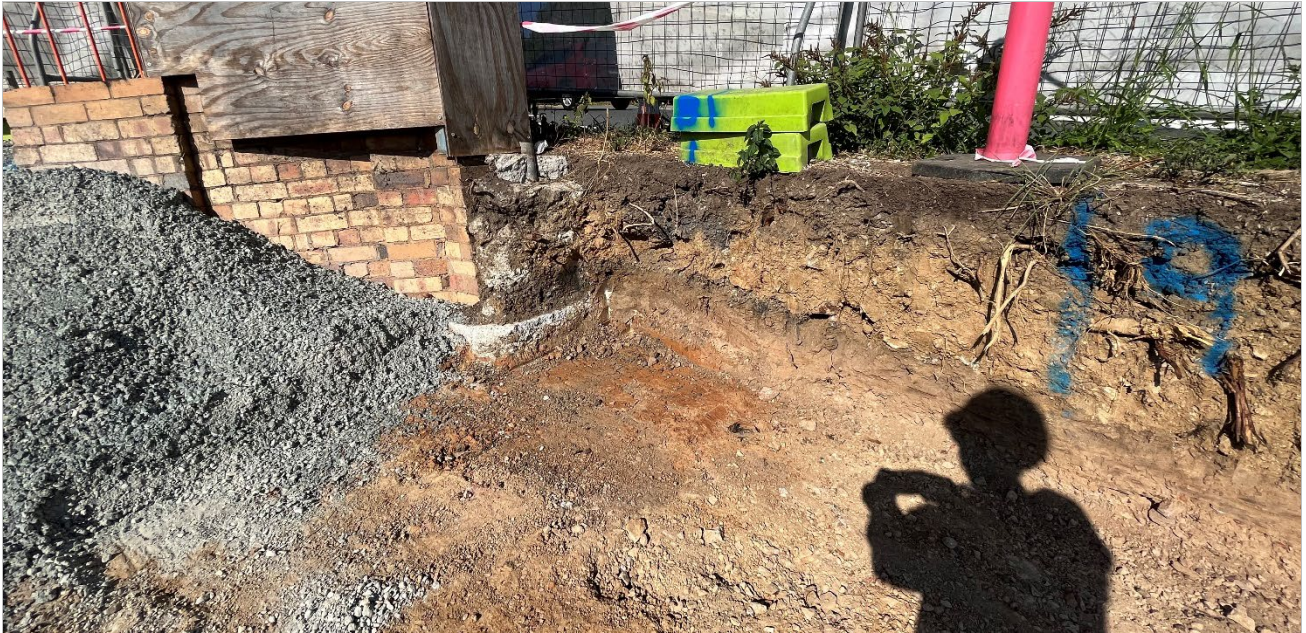
Heritage  
wall

Excavation along the south western boundary of the Site with the footings of the heritage wall exposed. The footings of the heritage wall extended to natural ground

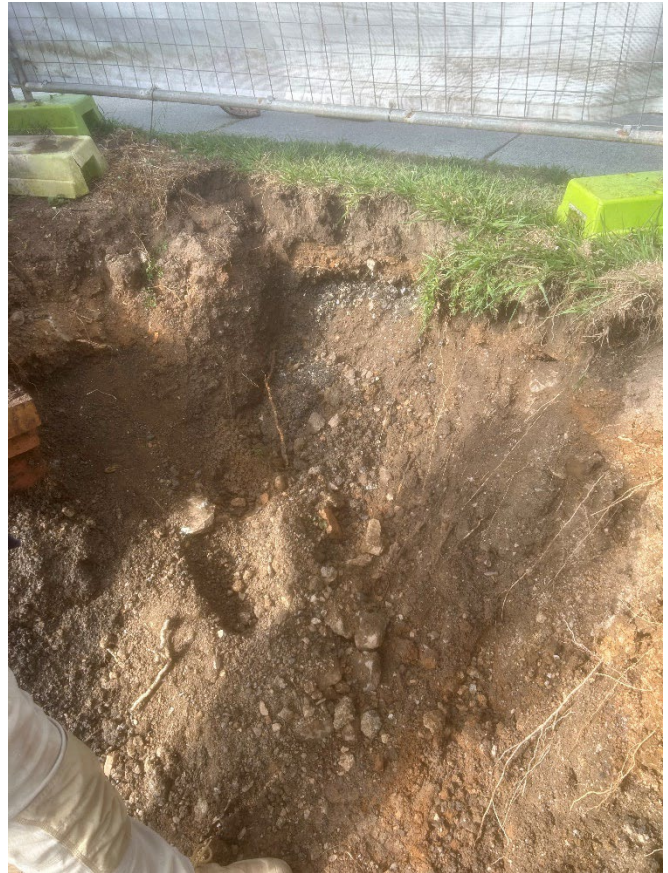
Excavation in the south western corner of the Site extended beyond the boundary of the Site into the Road Reserve. The photograph shows the excavation taking place past the footings of the heritage wall.
