client:	DEPARTMENT OF VETERAN AFFAIRS		
project:	DVA GREENSLOPES 51/53/55 HEADFORT STREET, GREENSLOPES, QLD		
title:	SITE LOCATION PLAN		
project no:	754-BNEEN282781	figure no:	FIGURE 1
		rev:	A

client:	DEPARTMENT OF VETERAN AFFAIRS		
project:	DVA GREENSLOPES 51/53/55 HEADFORT STREET, GREENSLOPES, QLD		
title:	SUMMARY OF HUMAN HEALTH EXCEEDANCES AND FILL DEPTH		
project no:	754-BNEEN282781	figure no:	FIGURE 3
		rev:	A

Figure 15 Pre-Remediation Illustrative Conceptual Site Model

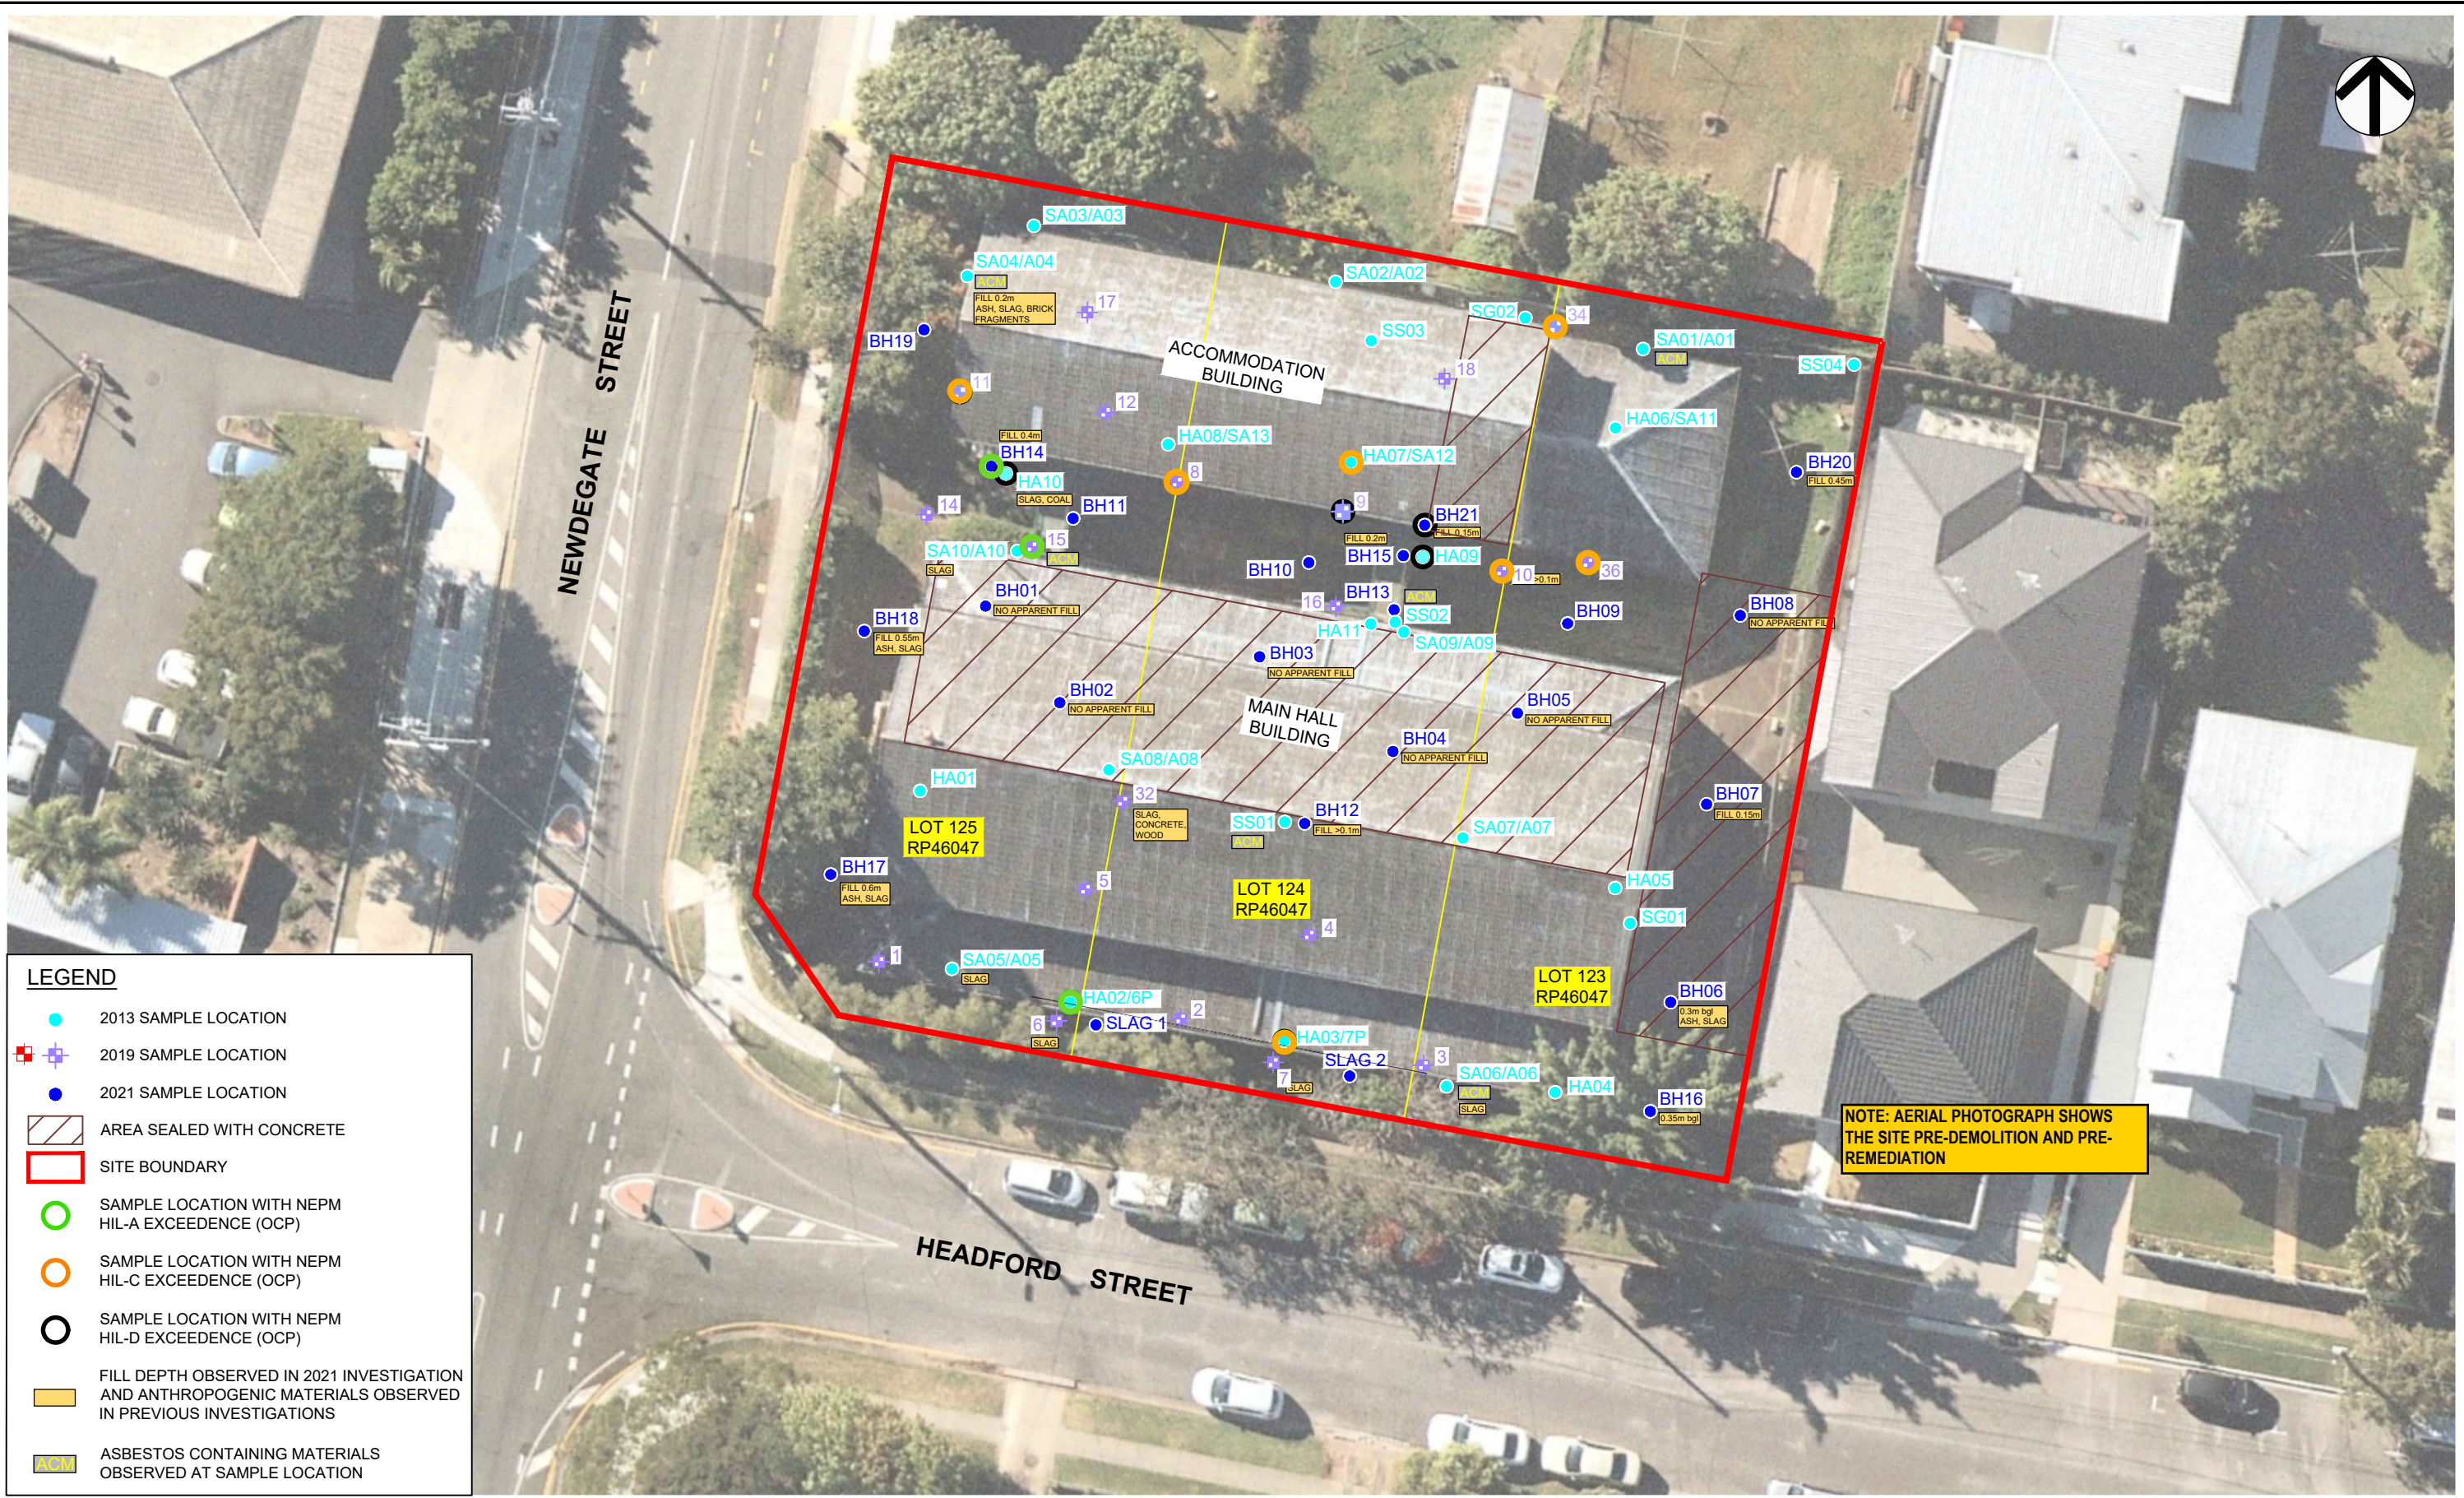
- 2013 SAMPLE LOCATION
- 2019 SAMPLE LOCATION
- 2021 SAMPLE LOCATION
- AREA SEALED WITH CONCRETE
- SITE BOUNDARY
- SAMPLE LOCATION WITH NEPM HIL-A EXCEEDENCE (OCP)
- SAMPLE LOCATION WITH NEPM HIL-C EXCEEDENCE (OCP)
- SAMPLE LOCATION WITH NEPM HIL-D EXCEEDENCE (OCP)
- FILL DEPTH OBSERVED IN 2021 INVESTIGATION AND ANTHROPOGENIC MATERIALS OBSERVED IN PREVIOUS INVESTIGATIONS
- ASBESTOS CONTAINING MATERIALS OBSERVED AT SAMPLE LOCATION

NOTE: AERIAL PHOTOGRAPH SHOWS THE SITE PRE-DEMOLITION AND PRE-REMEDICATION

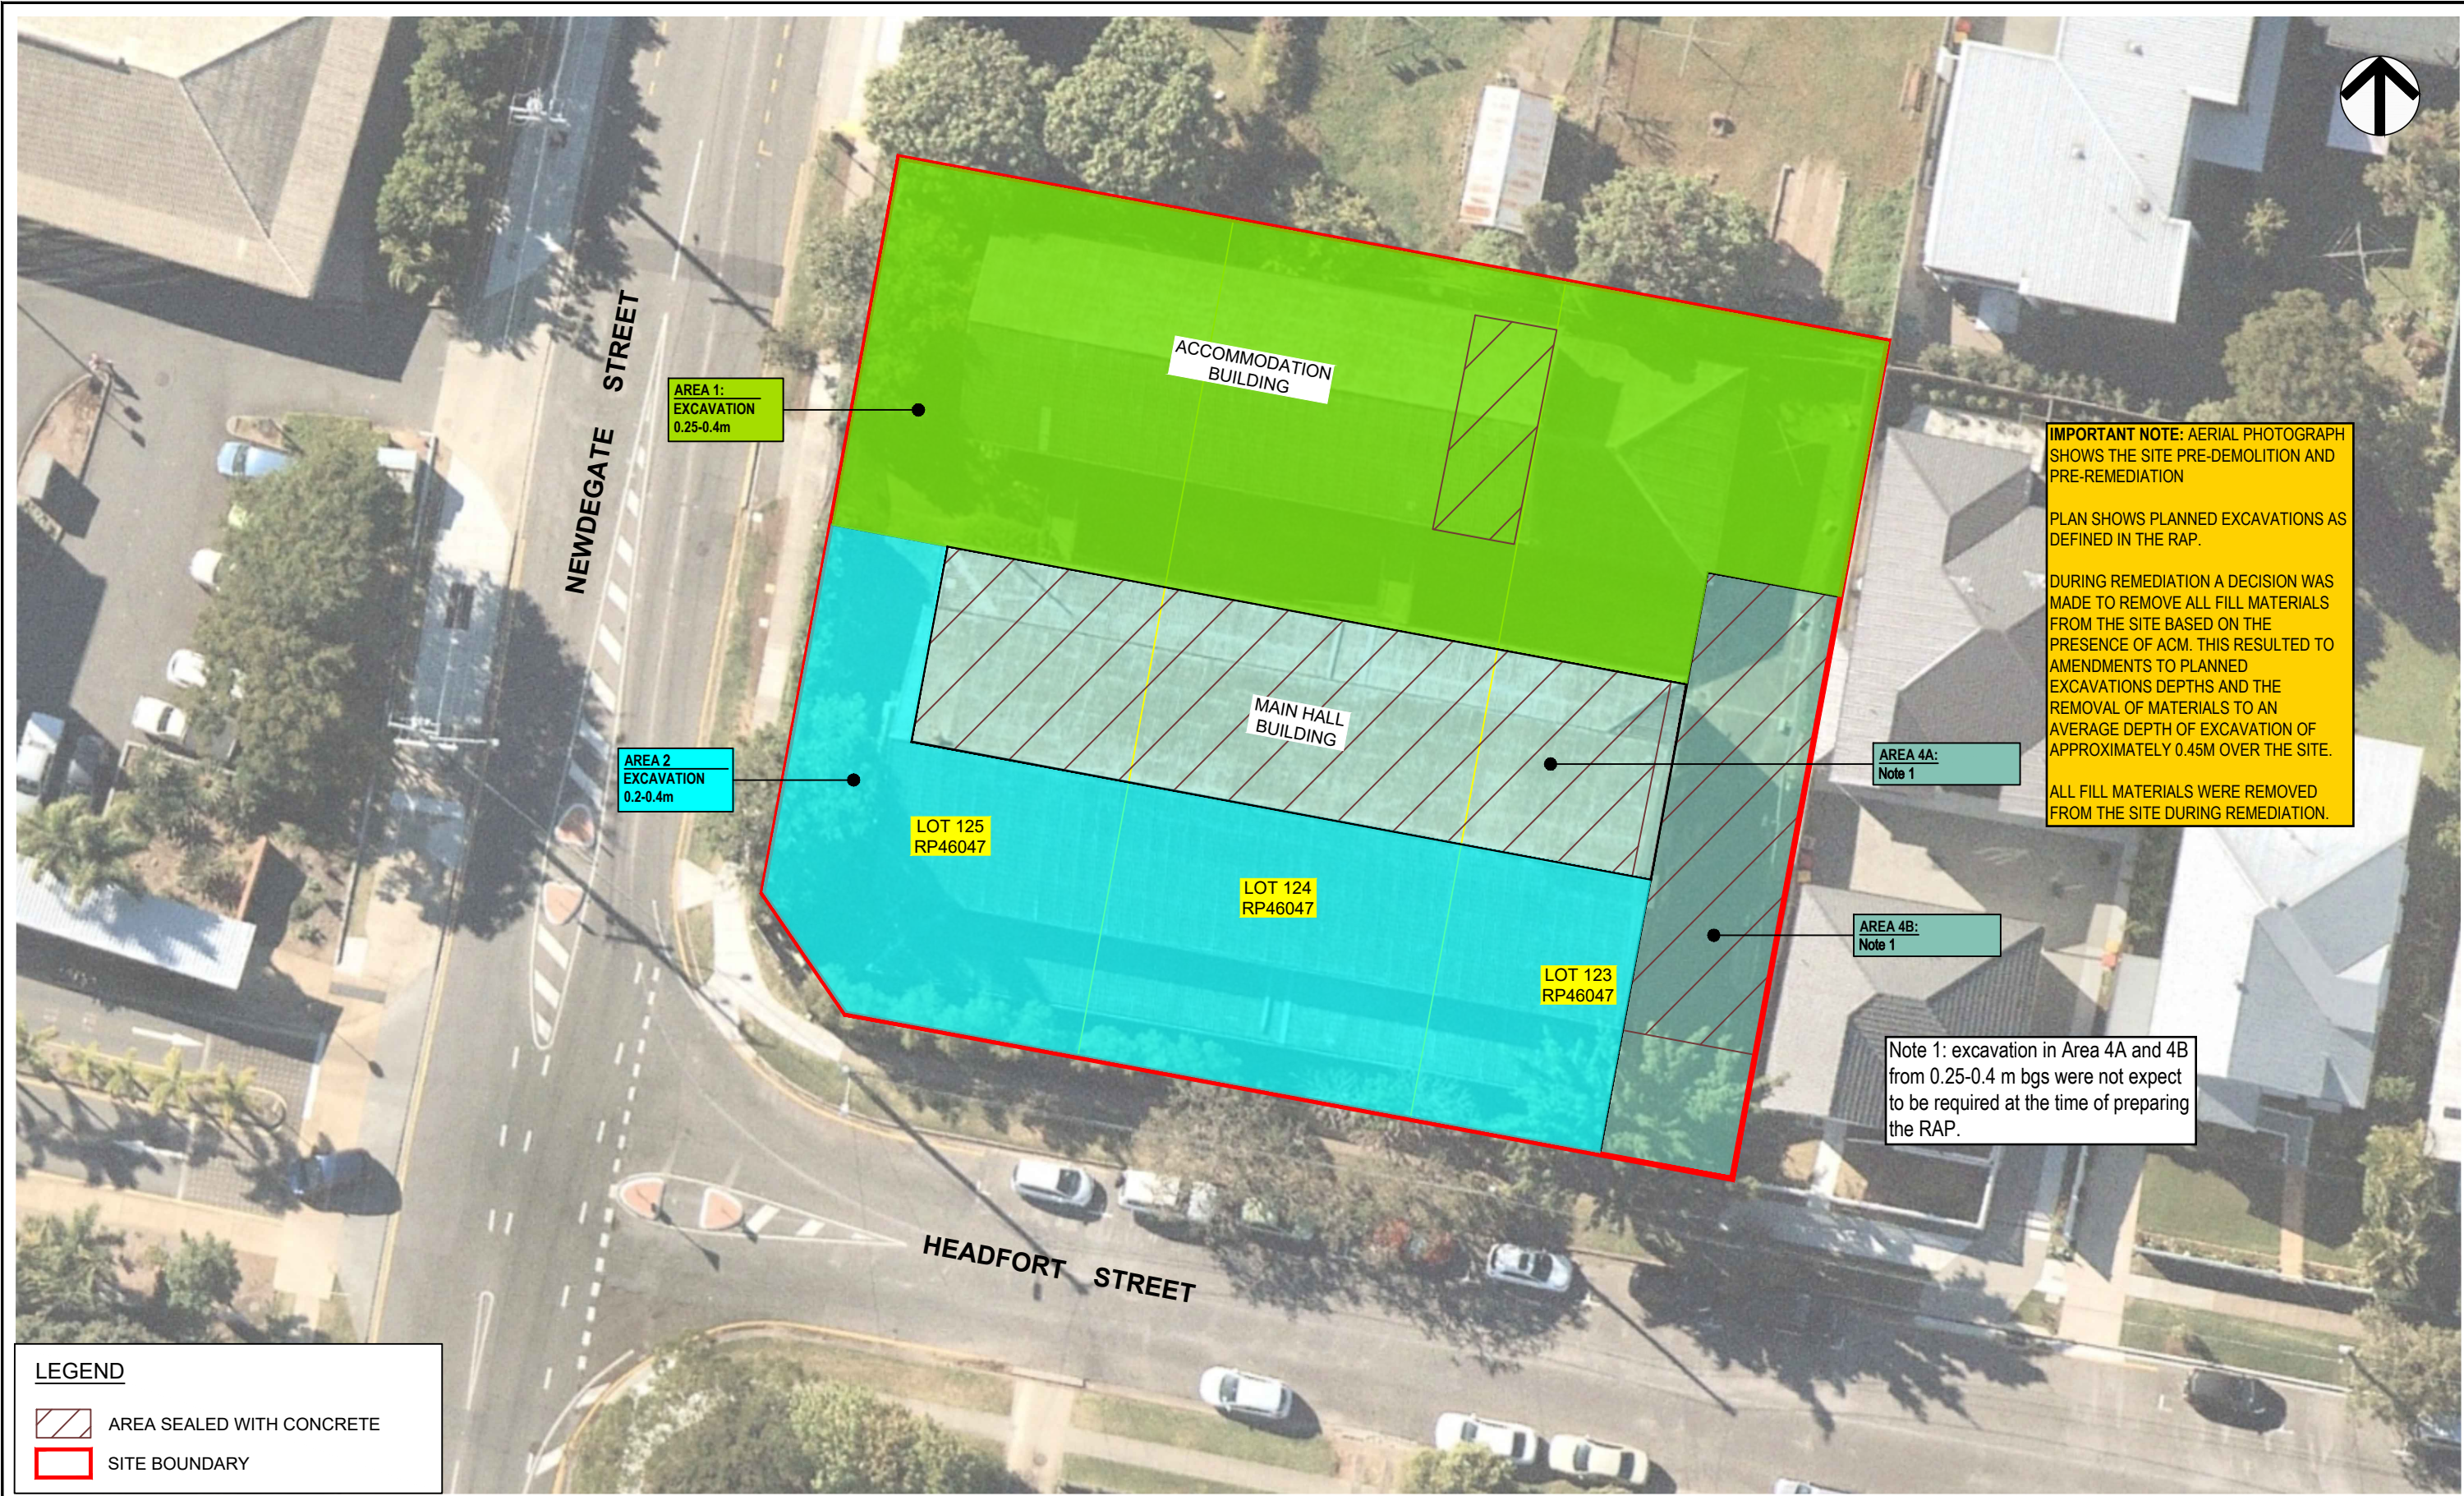
client:	DEPARTMENT OF VETERAN AFFAIRS		
project:	DVA GREENSLOPES 51/53/55 HEADFORT STREET, GREENSLOPES, QLD		
title:	RAP EXCAVATION PLAN 0.25-0.4 M BGS		
project no:	754-BNEEN282781	figure no:	FIGURE 4B
		rev:	A

PLAN SHOWS PLANNED EXCAVATIONS AS DEFINED IN THE RAP.

DURING REMEDIATION A DECISION WAS MADE TO REMOVE ALL FILL MATERIALS FROM THE SITE BASED ON THE PRESENCE OF ACM. THIS RESULTED TO AMENDMENTS TO PLANNED EXCAVATIONS DEPTHS AND THE REMOVAL OF MATERIALS TO AN AVERAGE DEPTH OF EXCAVATION OF APPROXIMATELY 0.45M OVER THE SITE.

ALL FILL MATERIALS WERE REMOVED FROM THE SITE DURING REMEDIATION.

Note 1: excavation in Area 4A and 4B from 0.25-0.4 m bgs were not expect to be required at the time of preparing the RAP.

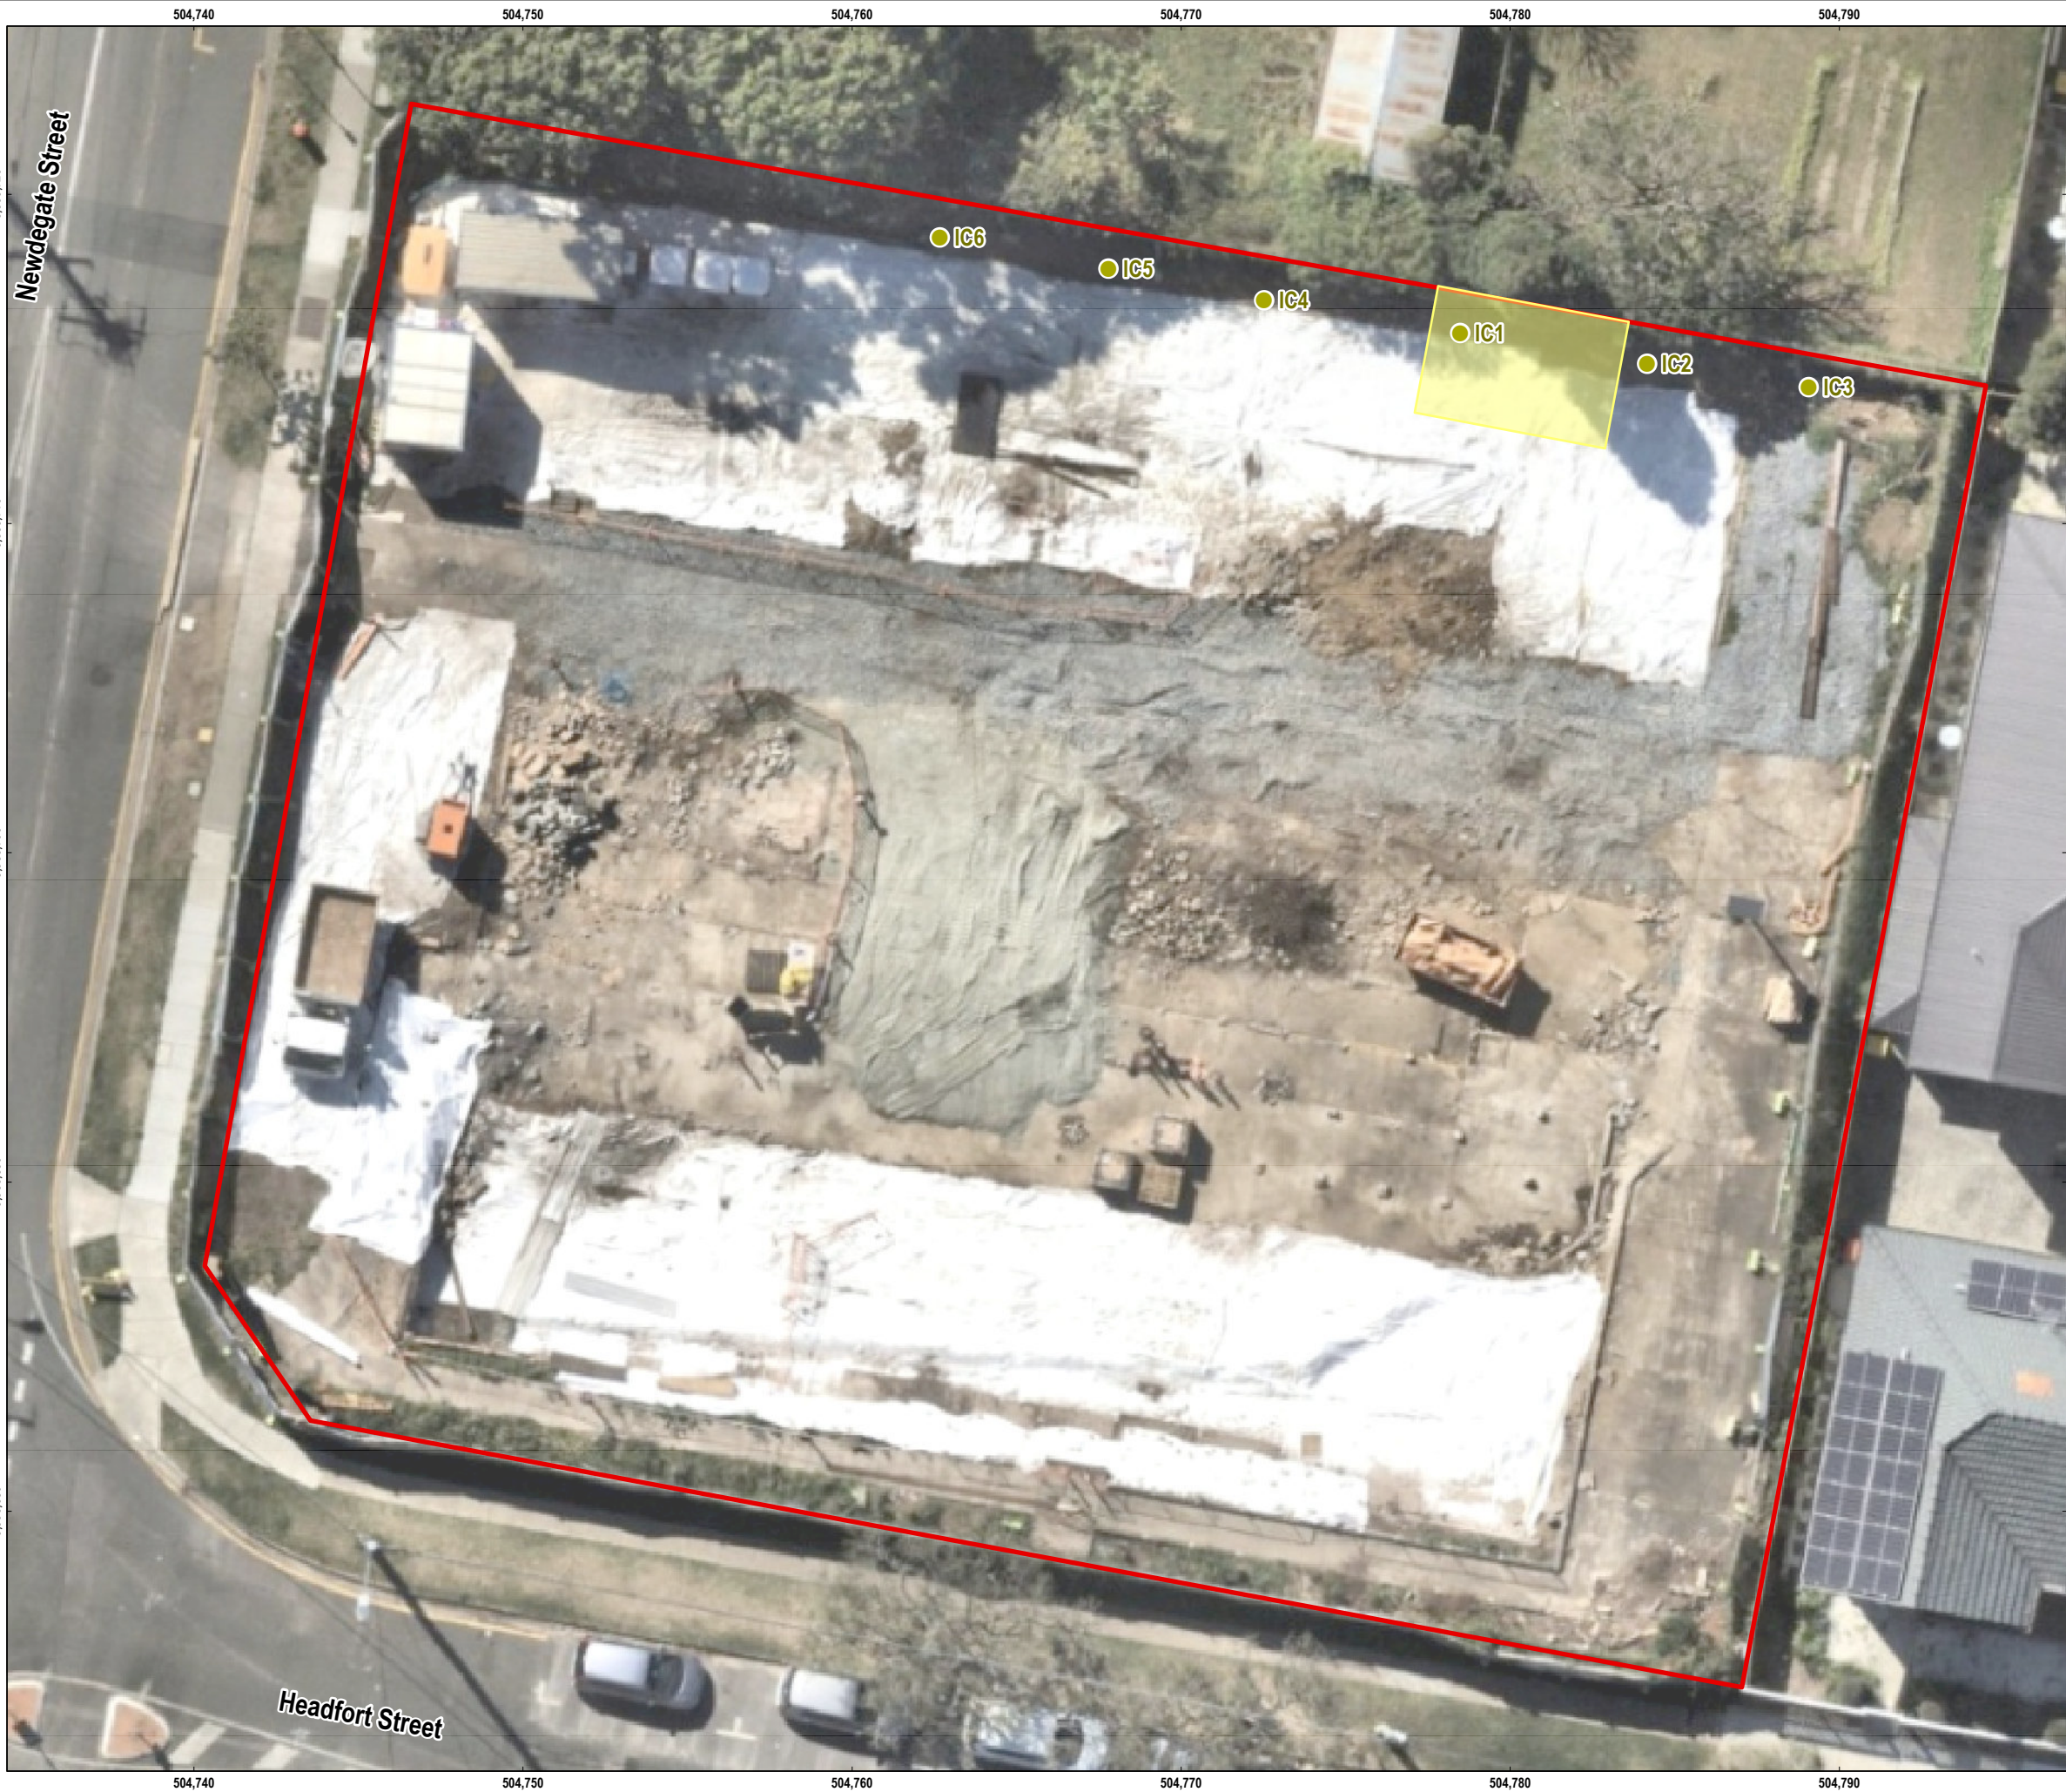
Area 1C Delineation Locations

- LEGEND**
- Area 1C boundary Delineation Locations
 - Area 1C
 - ▭ Surveyed Property Boundary

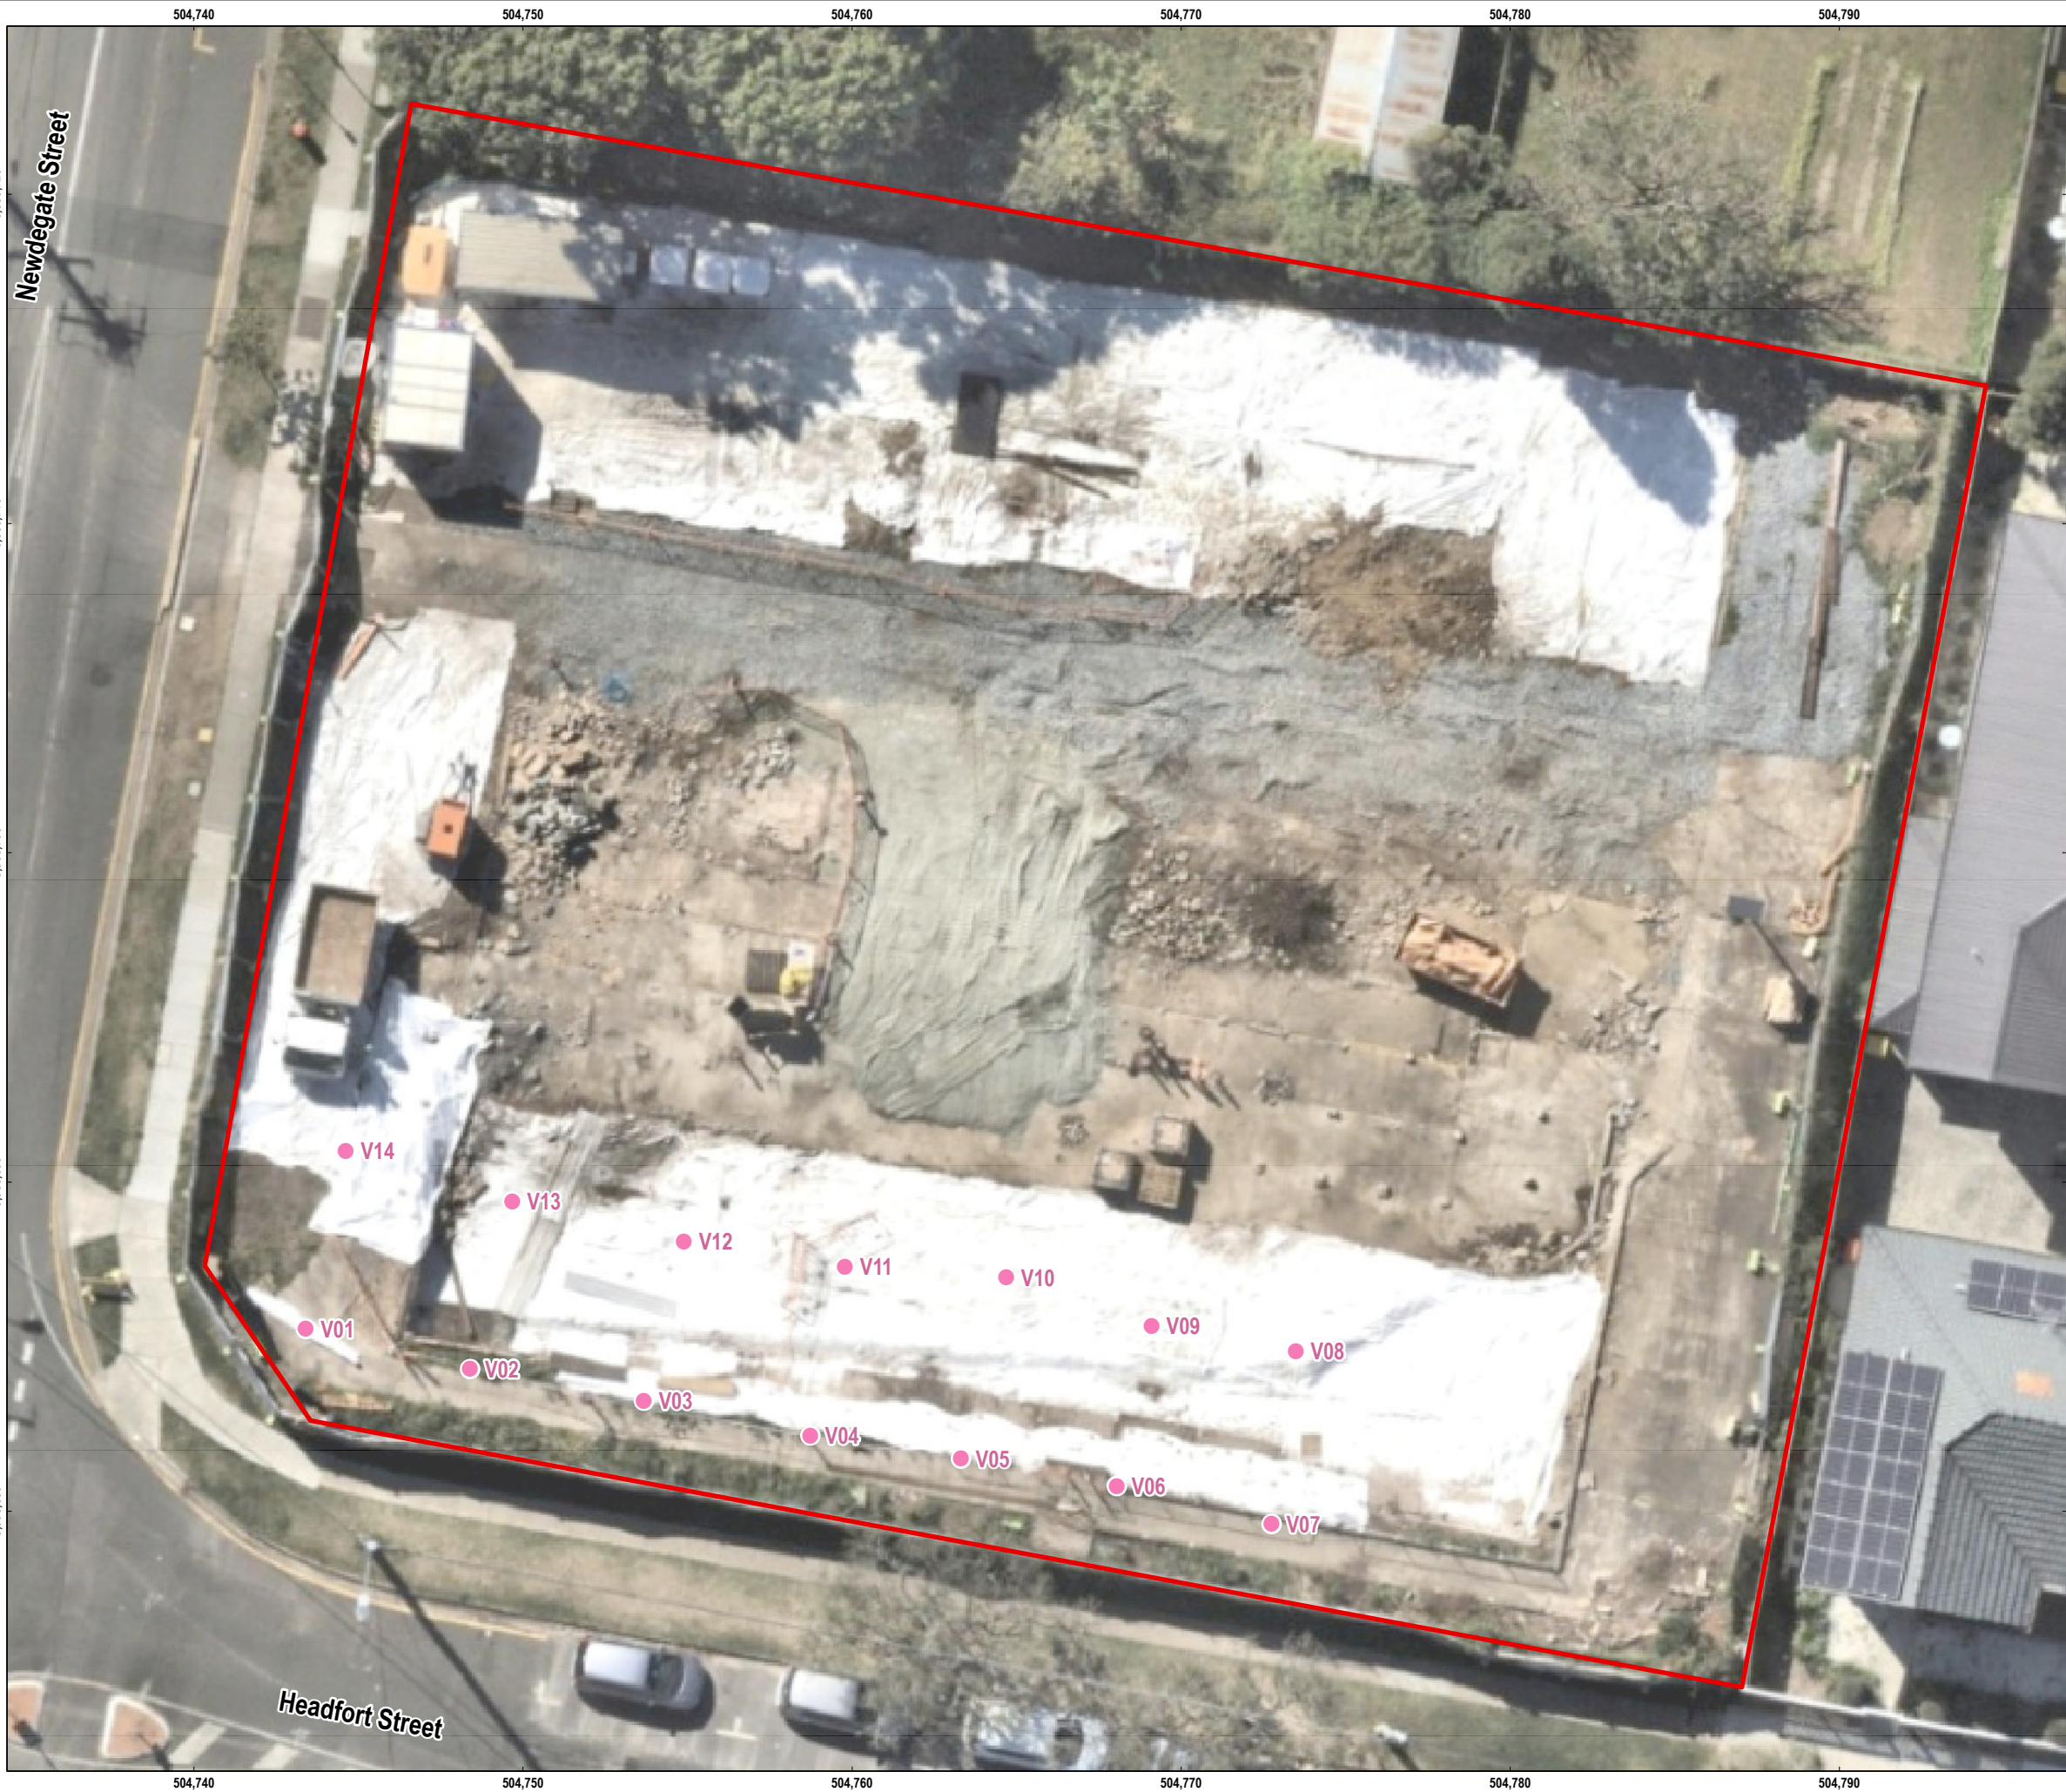
FIGURE 6 **DRAFT**
**Floor Validation Sampling
Prior to Importing Fill**

- LEGEND**
- Floor Sampling Pre Import of Material
 - ▭ Surveyed Property Boundary

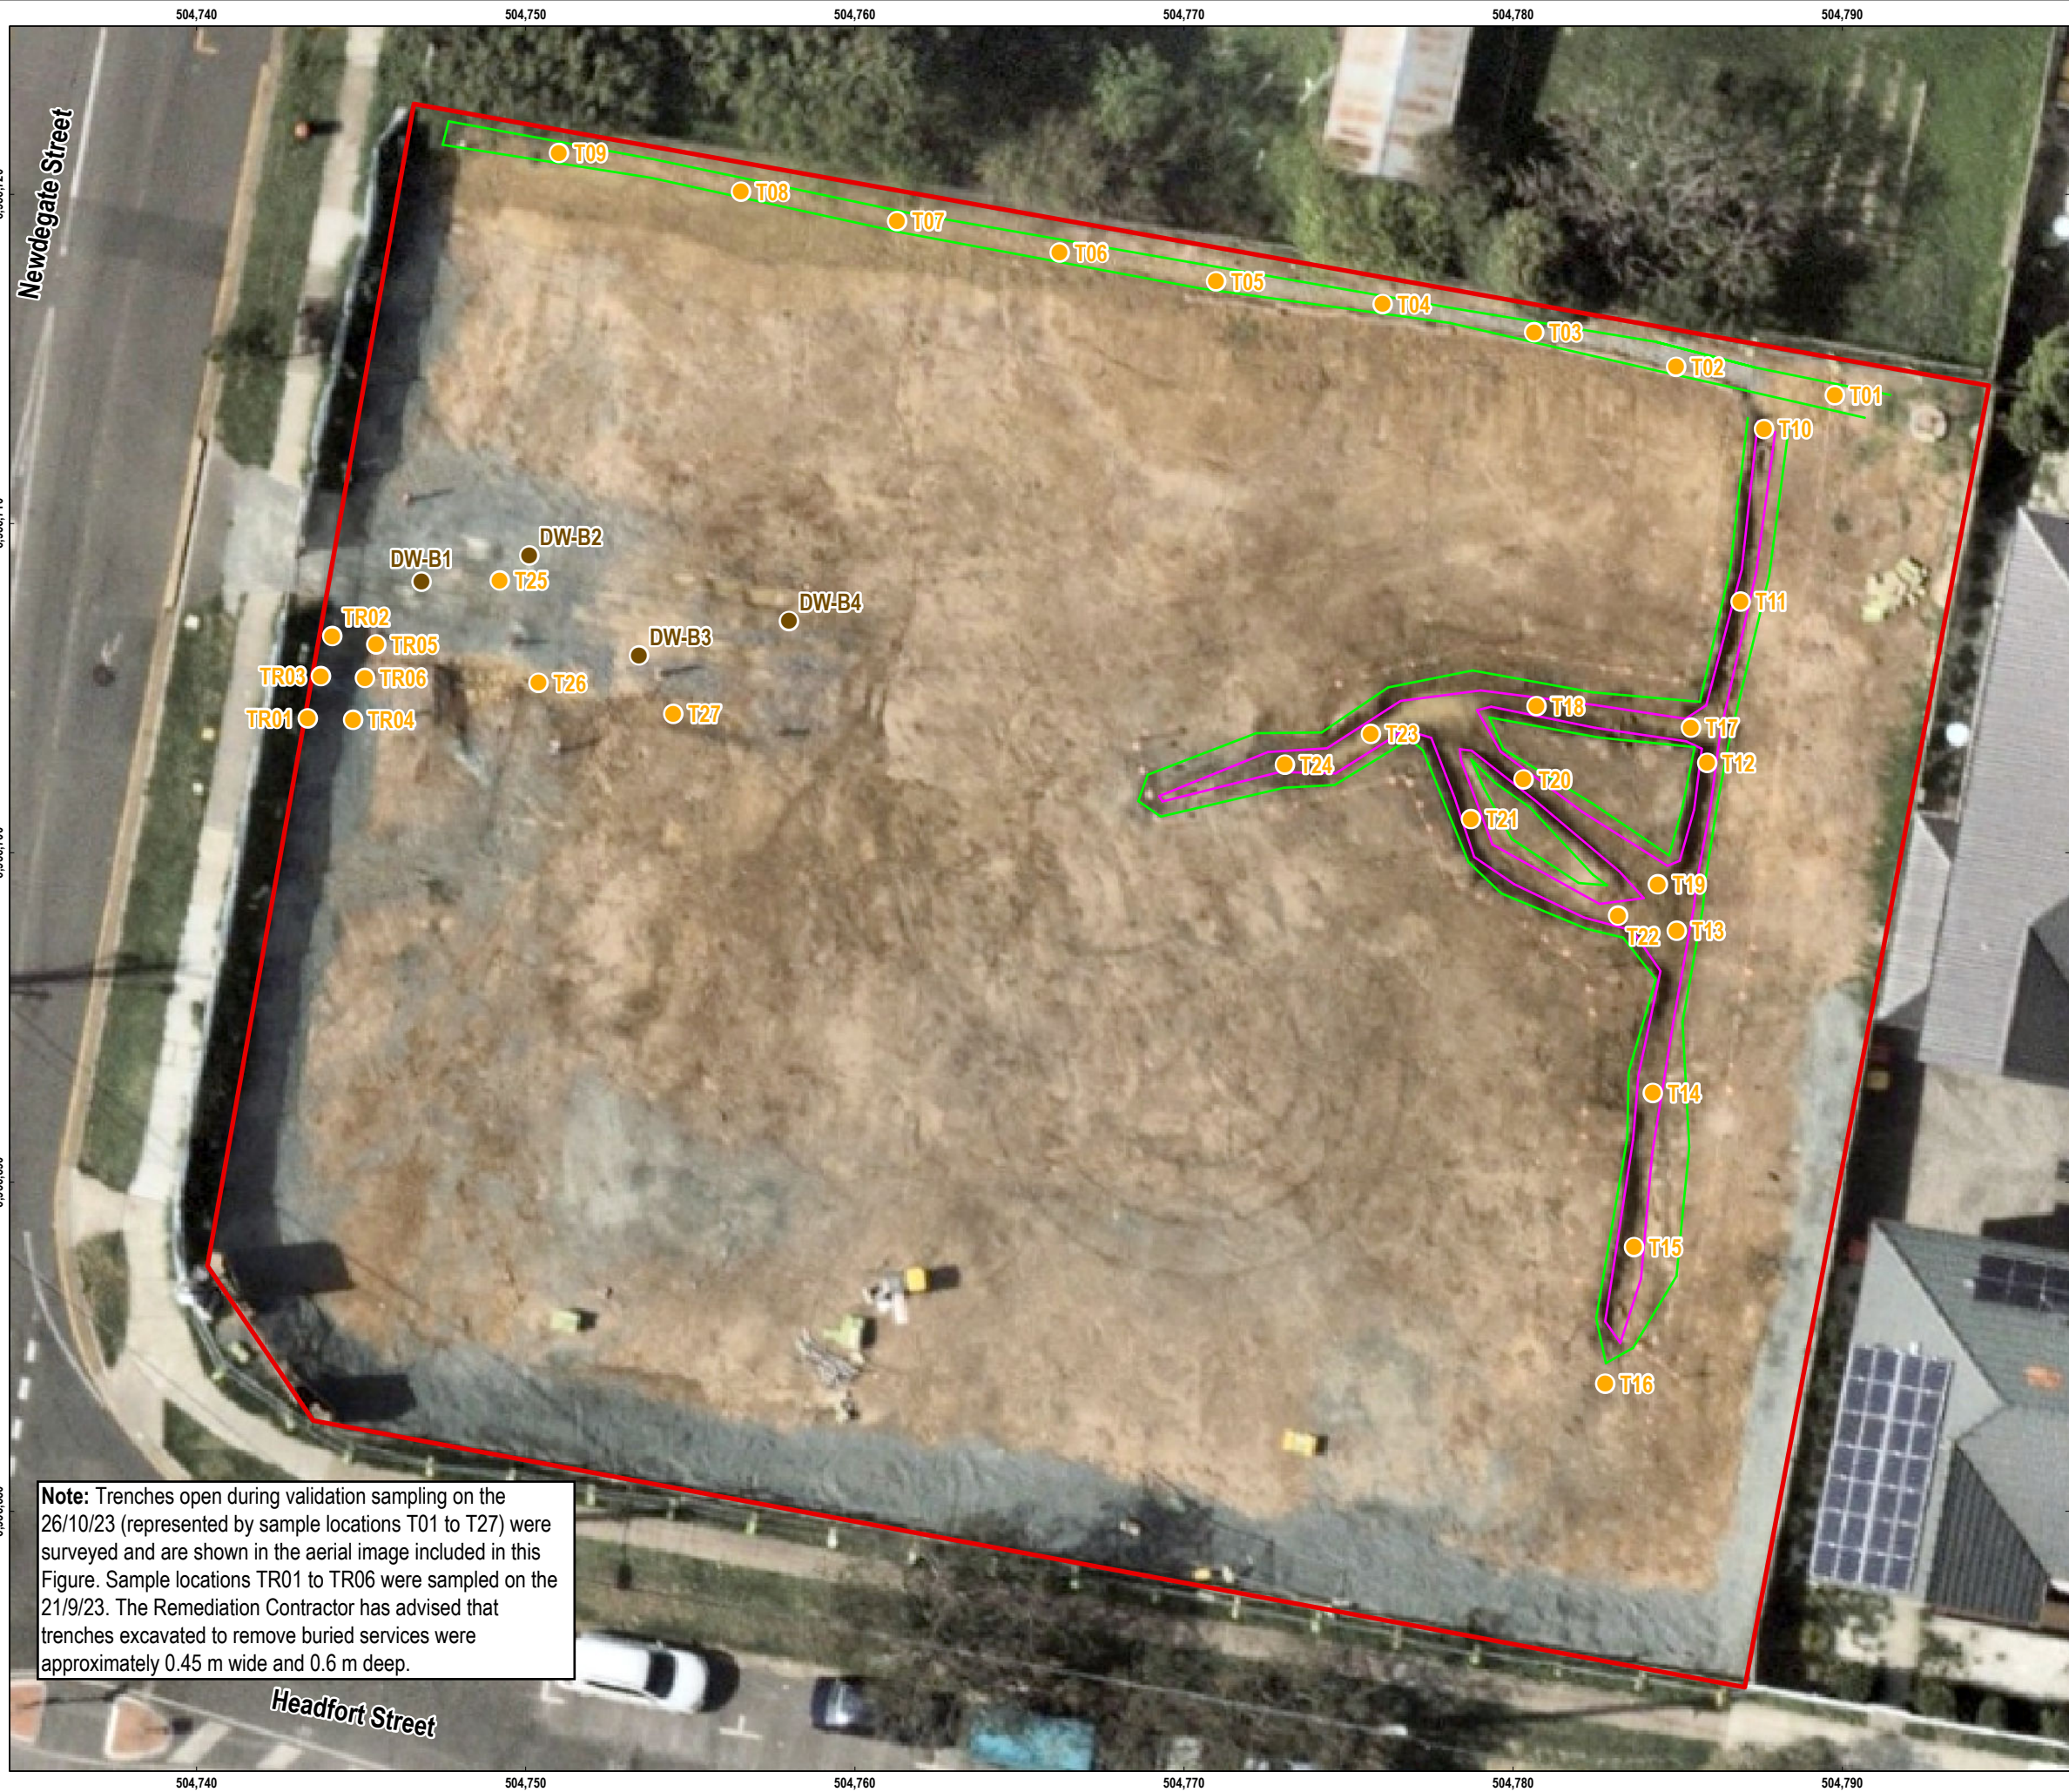
**Trench and Driveway
Sampling Locations**

- LEGEND**
- Trench Validation Point
 - Driveway Validation Sample
 - Top of trench
 - Bottom of trench
 - ▭ Surveyed Property Boundary

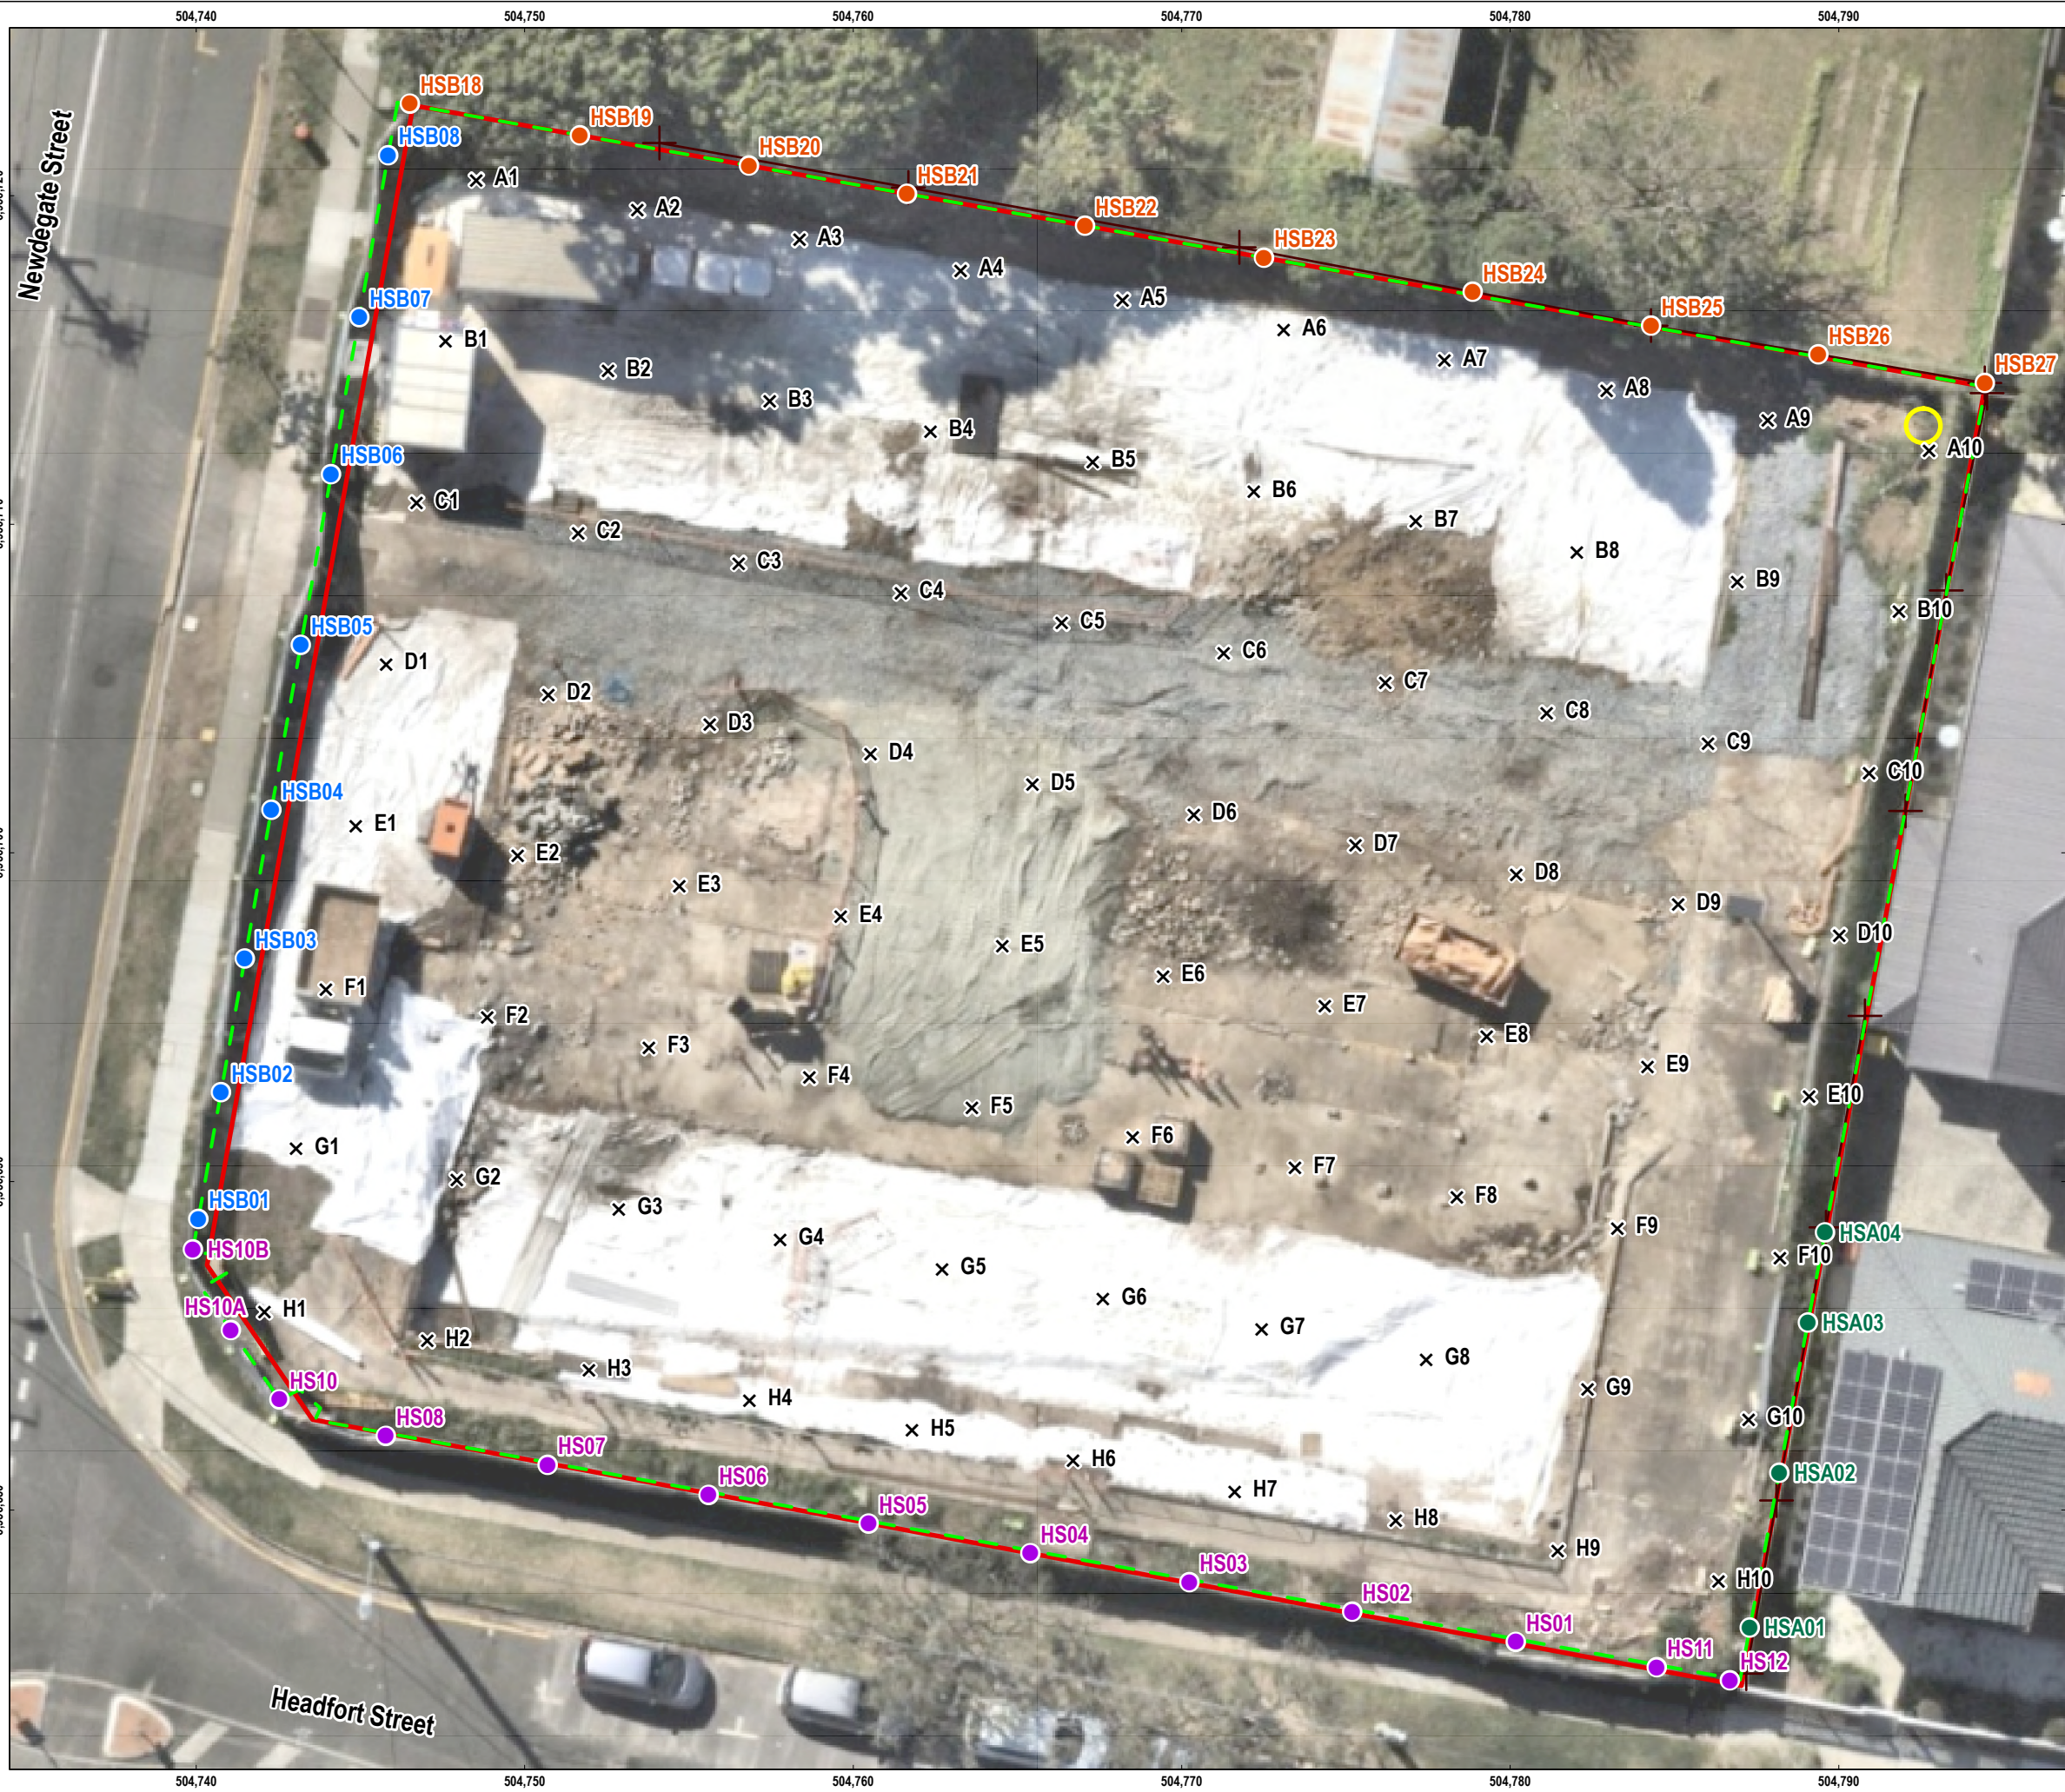
Final Excavation Floor
and Boundary Validation Samples

- × Excavation Floor Validation Point
- Headfort Street Boundary Validation Point
- Newdegate Street Boundary Validation Point
- Northern Boundary Validation Point
- Eastern Boundary Validation Point
- Horizontal Extent of Excavation
- Manhole Cover
- Surveyed Property Boundary
