client:	DEPARTMENT OF VETERAN AFFAIRS		
project:	DVA GREENSLOPES 51/53/55 HEADFORT STREET, GREENSLOPES, QLD		
title:	SITE LOCATION PLAN		
project no:	754-BNEEN282781	figure no:	FIGURE 1
		rev:	A

client:	DEPARTMENT OF VETERAN AFFAIRS		
project:	DVA GREENSLOPES 51/53/55 HEADFORT STREET, GREENSLOPES, QLD		
title:	SUMMARY OF HUMAN HEALTH EXCEEDANCES AND FILL DEPTH		
project no:	754-BNEEN282781	figure no:	FIGURE 3
		rev:	A

Figure 15 Pre-Remediation Illustrative Conceptual Site Model

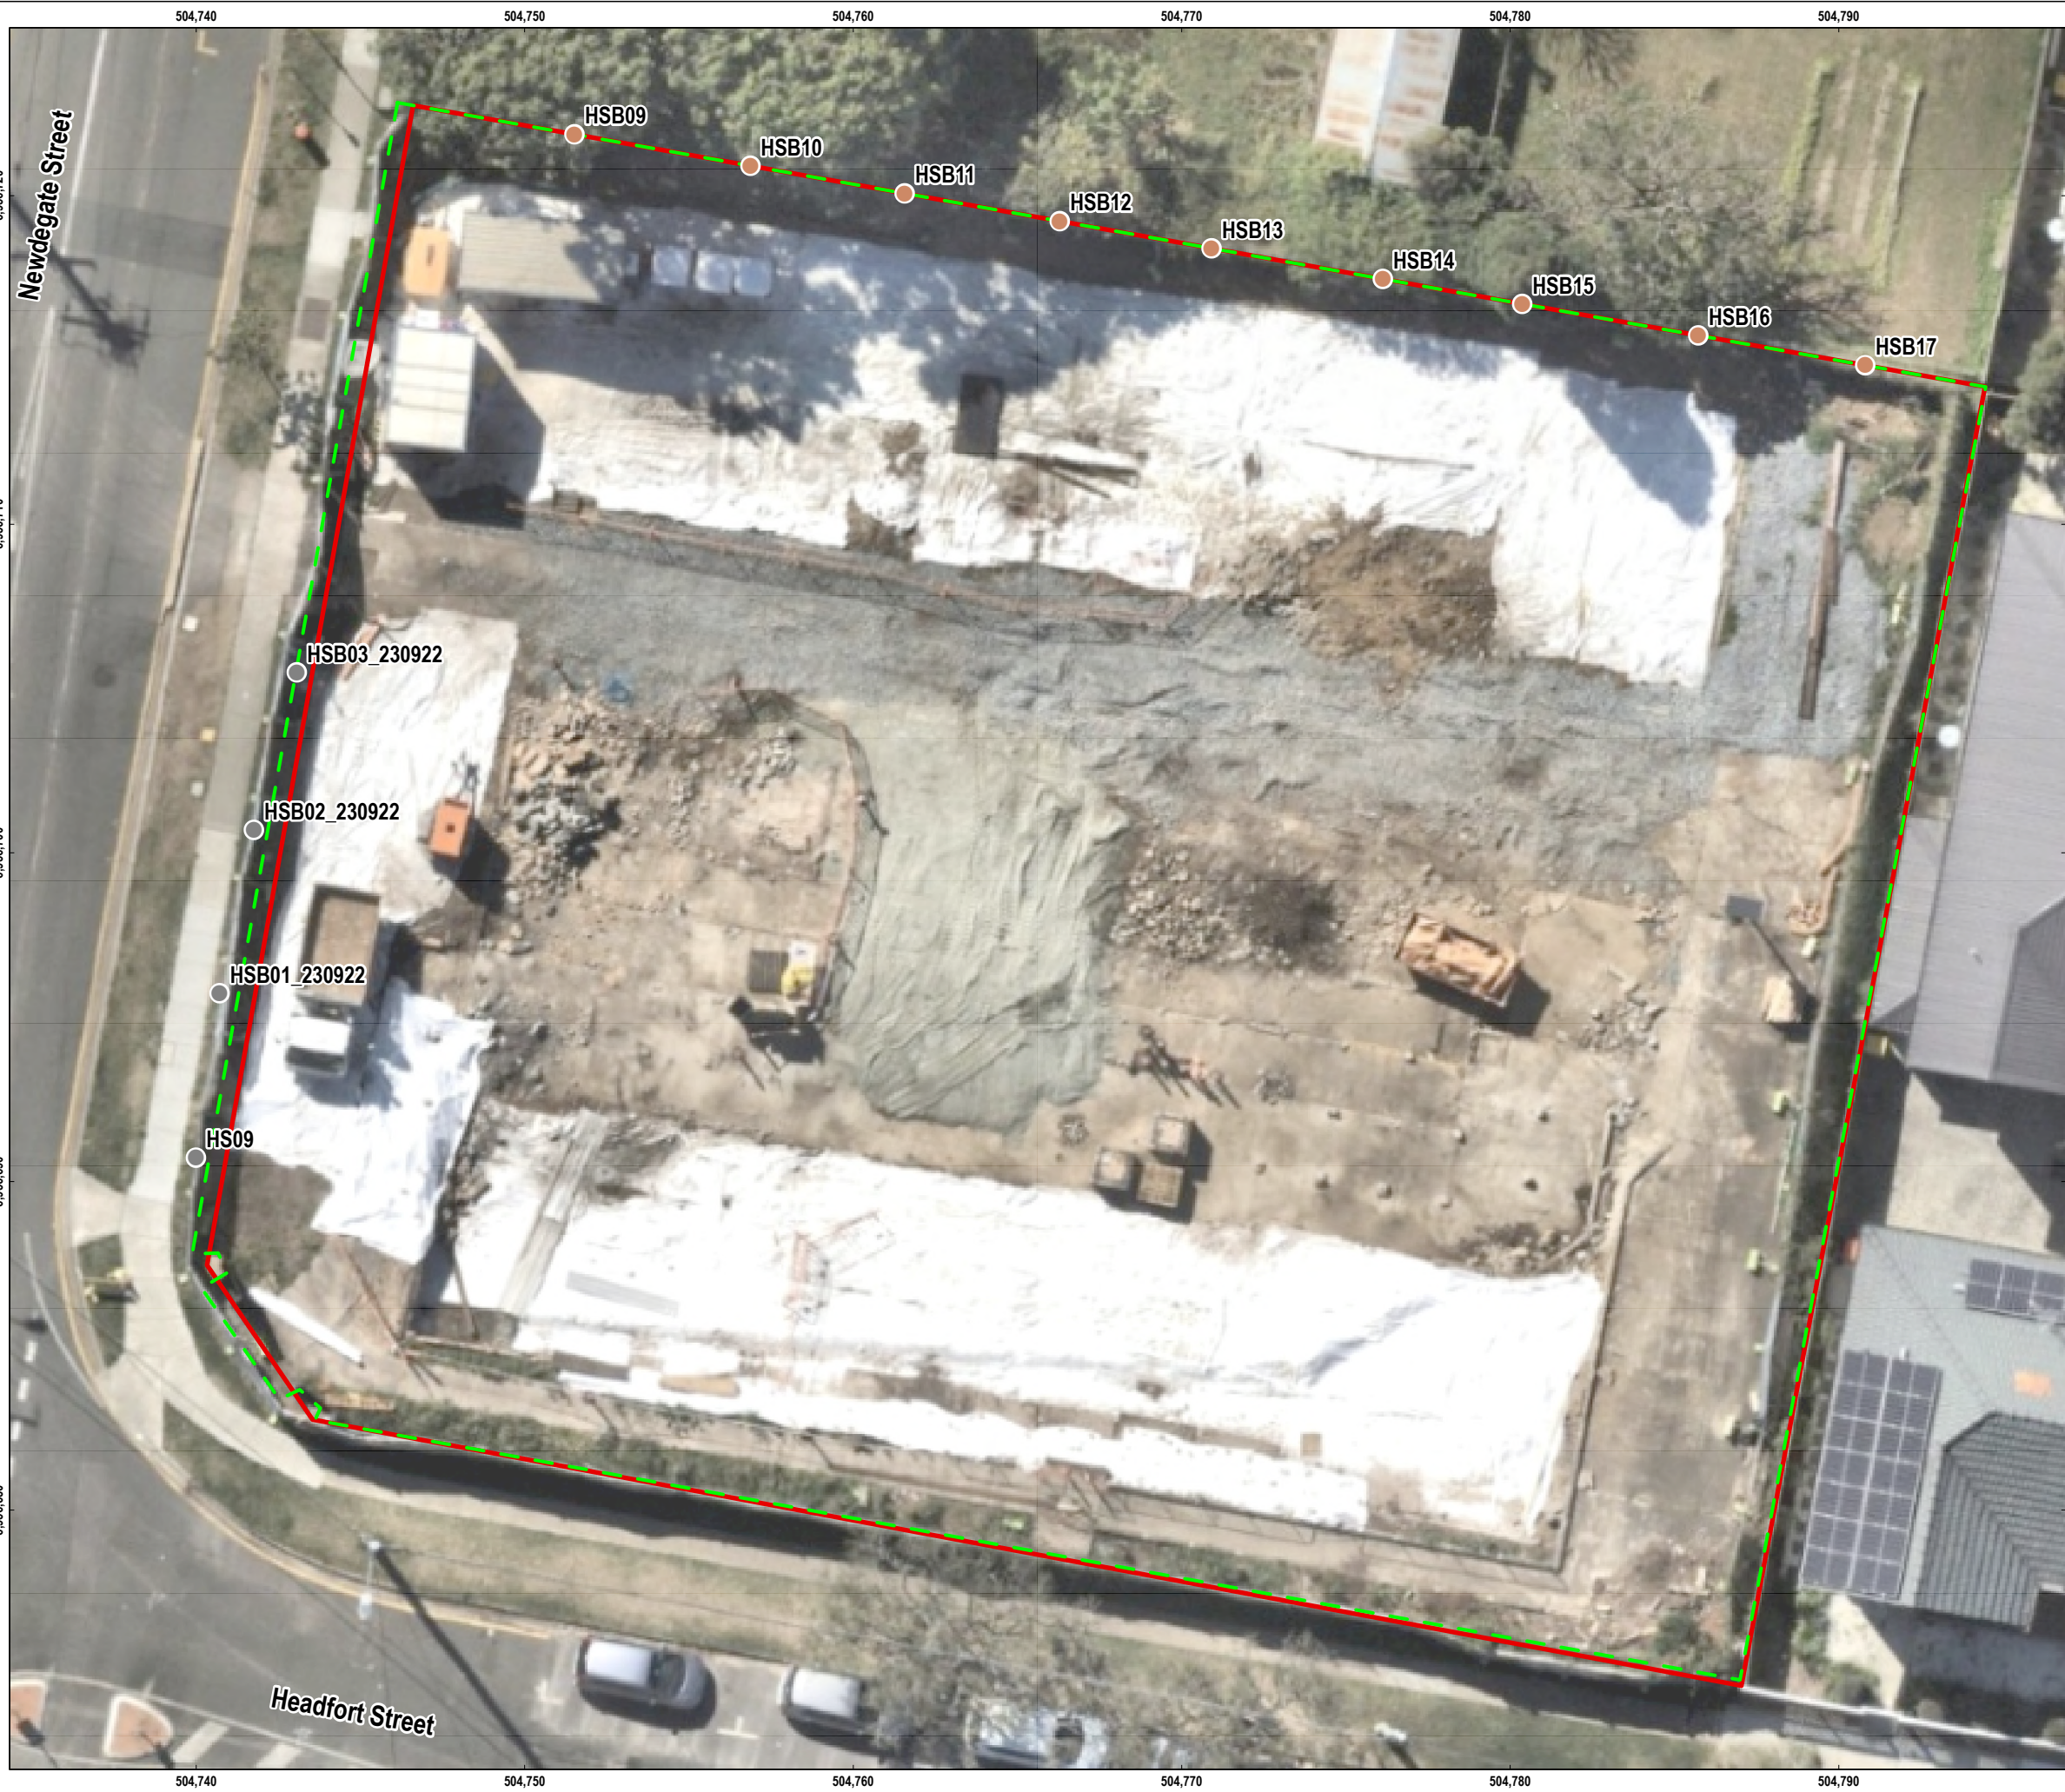
DEPARTMENT OF VETERAN AFFAIRS
DVA GREENSLOPES
51-55 HEADFORT STREET, GREENSLOPES, QLD
FIGURE 9 **DRAFT**
**Redundant Newdegate Street &
Northern Boundary Validation Locations**

- LEGEND**
- Redundant Newdegate Street Validation Locations
 - Redundant Northern Boundary Validation Location
 - Horizontal Excavation Extent
 - ▭ Surveyed Property Boundary

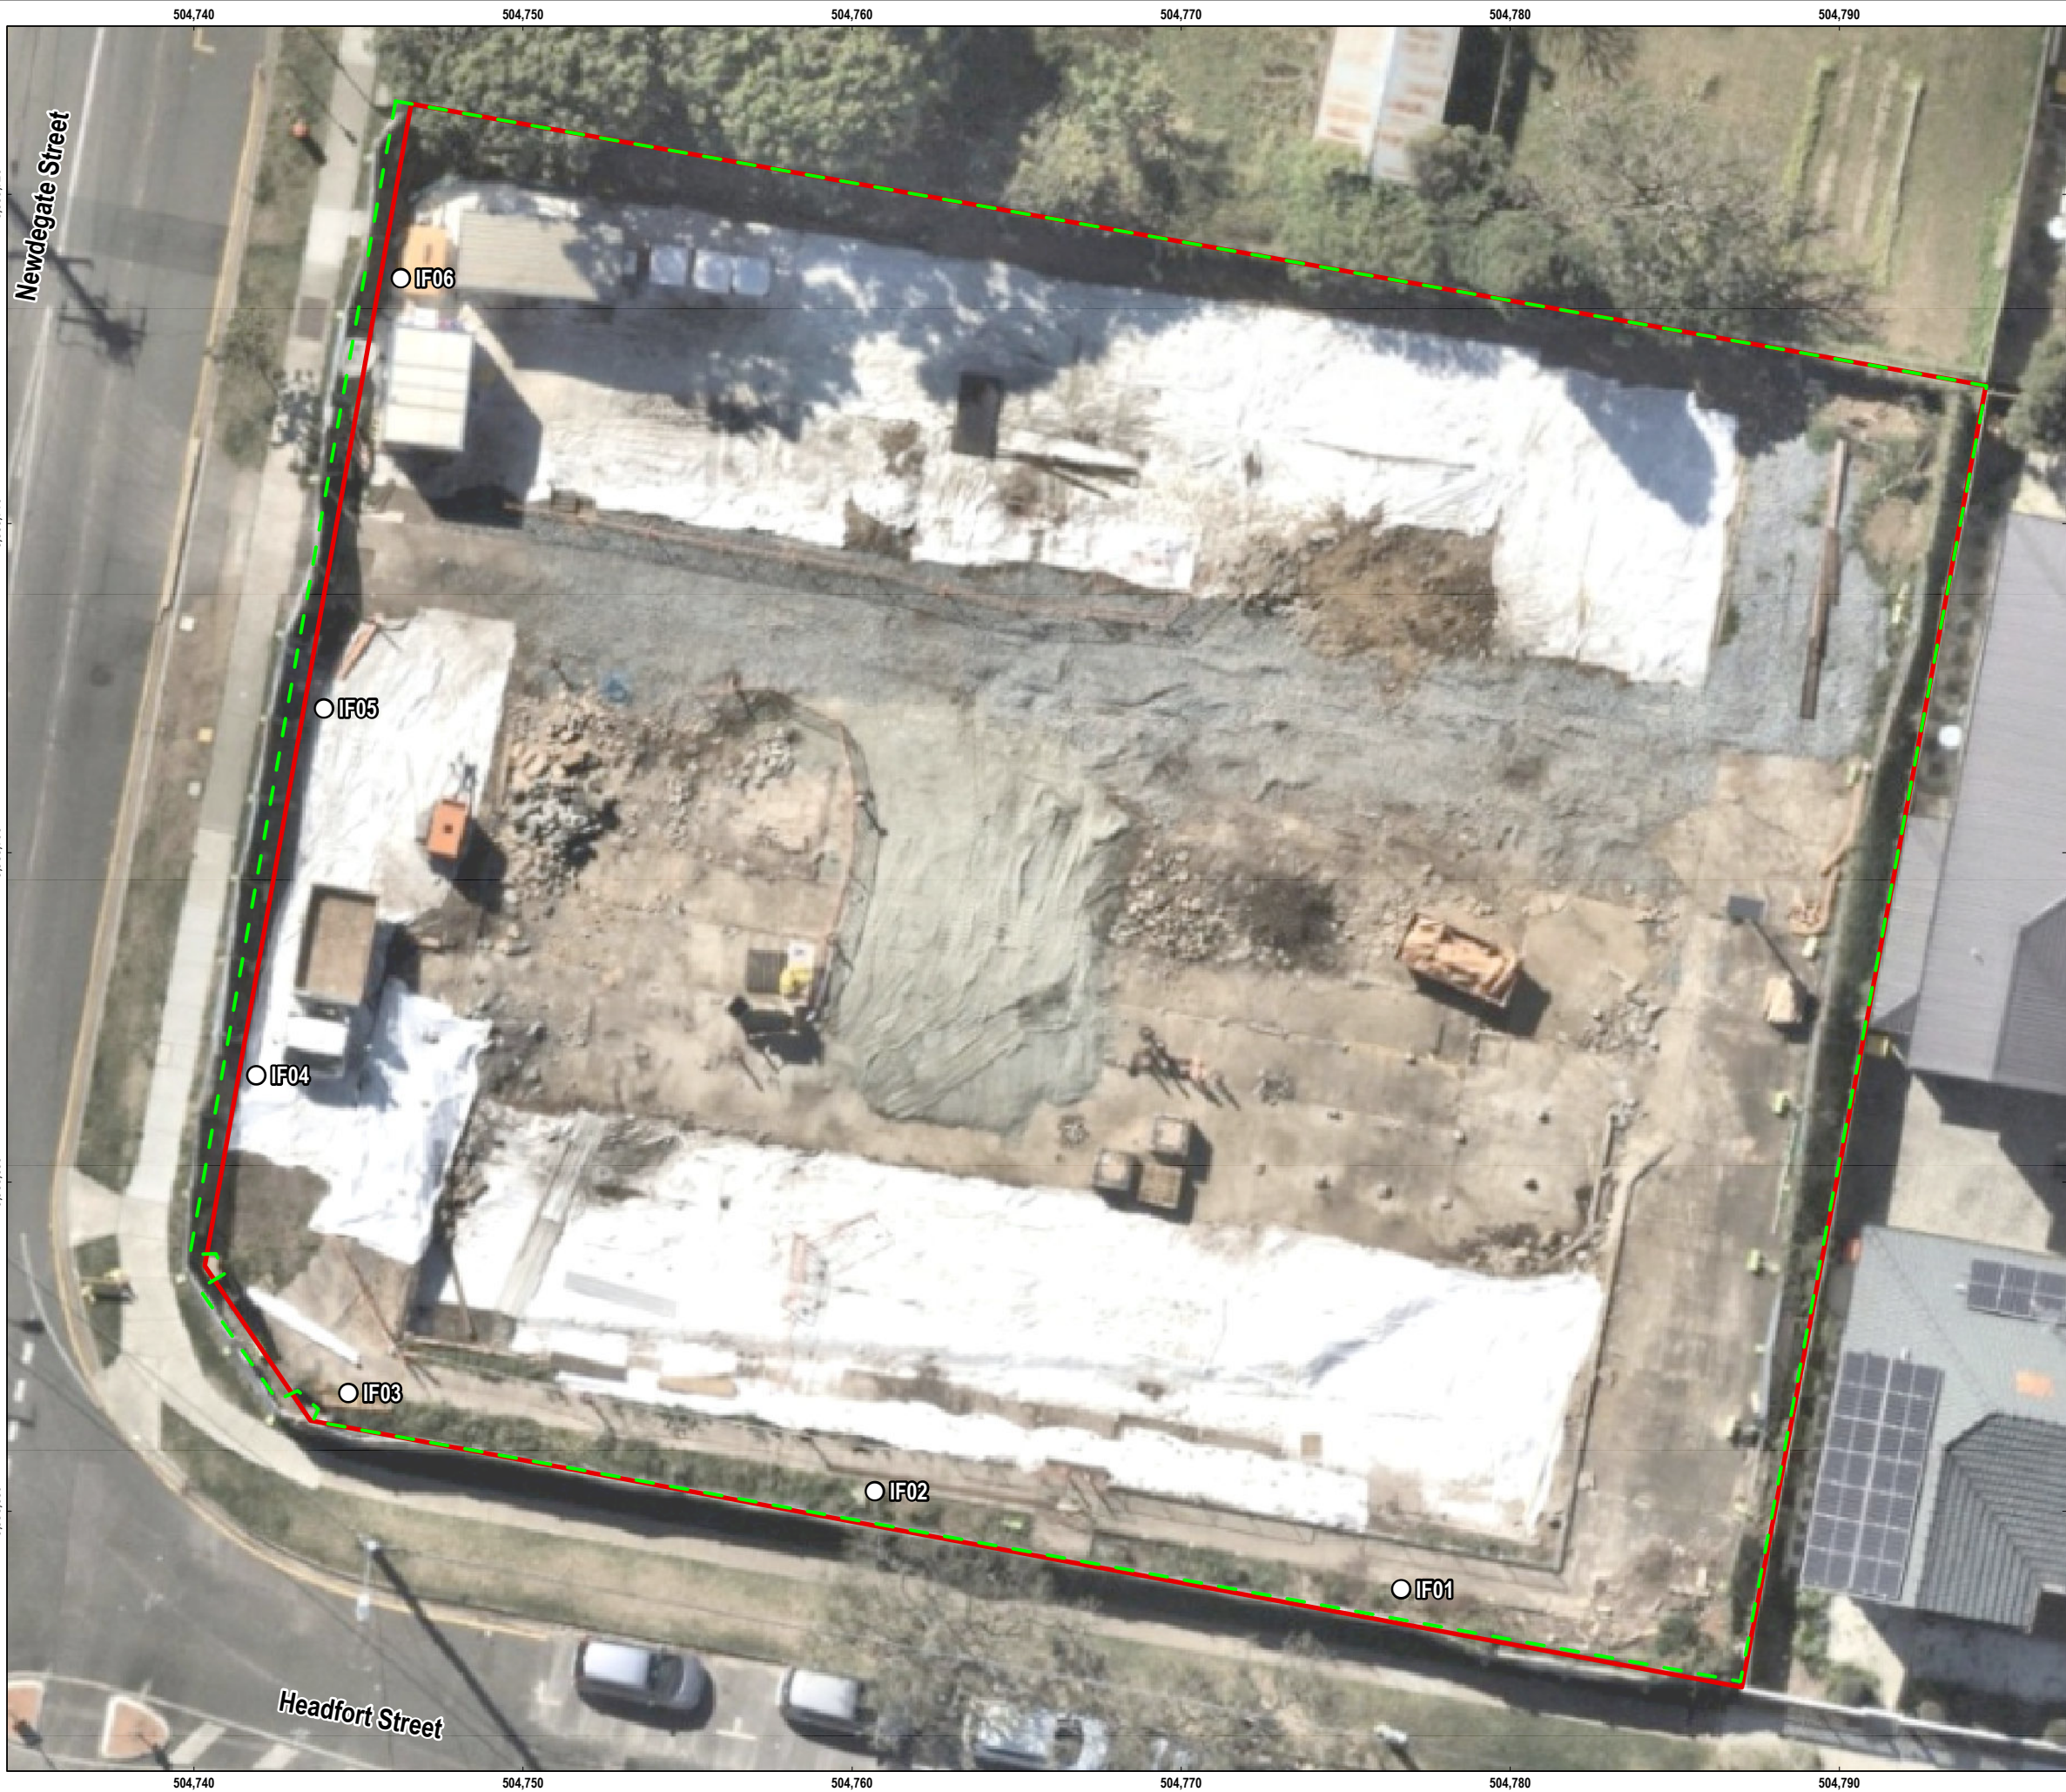
DEPARTMENT OF VETERAN AFFAIRS
DVA GREENSLOPES
51-55 HEADFORT STREET, GREENSLOPES, QLD
FIGURE 10 **DRAFT**
Imported Fill Sample Locations

- LEGEND**
- Imported Fill Sample Locations
 - Horizontal Excavation Extent
 - ▭ Surveyed Property Boundary

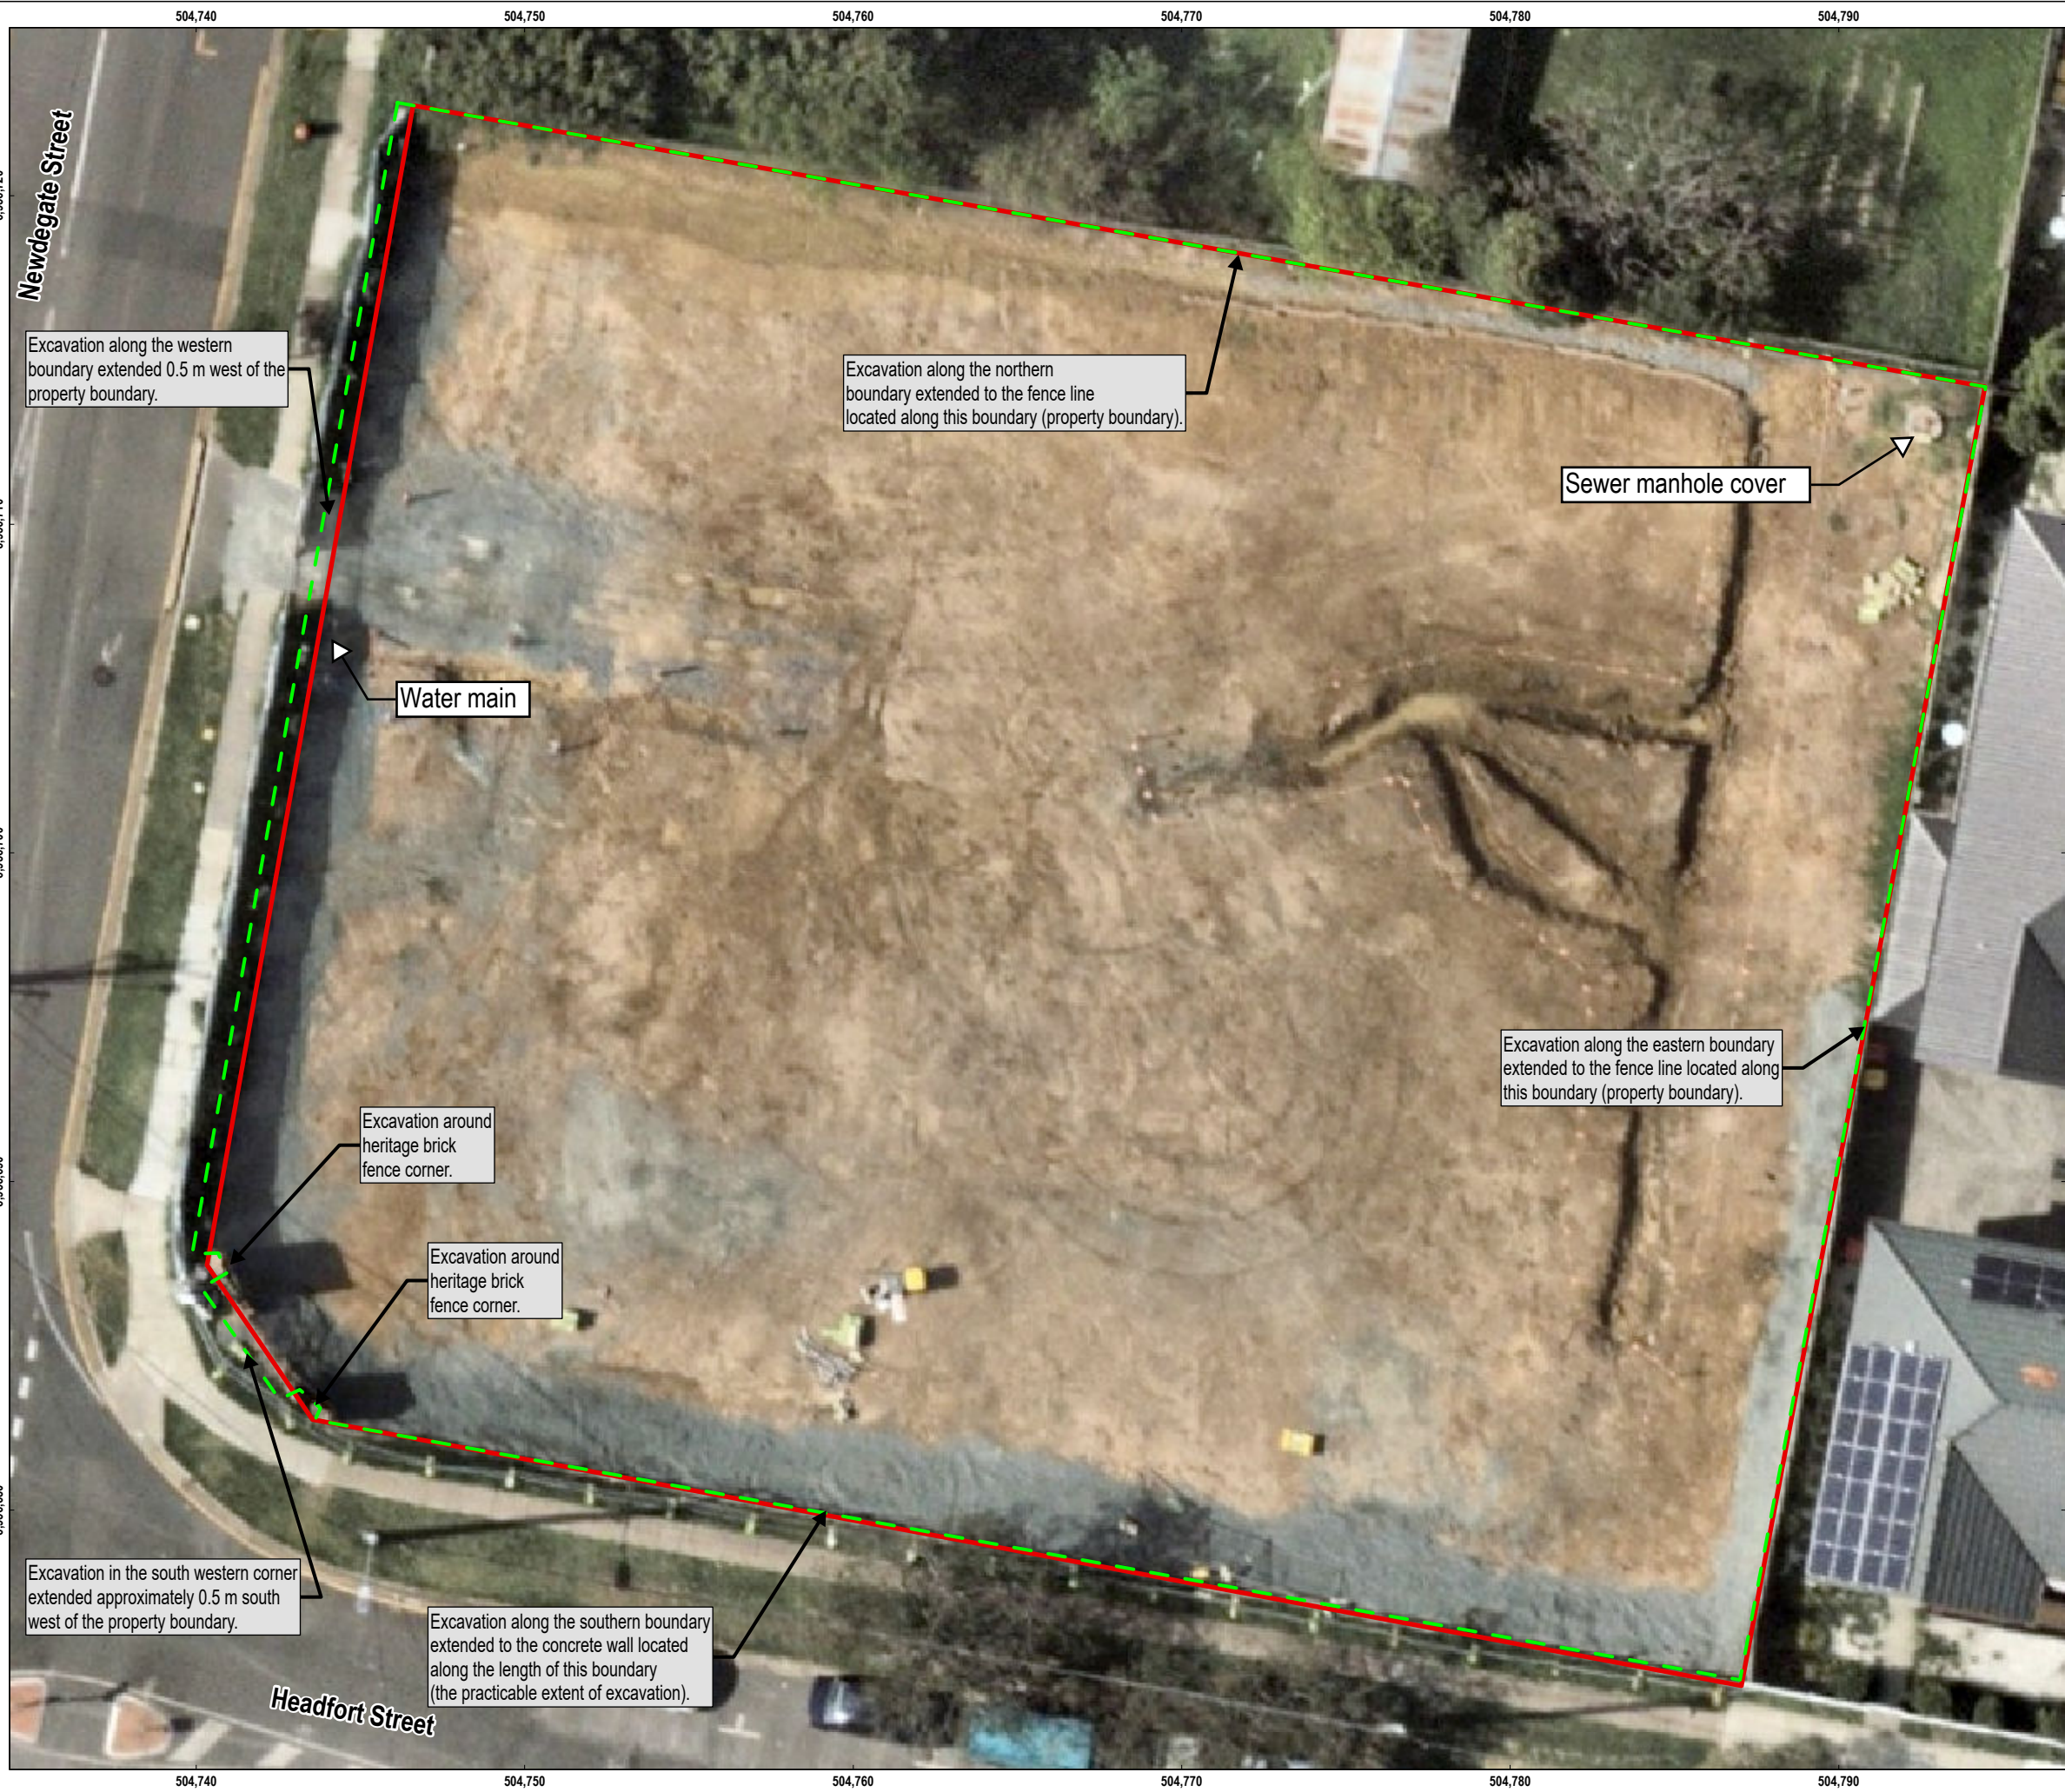
Excavation Extents

- LEGEND**
- Horizontal Excavation Extent
 - Surveyed Property Boundary

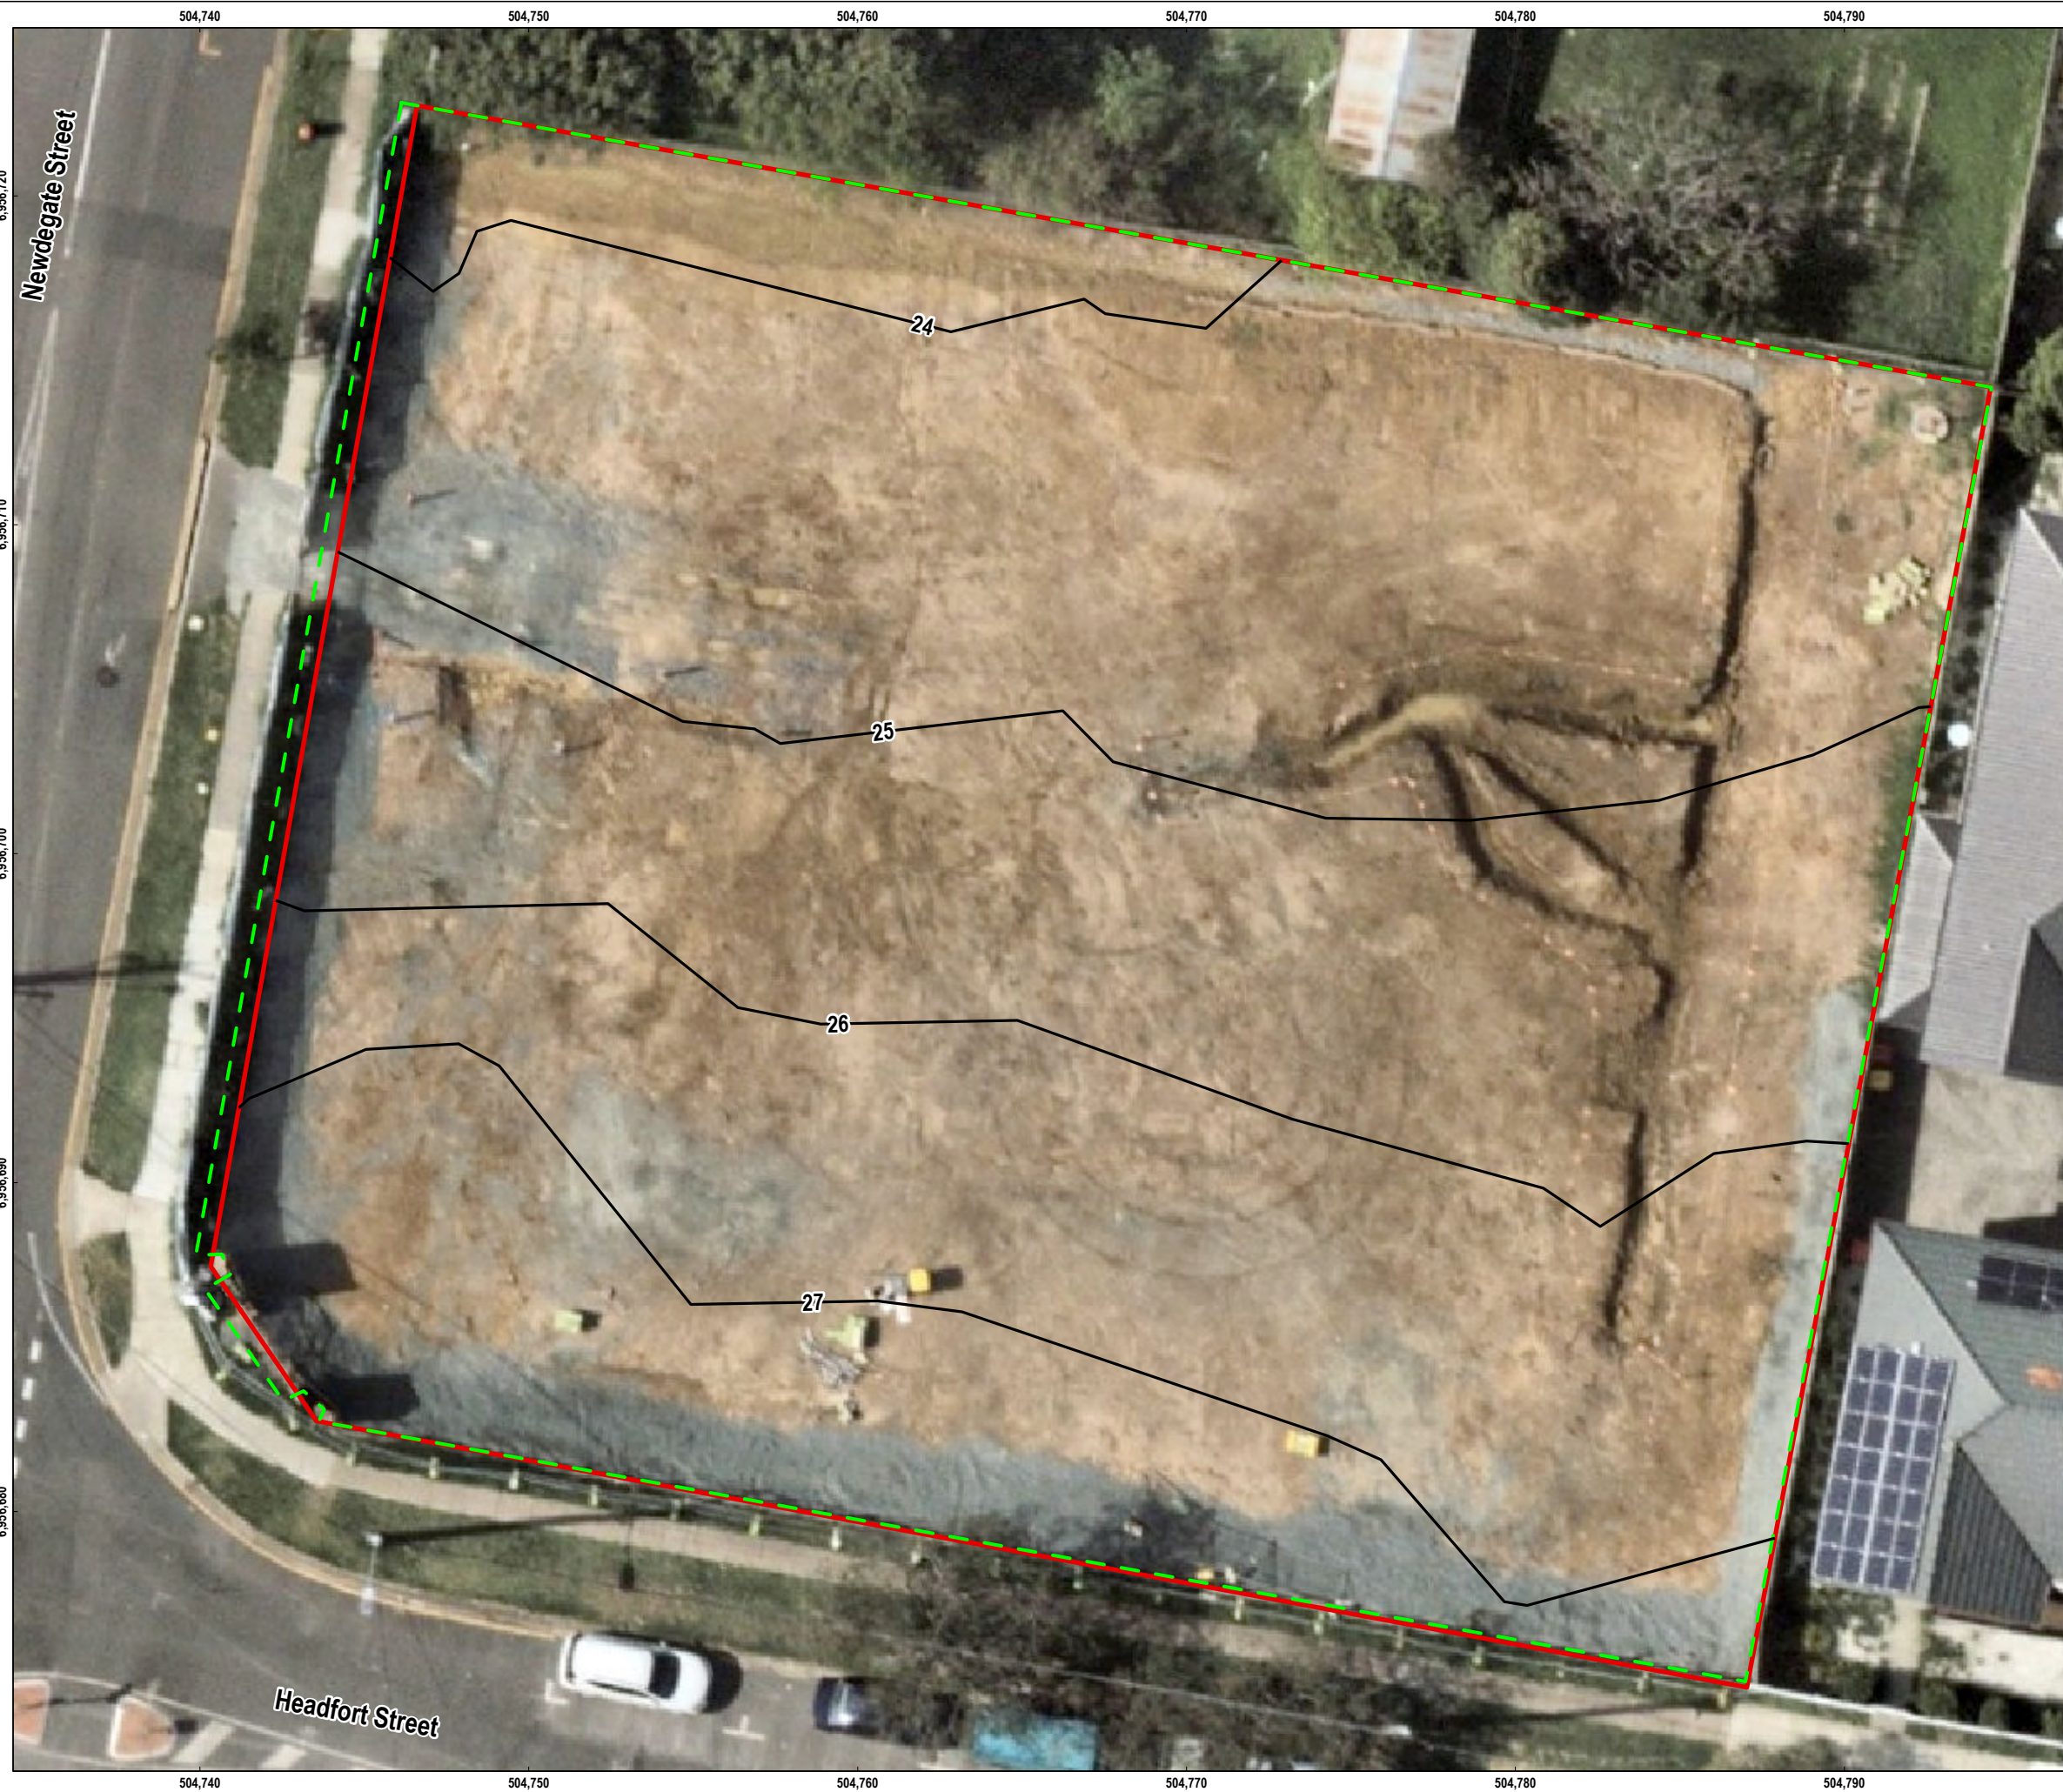
Pre-Remediation Ground Levels

Site boundary and investigation locations from Tetra Tech Coffey.
Contours from Department of Resources Queensland
Aerial imagery from Nearmap (capture date: 13/11/2023)

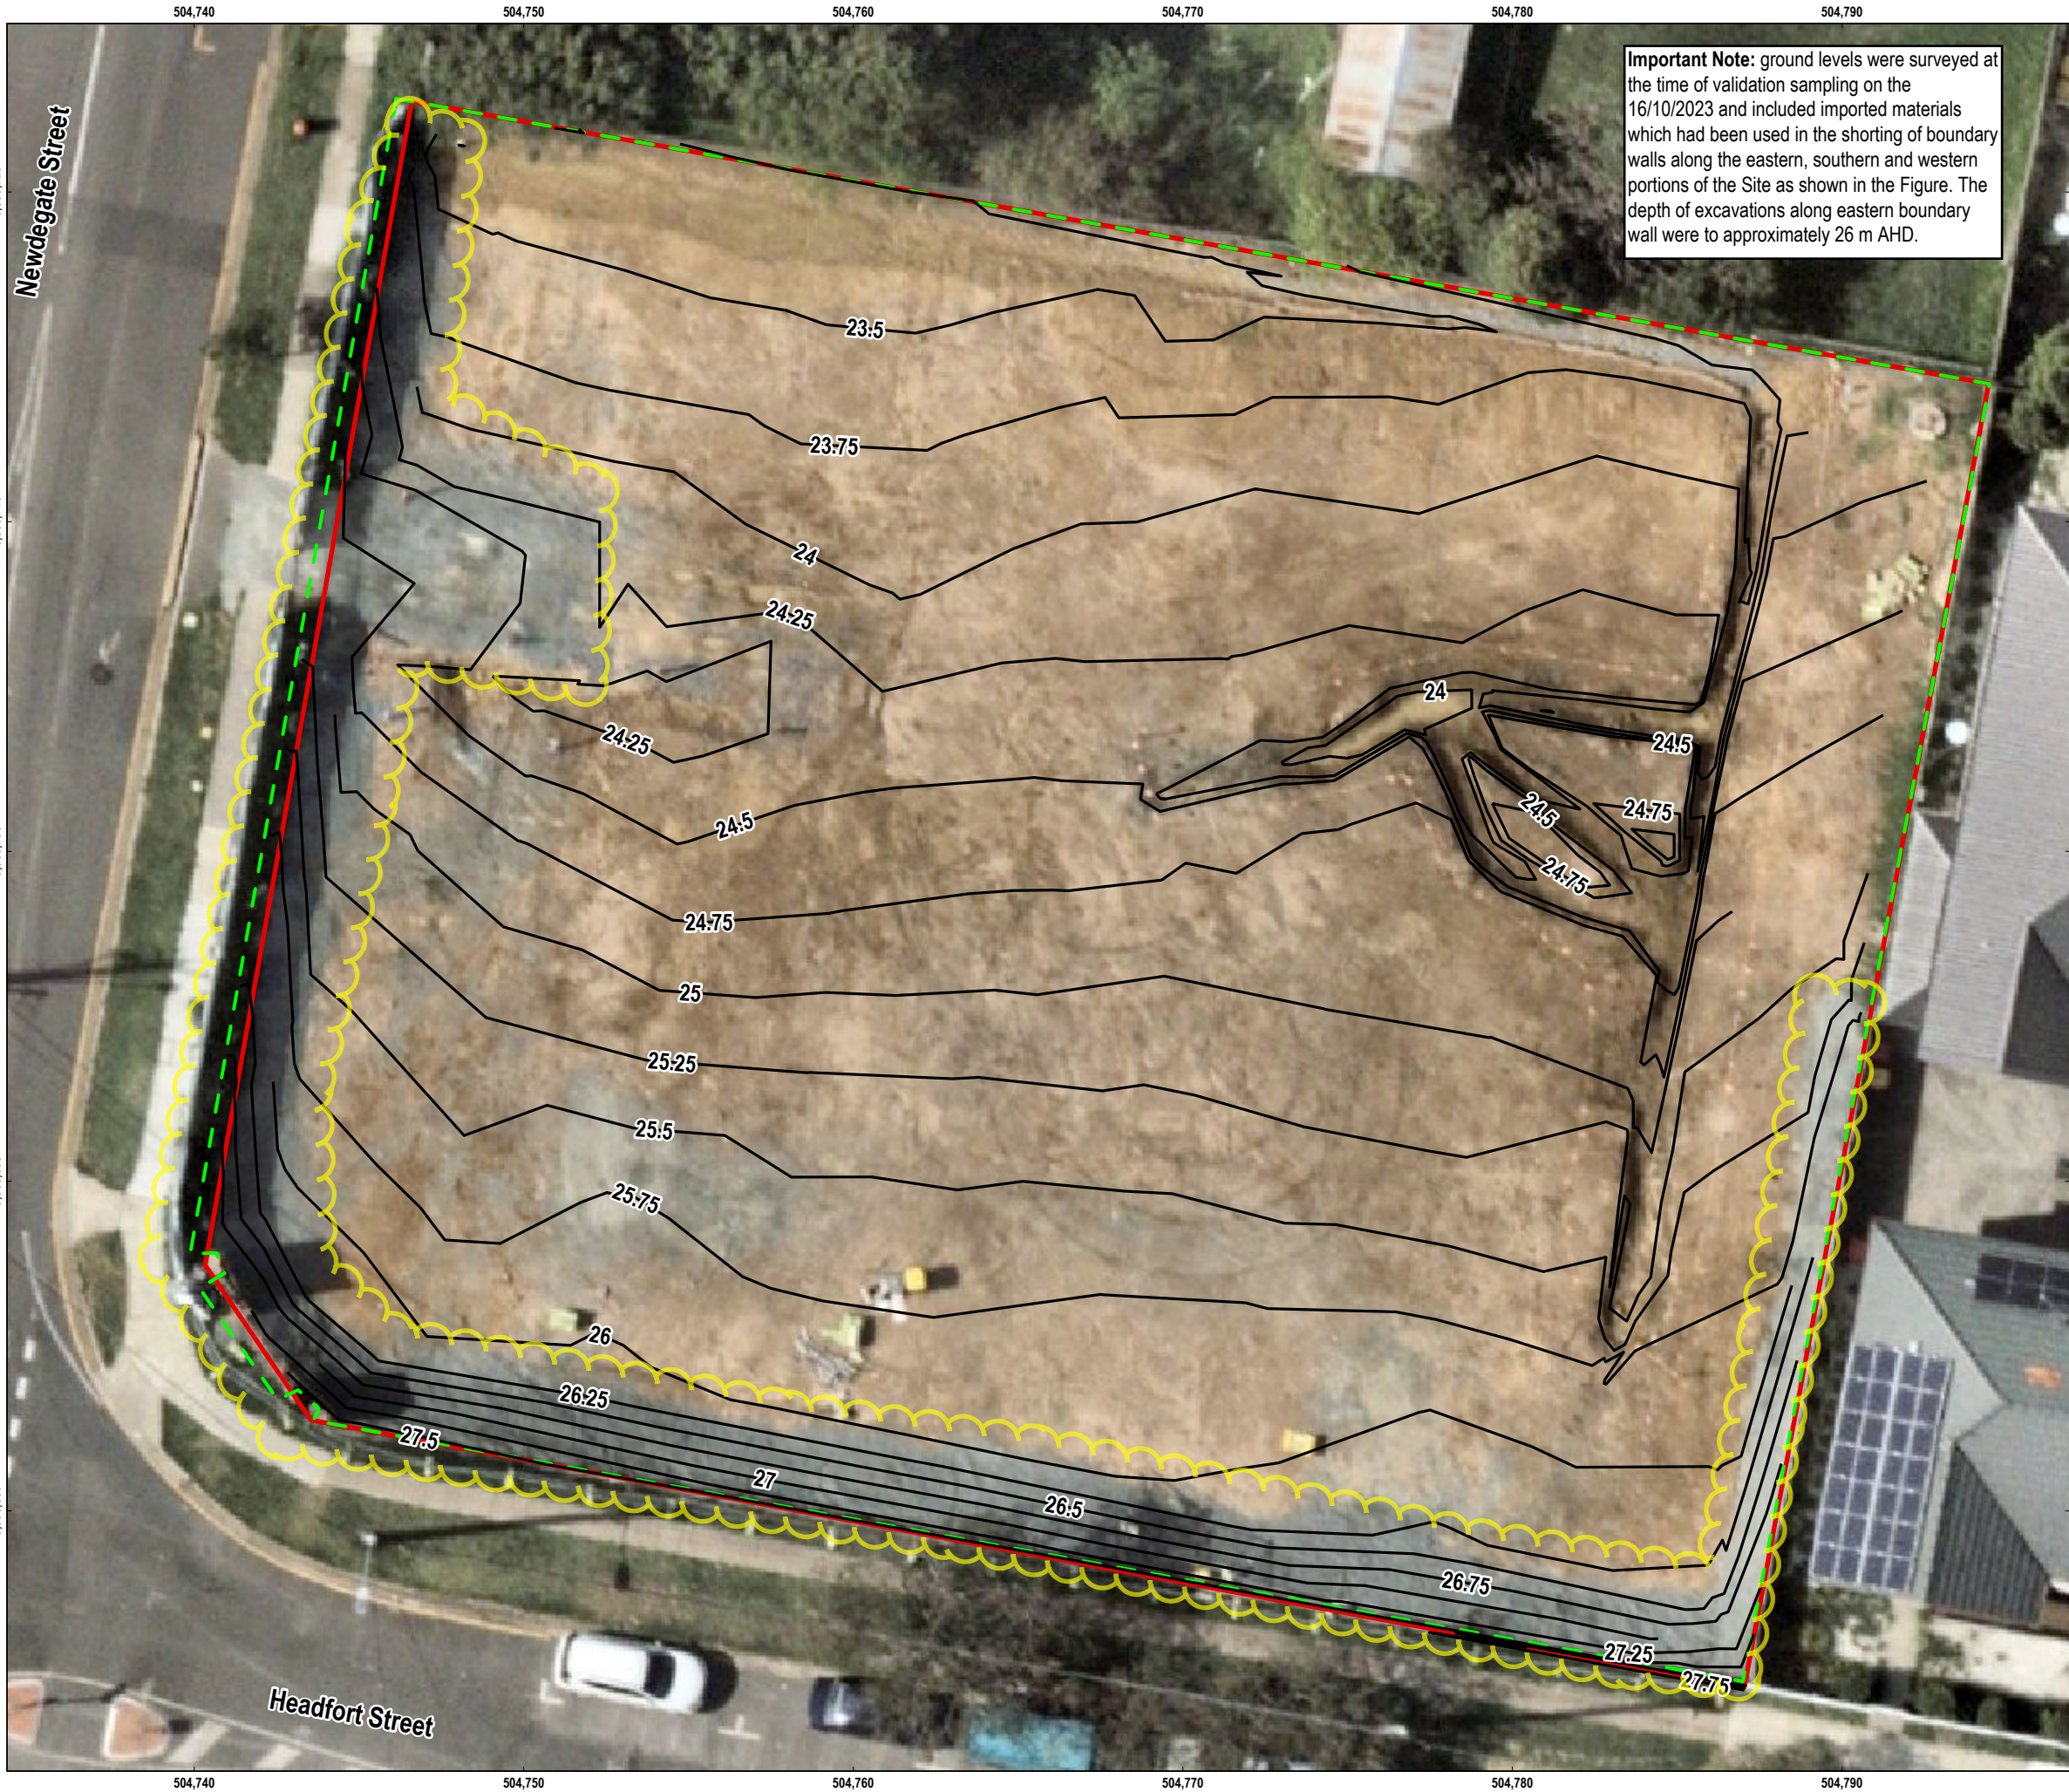
Post-Remediation Ground Levels

Important Note: ground levels were surveyed at the time of validation sampling on the 16/10/2023 and included imported materials which had been used in the shoring of boundary walls along the eastern, southern and western portions of the Site as shown in the Figure. The depth of excavations along eastern boundary wall were to approximately 26 m AHD.

- LEGEND**
- Horizontal Excavation Extent
 - Surveyed Property Boundary
 - Approximate location of imported materials used for shoring of boundary walls
