D.1 BOUNDARY FENCE PHOTOGRAPHS

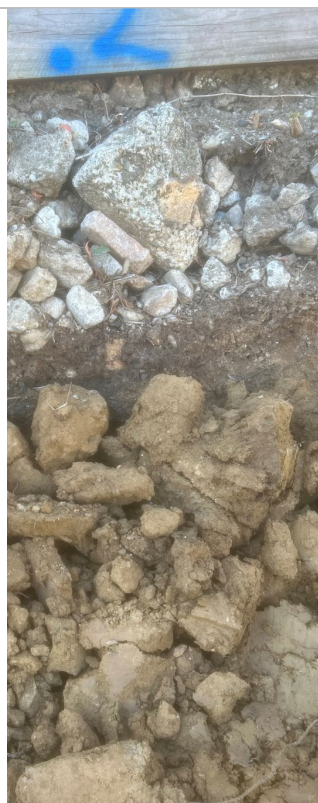
Example of excavation to Eastern Boundary Fence

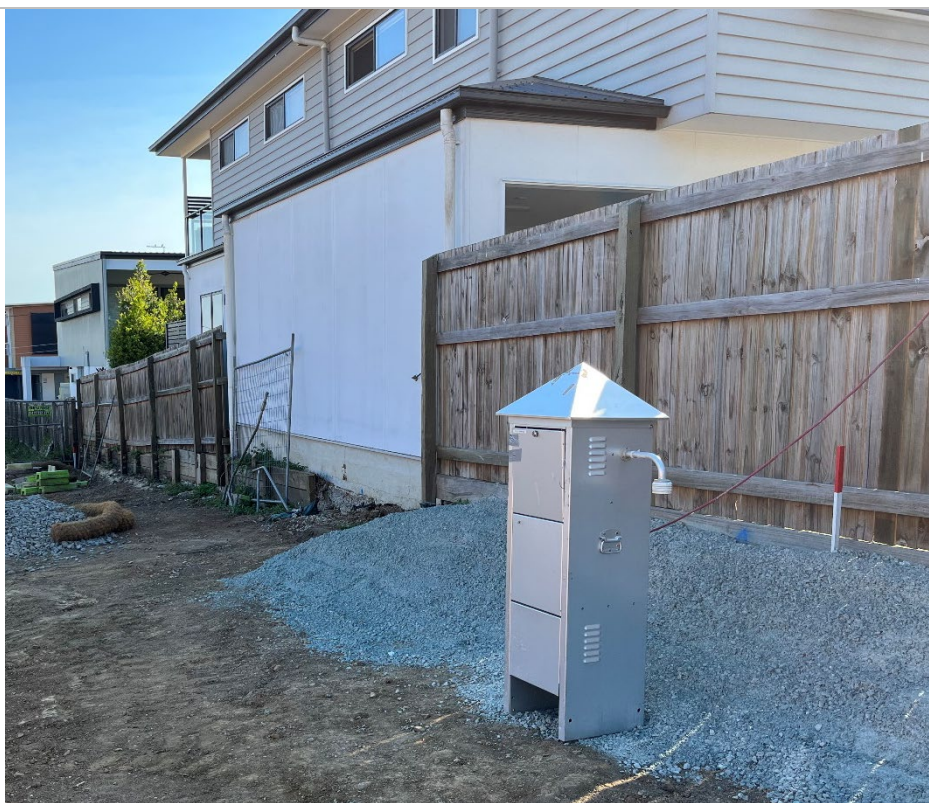
Eastern Boundary Fence with boundary fence. Imported material was place along the boundary fence following excavation and validation.

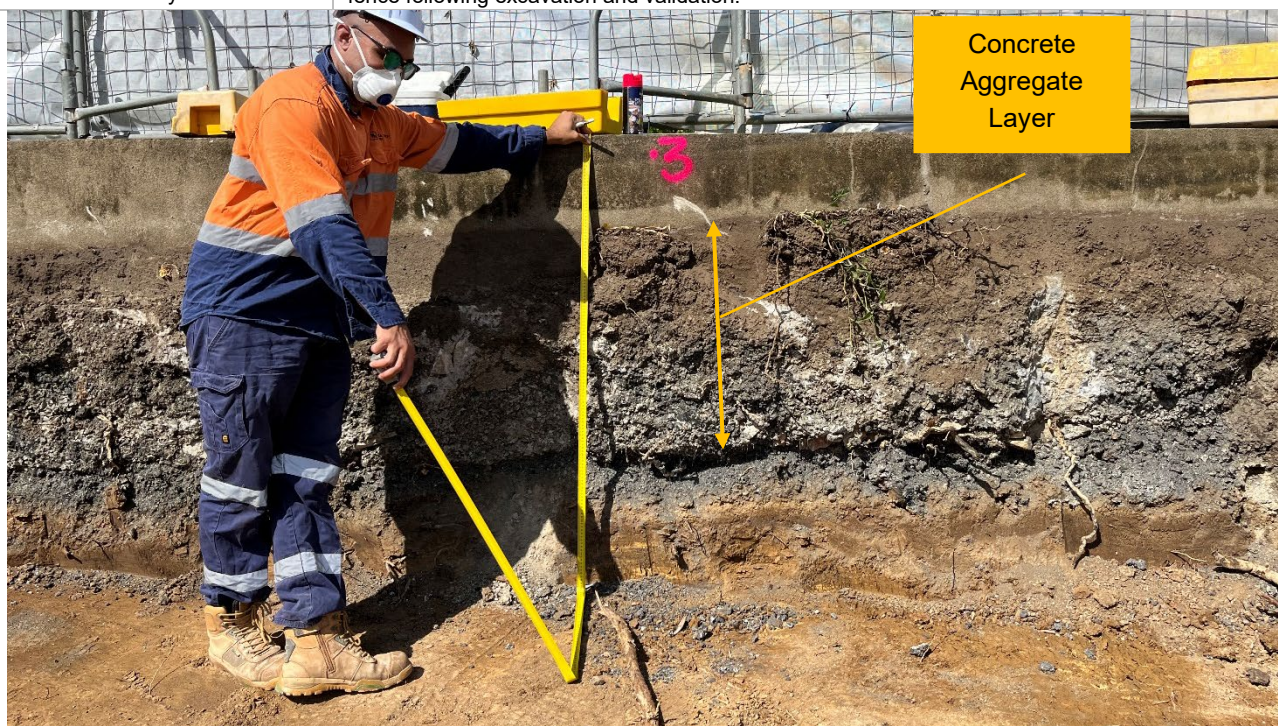
Excavation along the southern boundary was undertaken to the retaining wall which was the practicable limit of excavation.

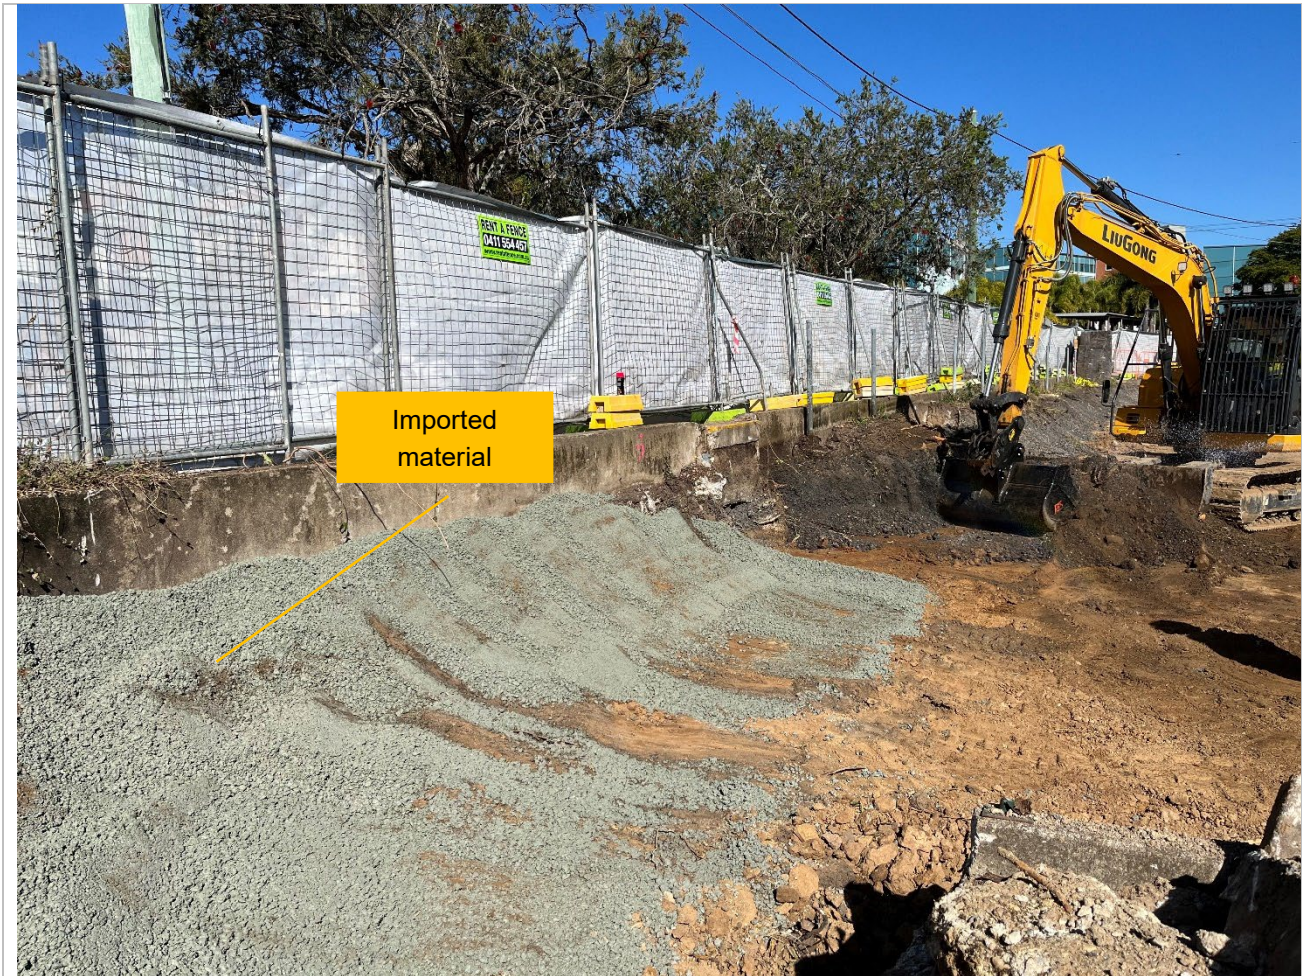
Excavation along the southern boundary. Imported material was placed against wall following excavation and collection of validation samples.

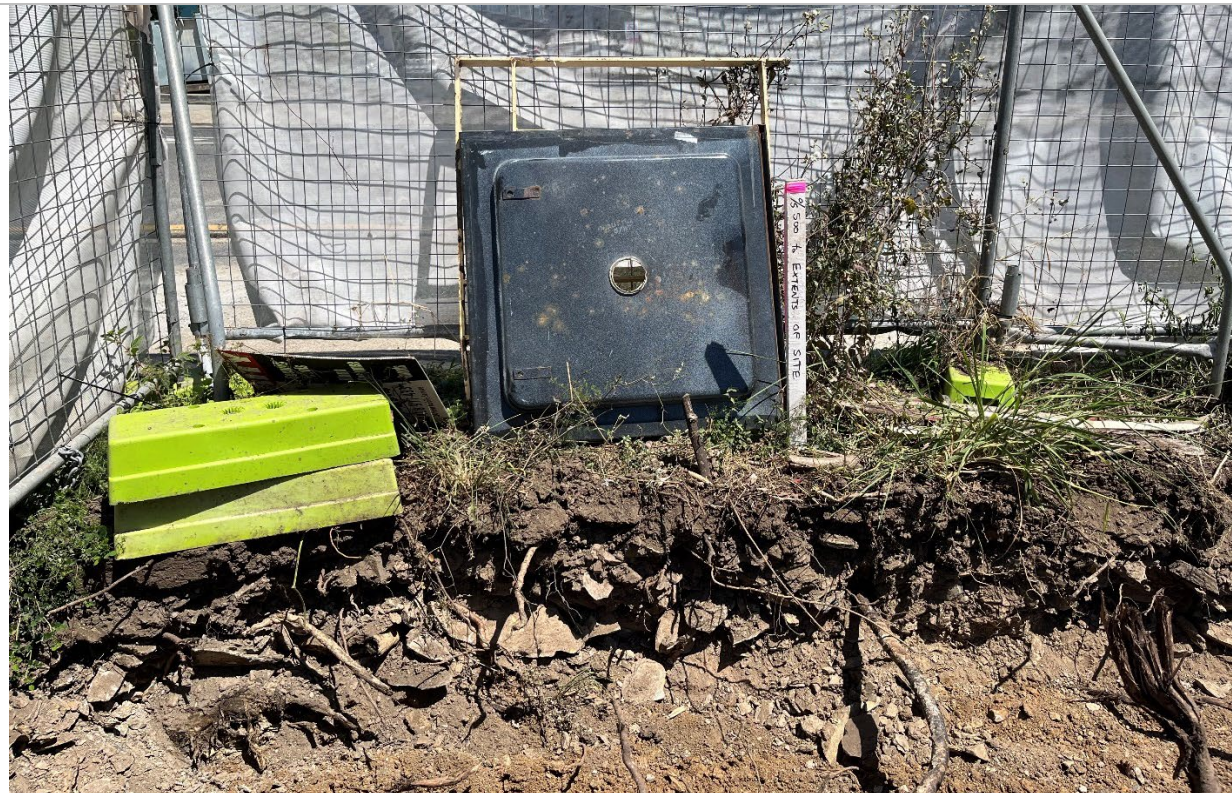
Excavation along the western boundary of the Site. The survey peg shown is offset 0.5 m west off the Site boundary.

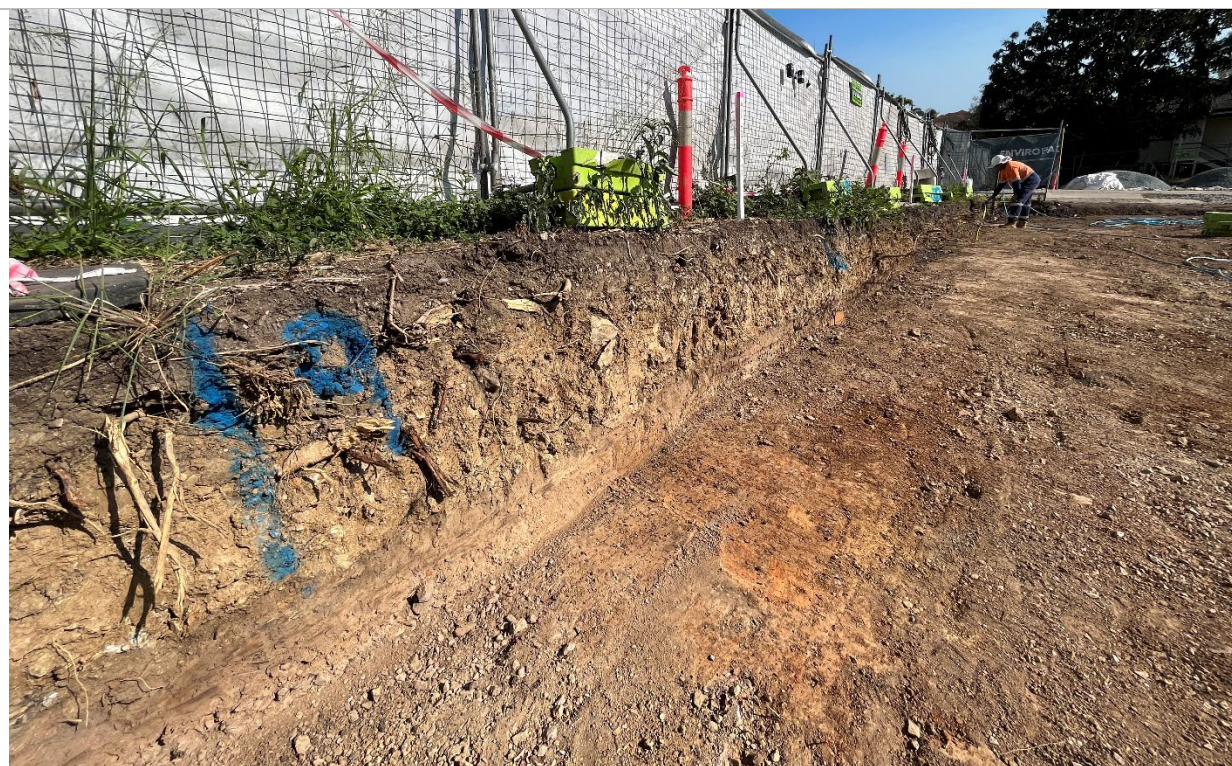
Excavation along the western boundary of the Site. The survey peg shown is offset 0.5 m west off the Site boundary.

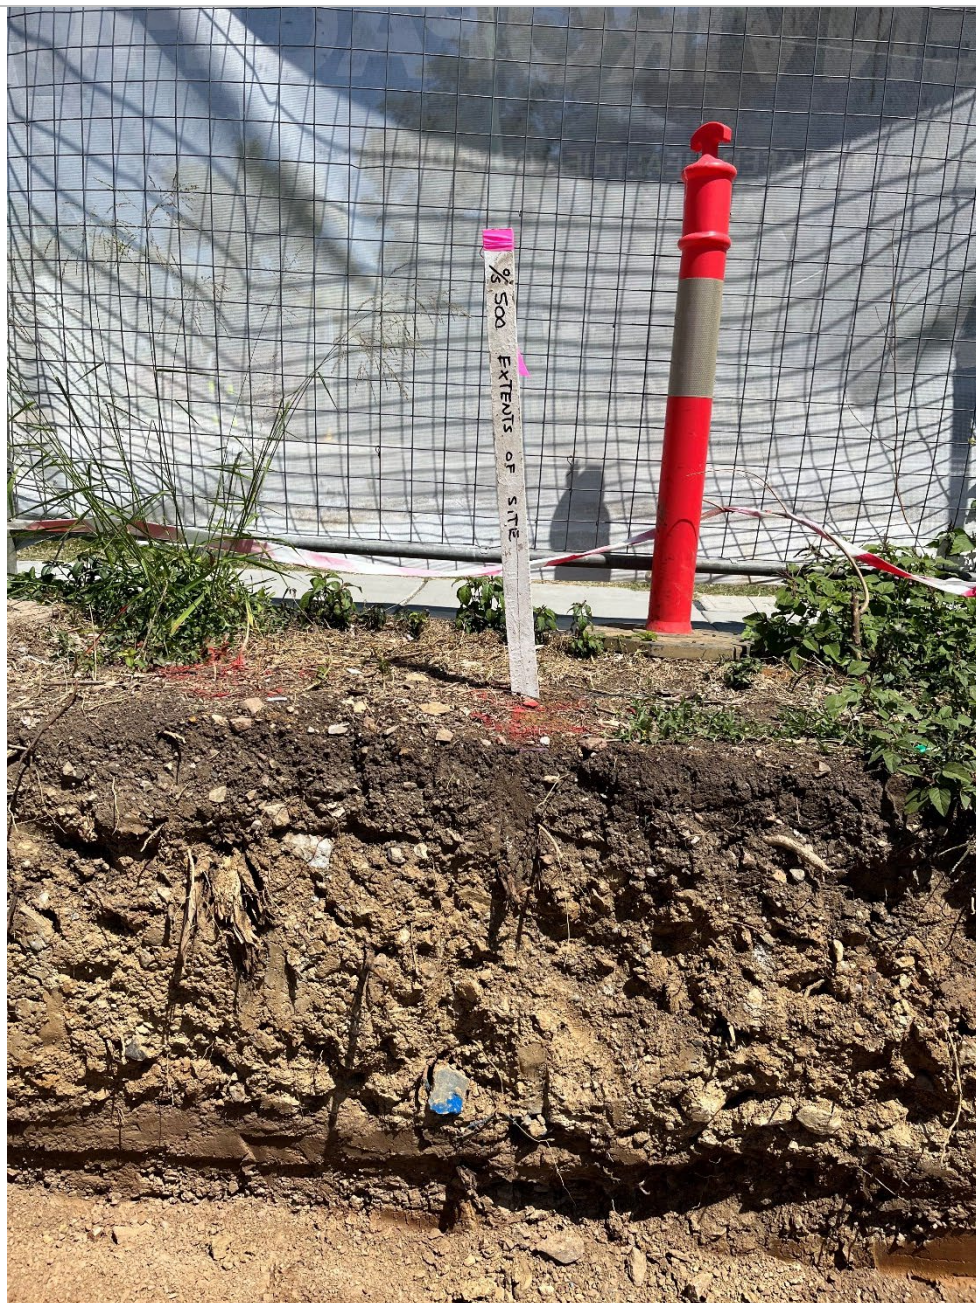
Excavation along the western boundary of the Site. The survey peg shown is offset 0.5 m west off the Site boundary.
