**Department of Veteran Affairs**

**114 Newdegate Street Greenslopes  
Remediation Planning**

Sampling, Analysis and Quality Plan (SAQP)

19 July 2021

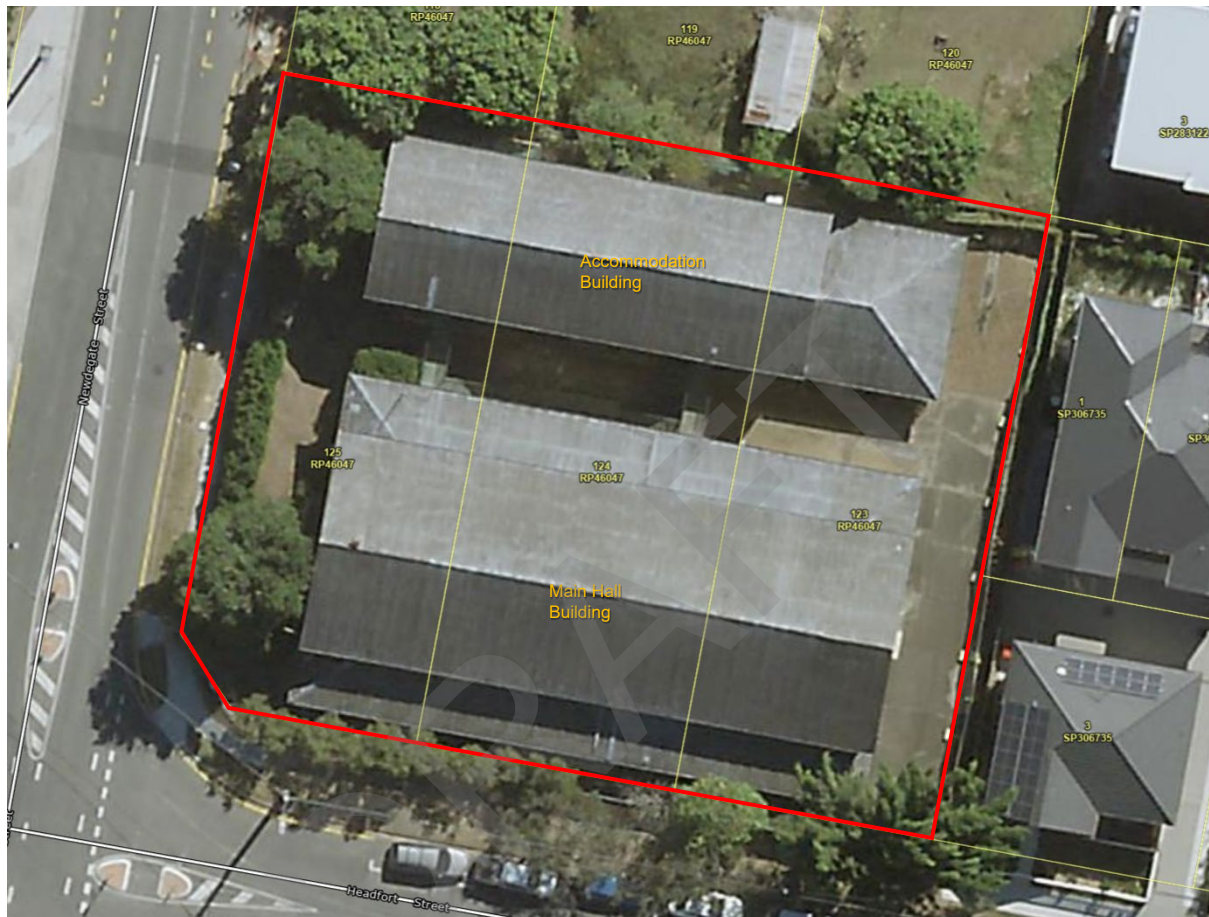
Figure 2-1 114 Newdegate Street, Greenslopes (Image source: Queensland Globe, 2021)

Two buildings are located on the Site and comprise a former Main Hall Building and Accommodation Building (see Figure 2-1). The Site is currently not in use due to the condition of the buildings and the presence of ACM.

The Site is located on the corner of Newdegate Street and Headfort Street, Greenslopes, Brisbane. The Site is shown in Figure 2-1 below, and the location of the Site in Brisbane is shown in Figure 1, Appendix A.

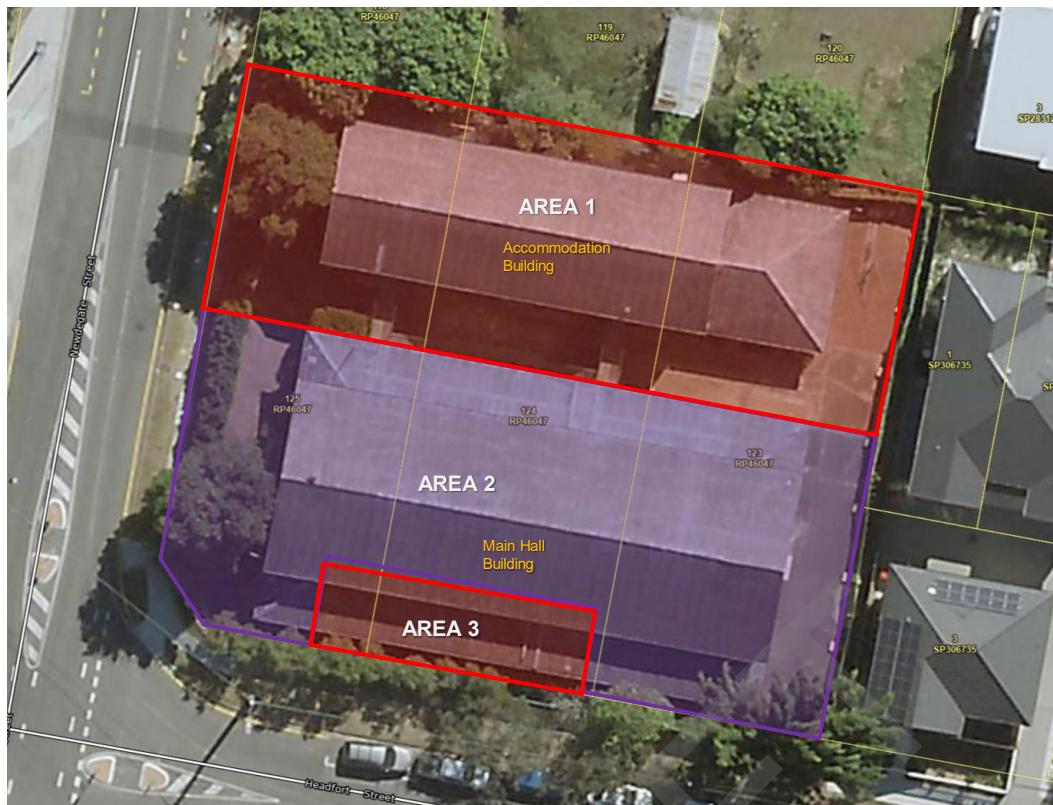
Figure 5-1 Areas of Interest

- **Area 1:** This area includes the former Accommodation Building. OCP contamination which exceeds HIL-C guidelines has been reported predominantly in surface soil materials less than 0.2 m depth along the southern perimeter of the building, and to a lesser amount along the western and northern side of the building and within a small area within the central portion of the building. OCP contamination which exceeds HIL-C was reported in one location (11) at 0.45 m depth.
- **Area 2:** This area includes the former Main Hall. With the exception of a small area of OCP contamination in Area 3, OCP contamination in Area 2 is below the HIL-C guidelines.
- **Area 3:** Area 3 is located along the southern boundary of the Site and has OCP contamination which exceeds the HIL-C guidelines in surface soil materials less than 0.2 m depth.

- **Asbestos:** ACM fragments have been observed in surface soil materials within Area 1 and Area 2/3. Previous investigations have also found Asbestos Fines (loose asbestos fibres) in soil materials in both Area 1 and Area 2.
- **Fill Material:** Fill material containing anthropogenic materials (e.g. wood, concrete, brick, slag, coal) have been observed in shallow soil materials. While fill materials containing anthropogenic materials such as slag, concrete and brick may be within NEPM Guidelines, such materials are undesirable aesthetically for a park and may pose physical hazards (sharp and angular) and should therefore be removed.

Based on the data from previous investigations the Site has been conceptualised into three main areas of interest (AOI) which are shown in Figure 5-1. These are summarised as follows.
