114 Newdegate Street Greenslopes Remediation Planning

Supplementary Investigation

Department of Veteran Affairs

Reference: 754-BNEEN282781

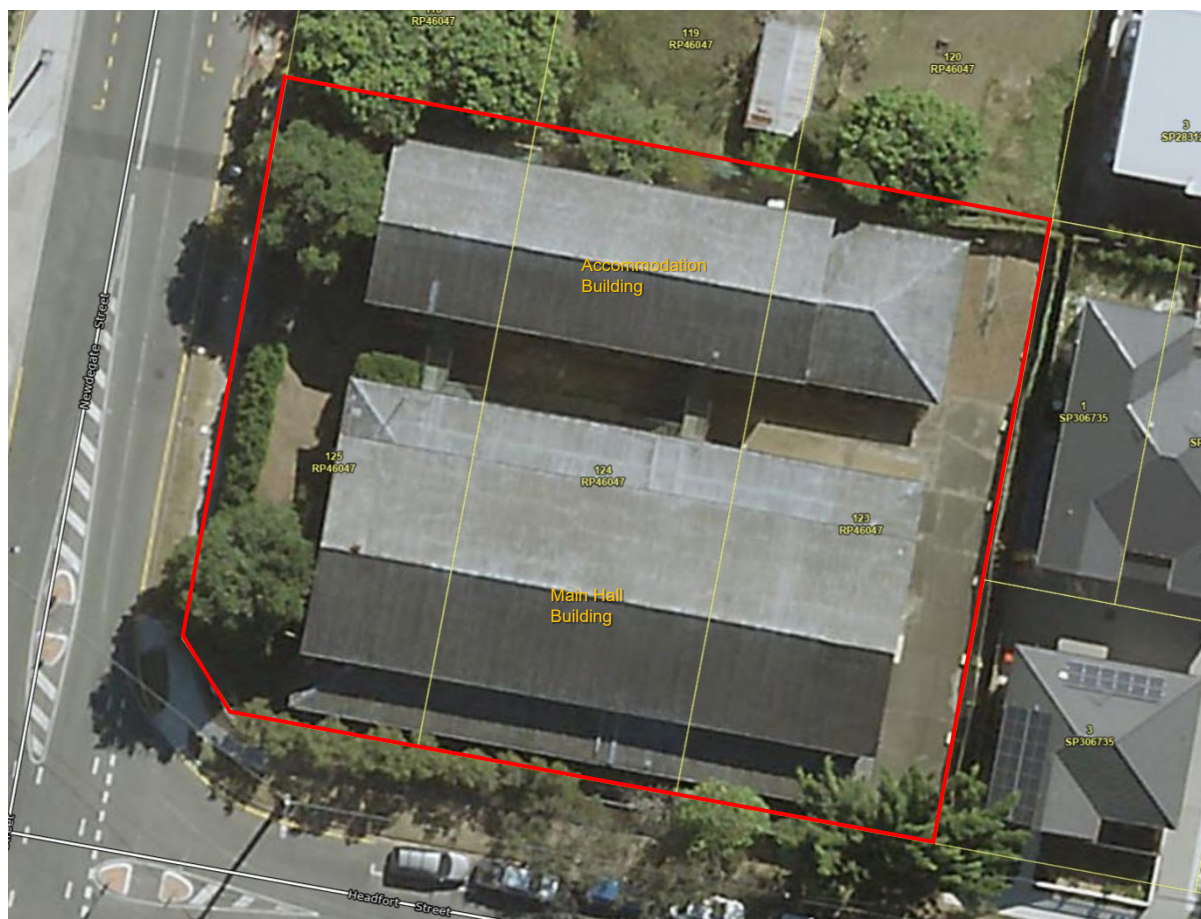
Figure 2-1 114 Newdegate Street, Greenslopes (Image source: Queensland Globe, 2021)

Two buildings are located on the Site and comprise a former Main Hall Building and Accommodation Building (see Figure 2-1). The Site is currently not in use due to the condition of the buildings and the presence of ACM.

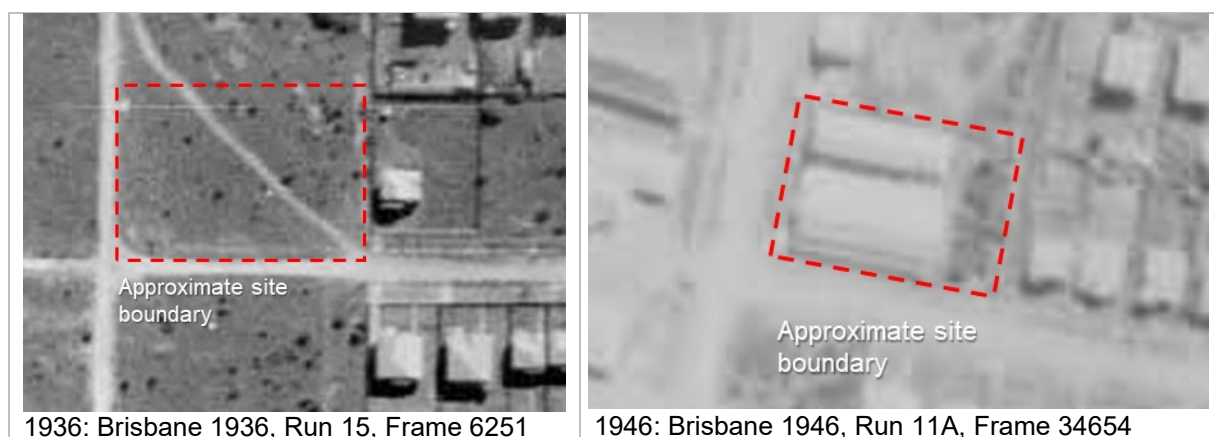
Historical aerial photography shows the Site was cleared land in 1936, and potentially in use for rural purposes (see image below). The site was acquired by the Commonwealth of Australia in 1945 for the development of the Australian Red Cross Centre (ARCC). The ARCC was developed on the Site in approximately 1945 and is shown in historical aerial imagery from 1946 (see image below).

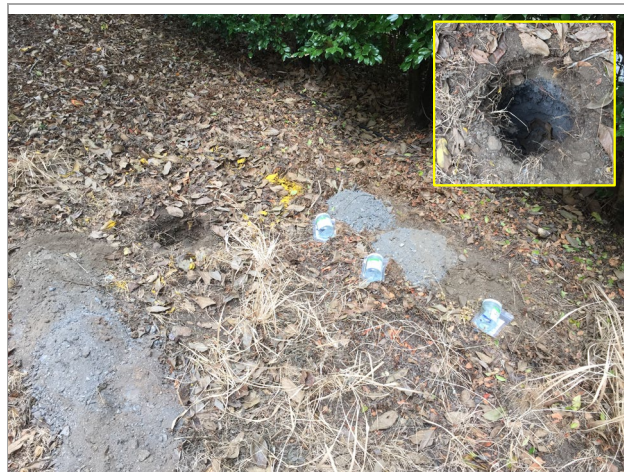
BH18 (3/9/21 Facing South West)

With the exception of the observed ash and slag in fill materials, no visual or olfactory evidence of contamination (i.e. ACM, staining, or odours) was noted during the investigation.

Figure 8-1 Examples of Ash/Slag Type Material

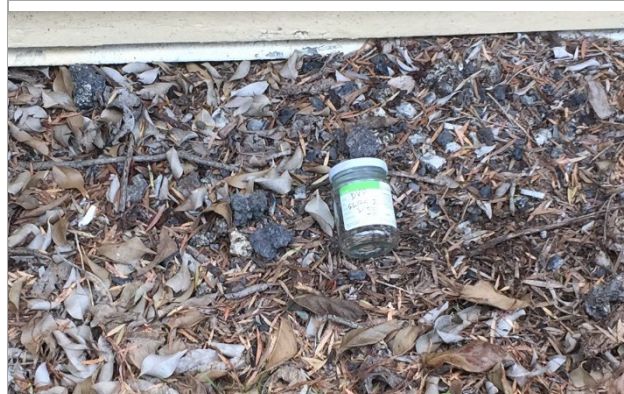
Slag 2 (3/9/21 Facing north and from garden bed along the southern side of Main Hall Building)

Two samples of the slag type material (Slag 1 and Slag 2) obtained from the garden bed along the southern extent of the Main Hall Building (refer to **Figure 6-2**) were analysed and found to have PAHs not above the LOR. Low concentrations of lead and zinc were reported in the Slag 1 sample and all other metal analytes were not above the LOR from Slag 1 and Slag 2. All results were below the NEPM HIL-A, HIL-C and EILs.

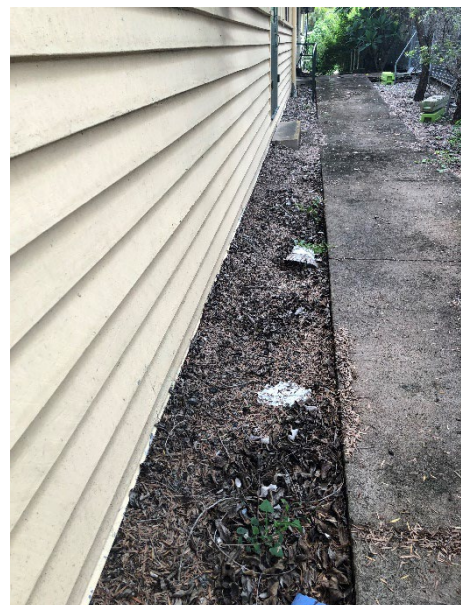
Figure 6-2 Slag Type Material in Garden Bed along Main Hall Building

In the 2021 investigation soil samples containing ash and/or slag type materials were intersected in BH06, BH17, BH18 and BH19. All samples of these materials reported PAHs not above the LOR and metals below the NEPM HIL-A, HIL-C and EILs. This finding is consistent with sample results from previous investigations where similar materials were investigated.

In summary where ash and/or slag type materials are encountered on the Site, contaminants of concern have not been reported.

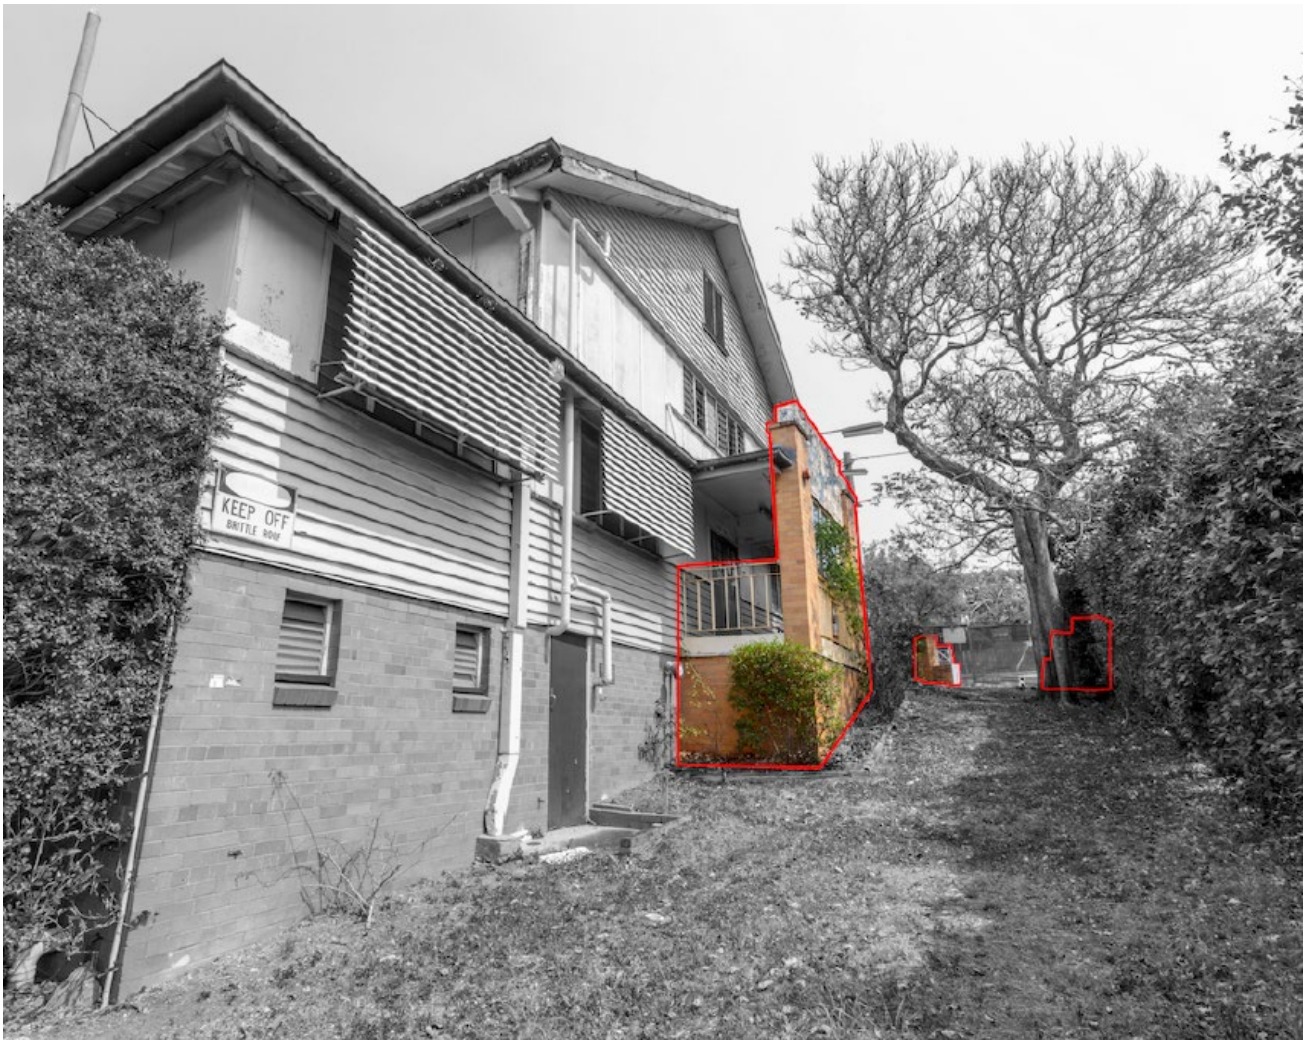
Figure 10-1 Brick Façade and Brick Gate

It is understood that as part of the redevelopment of the Site the brick façade and brick gate shown in the following image and in **Figure 4, Appendix A** are to be retained on-site for heritage purposes.

Source: Hayball (2021) Brisbane Legacy Concept Design. Note red outlines show location of gates and the façade.

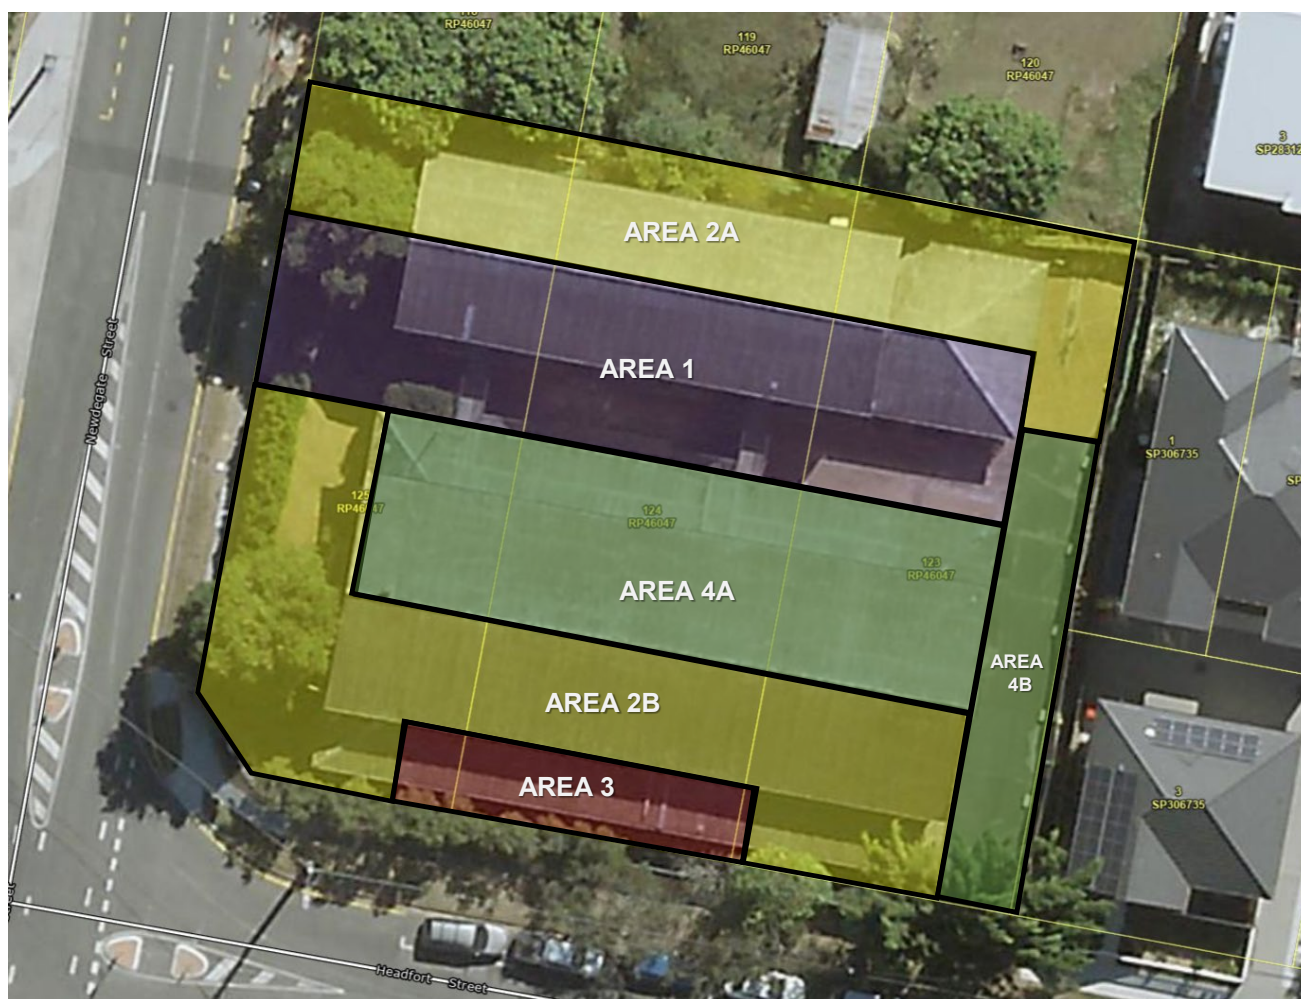
Figure 10-2 Remediation Areas

For remediation planning the Site has been segregated into six areas which are shown in **Figure 10-2**, and **Figure 4, Appendix A**.

Area	Proposed Excavation Depths
Area 1	<p>Requirement for Remediation</p> <p>OCPs in Area 1 exceed NEPM HIL-C guidelines for parks and open space areas and HIL-A guidelines for residential areas with accessible gardens. While the majority of OCP contamination is expected to be within the first 0.2 m bgs of soil, based on the existing data OCP contamination extends further into deeper soil deposits (~0.4 to 0.5 m bgs).</p> <p>ACM is potentially present in shallow soil materials. Fill materials containing anthropogenic materials which pose physical hazards (sharp and angular) are unsuitable for use in a park/open space are also potentially present ("Unsuitable Fill Materials").</p> <p>Proposed Excavation Depths</p> <p>Excavate and remove 0.25 m depth of soil for disposal to lined landfill as contaminated soil potentially containing ACM.</p> <p>Excavate a further 0.35 m depth of soil for disposal to lined landfill or re-use in an appropriately licenced resource recovering facility for commercial/industrial use.</p>
