Contaminated Land Site Audit Report (SAR)

Lot 123-125 RP46047

51, 53 and 55 Headfort Street, Greenslopes Queensland

13 September 2024

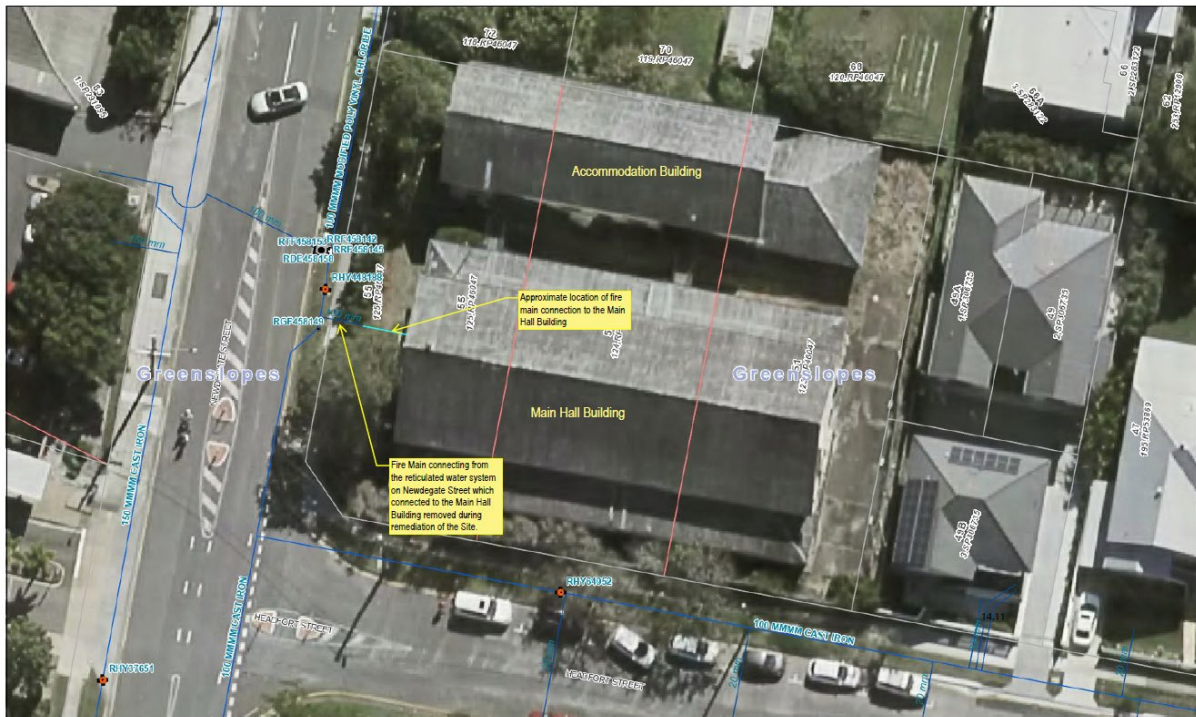
Plate 4. Layout of infrastructure removed during remediation including the reticulated potable water (fire main) and sewer (clay) pipes

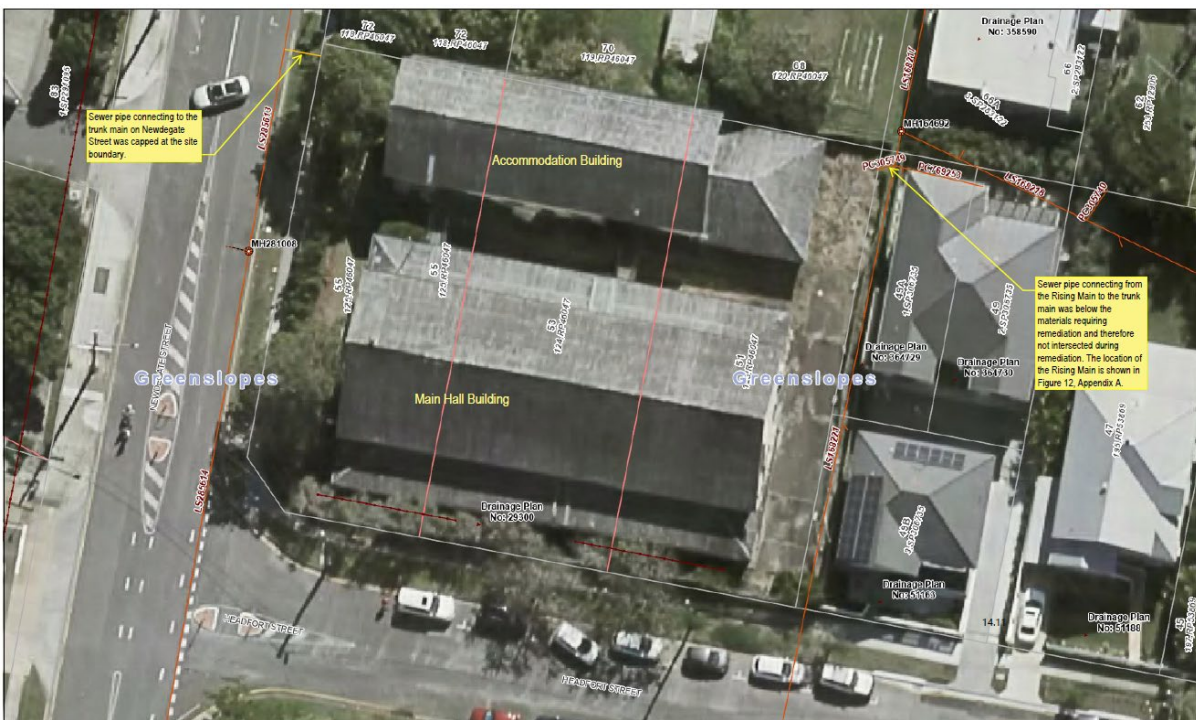
Plate 5. Layout of infrastructure removed during remediation including the sewer pipes on the northeast and north west site boundaries

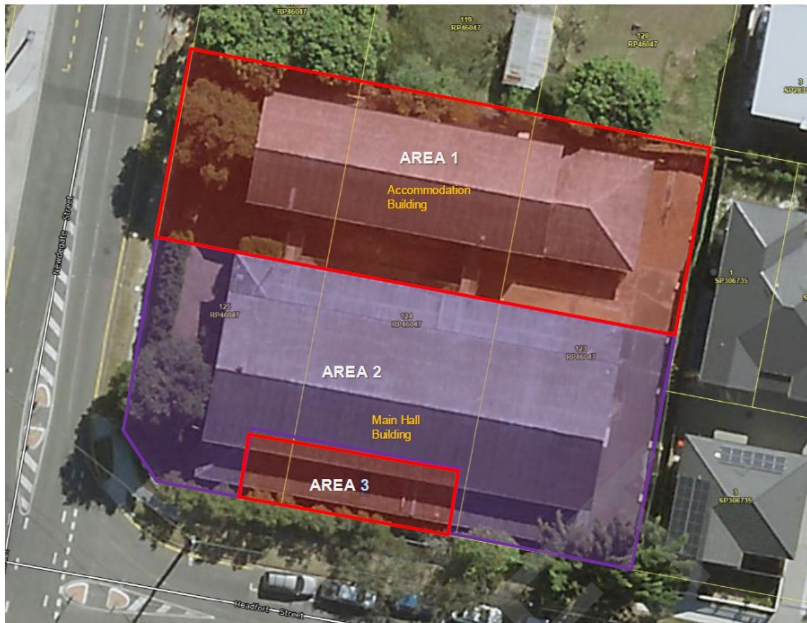
Plate 6. Areas of Interest identified within the SAQP (Coffey, 2021a)

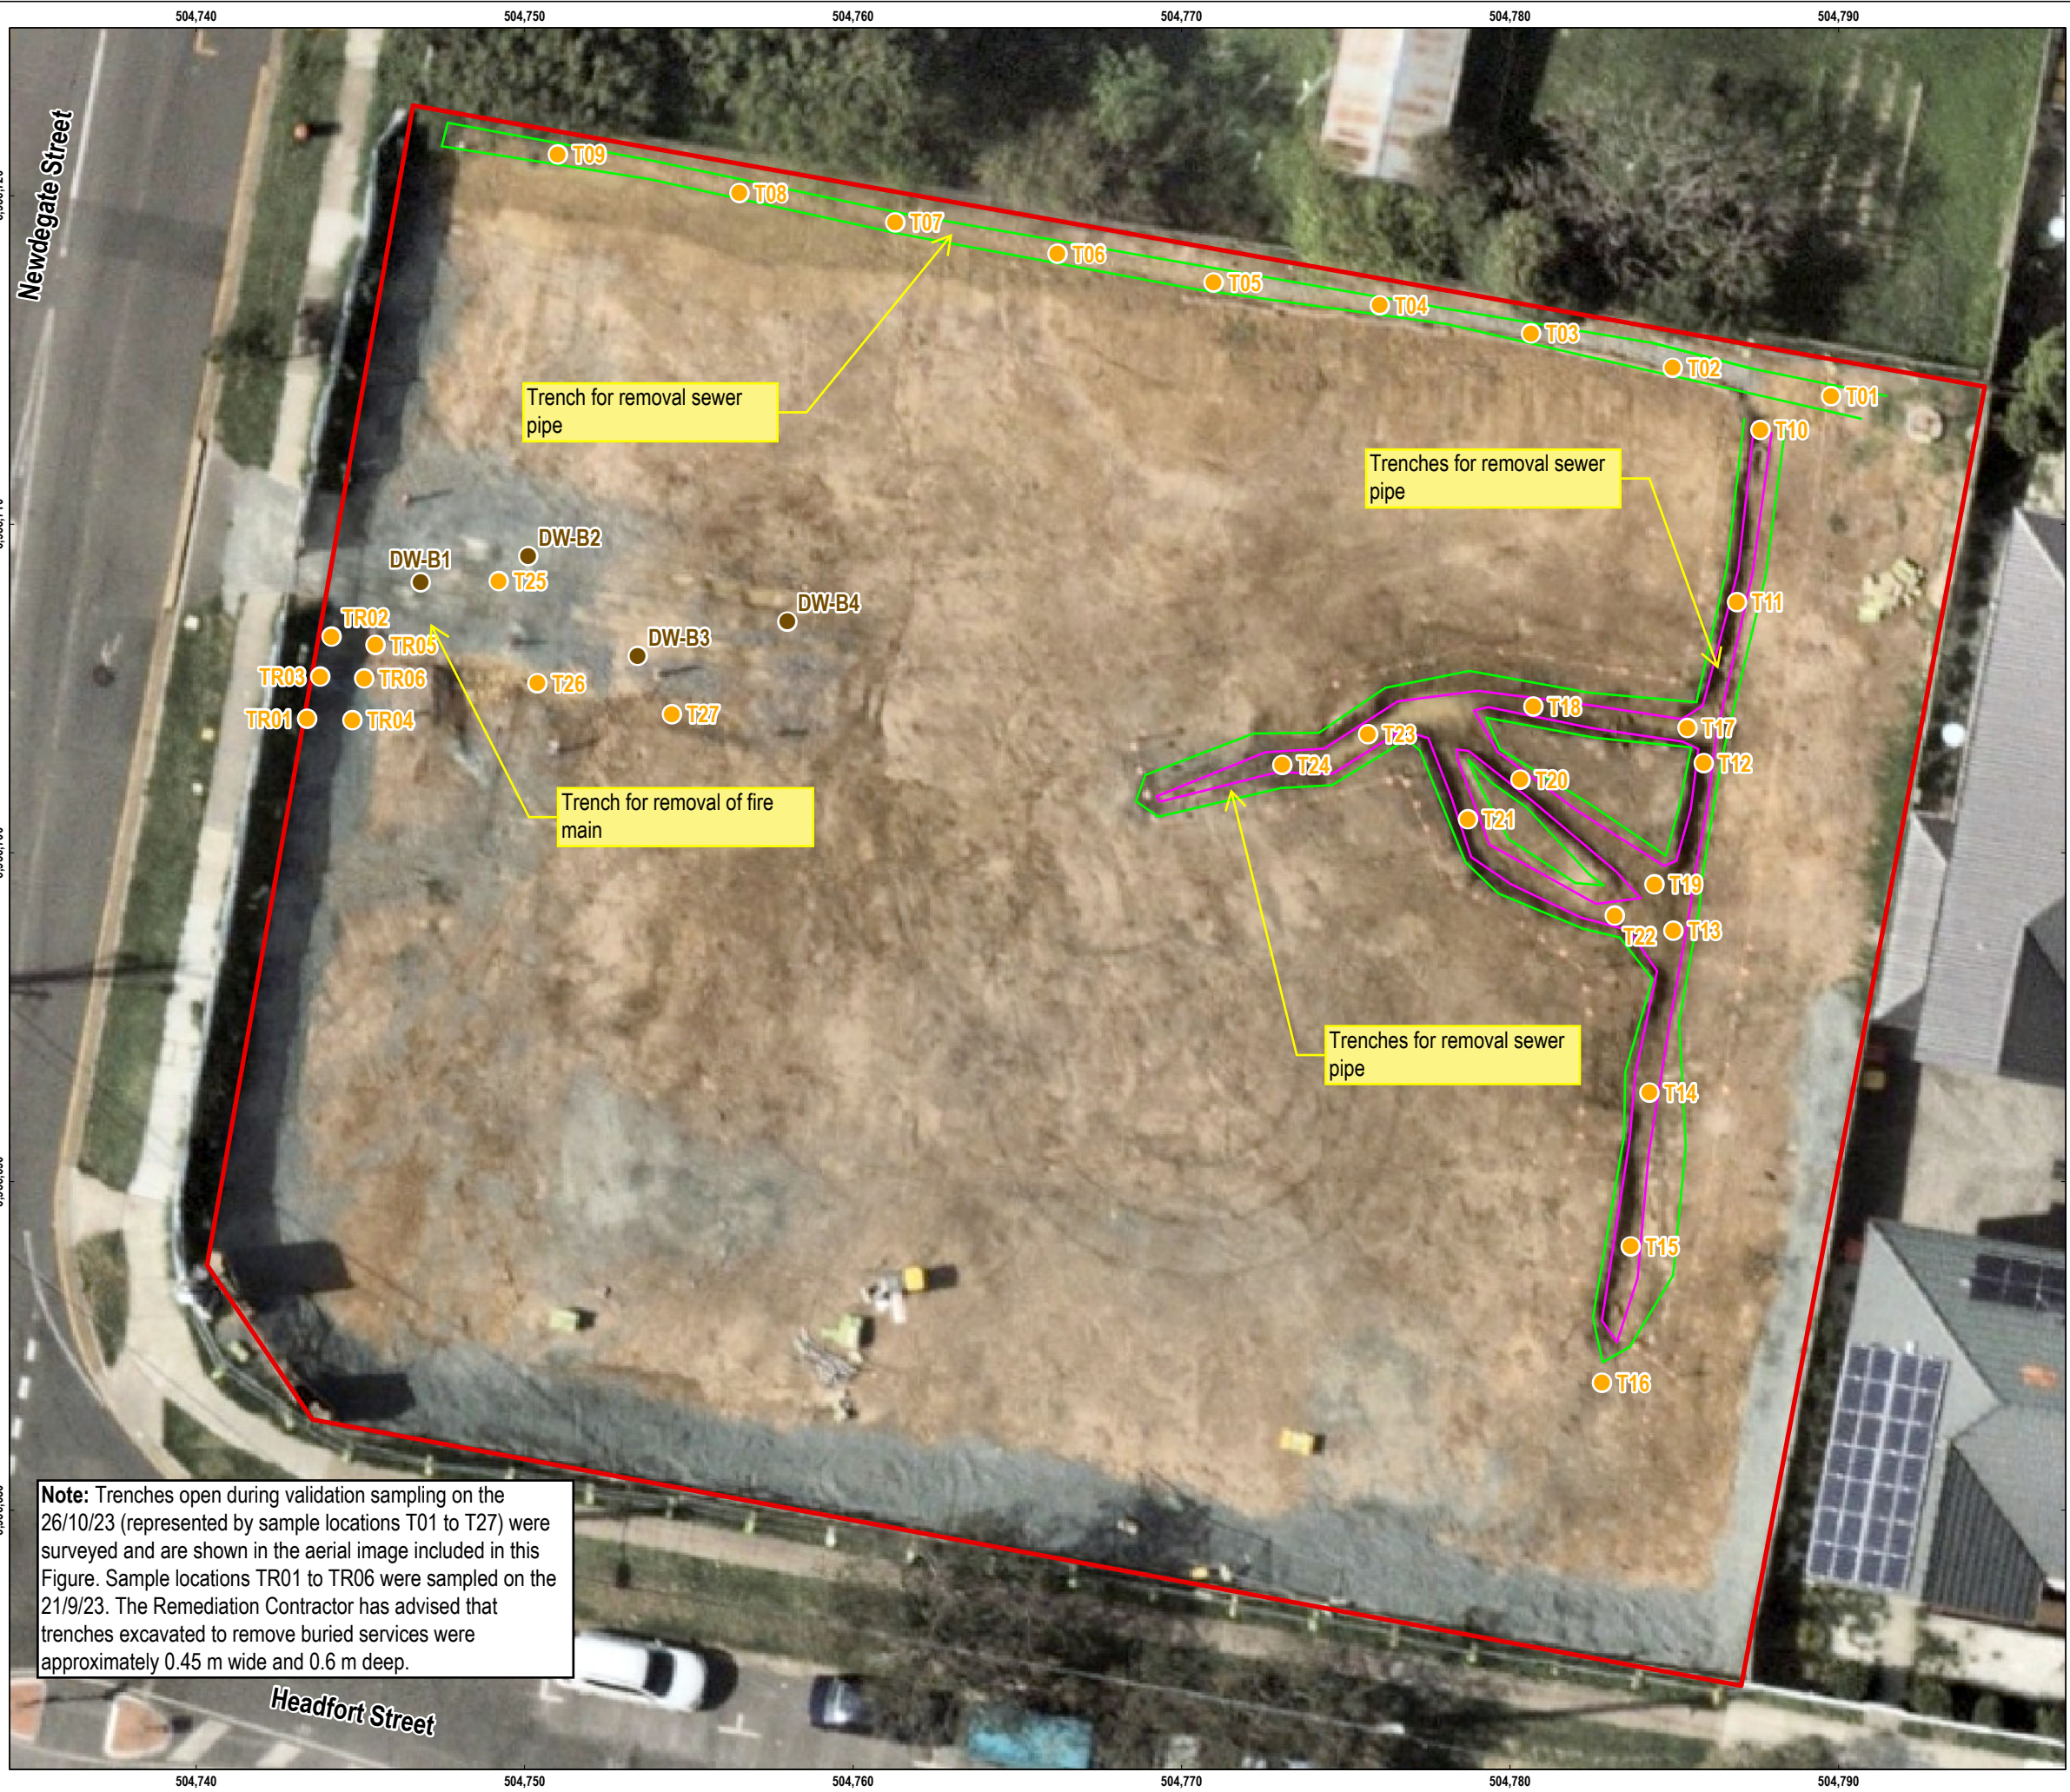
**Trench and Driveway
Sampling Locations**

Note: Trenches open during validation sampling on the 26/10/23 (represented by sample locations T01 to T27) were surveyed and are shown in the aerial image included in this Figure. Sample locations TR01 to TR06 were sampled on the 21/9/23. The Remediation Contractor has advised that trenches excavated to remove buried services were approximately 0.45 m wide and 0.6 m deep.

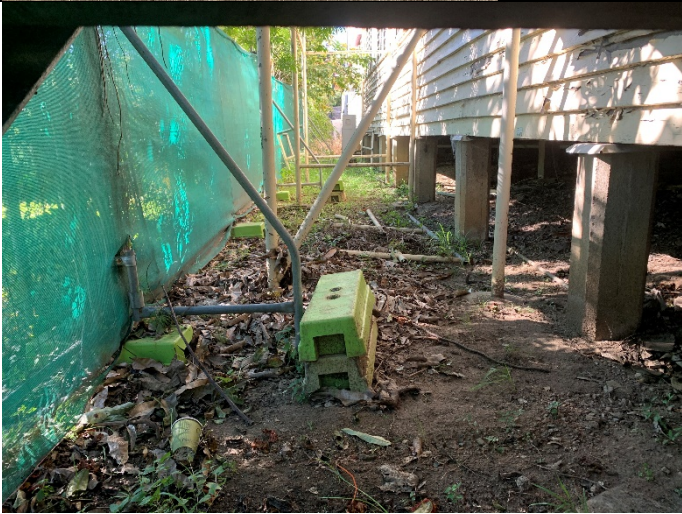
5	Northern building, from the eastern boundary. ACM roof visible.

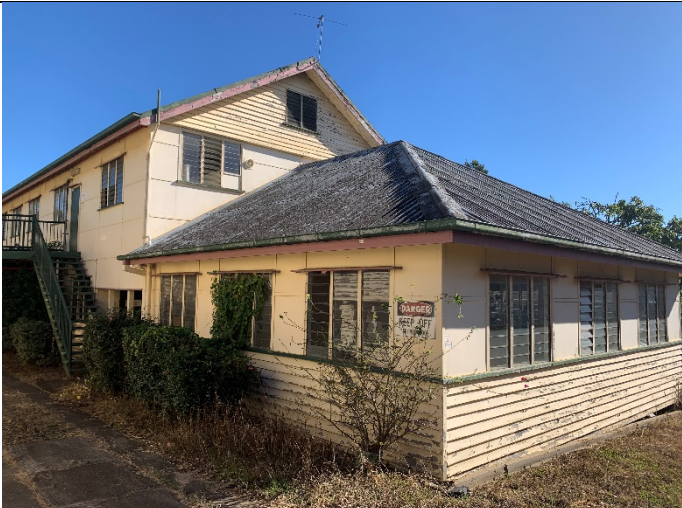
Photograph	Description	Image
6	Southern building from the western boundary. Services were reported to be disconnected.

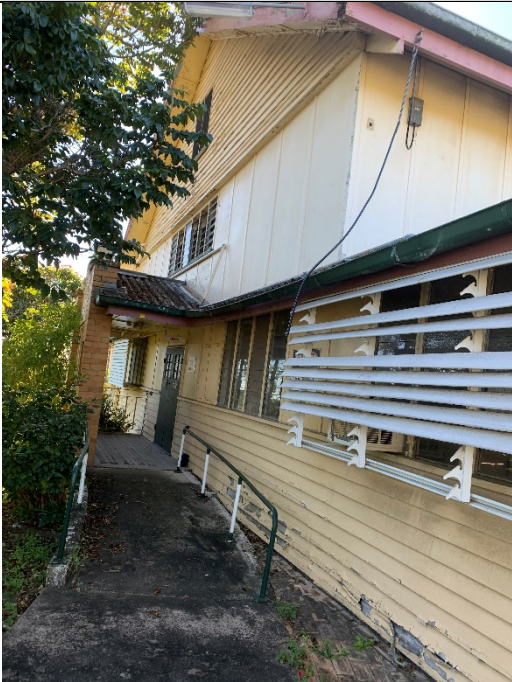
7	Southern building with a possible stormwater drain located approximately 2m west of the building

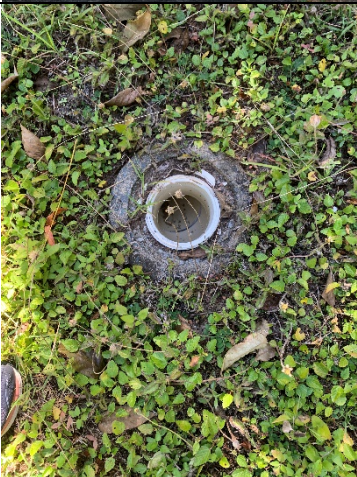
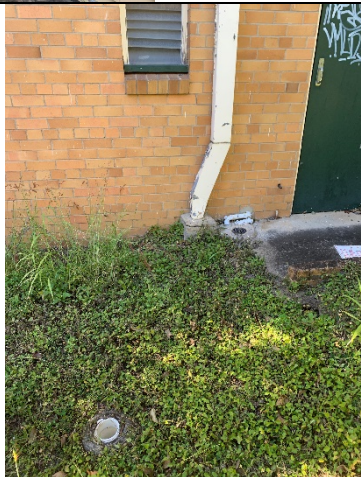
8	Central region of the site. Grass, bare soil and concrete (poor condition) coverings. Buildings not accessed.

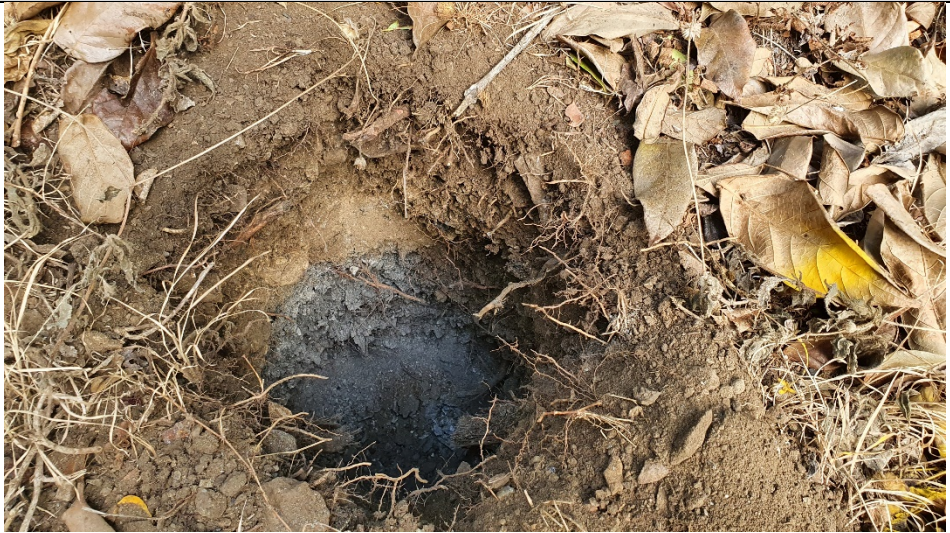
Photograph	Description	Image
4	<p>BH18</p> <p>Ash observed between 0.25 – 0.5 m bgl</p>

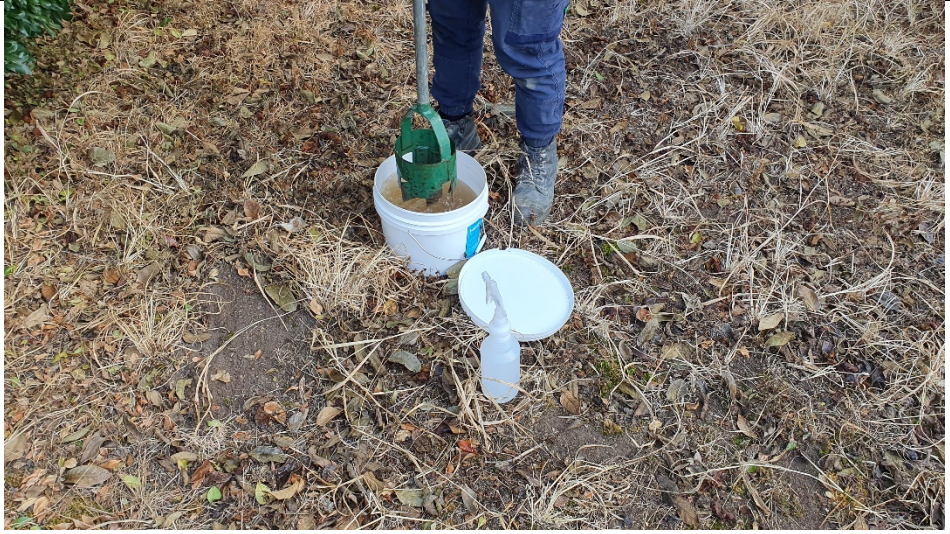
5	<p>Decontaminating equipment between BH19 and BH18</p> <p>Tap water in bucket and DI and Liquinox in the spray bottle</p>

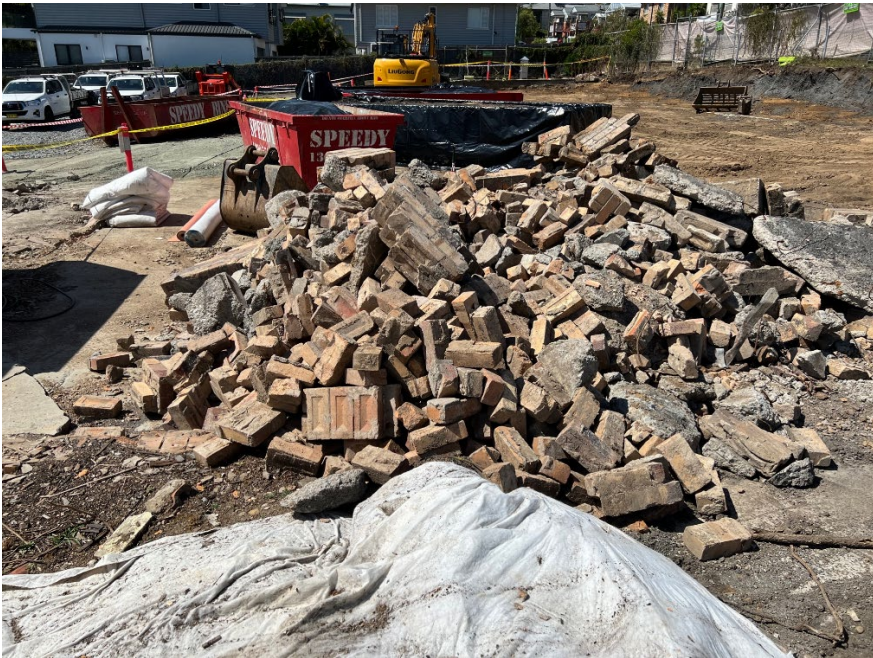
Photograph	Description	Image
1	<p>Looking south-east towards Area 2 excavation</p> <p>Skip bins contain ash / fill soils excavated from this area</p> <p>Brick / concrete stockpile in foreground are from excavation of inground material</p>

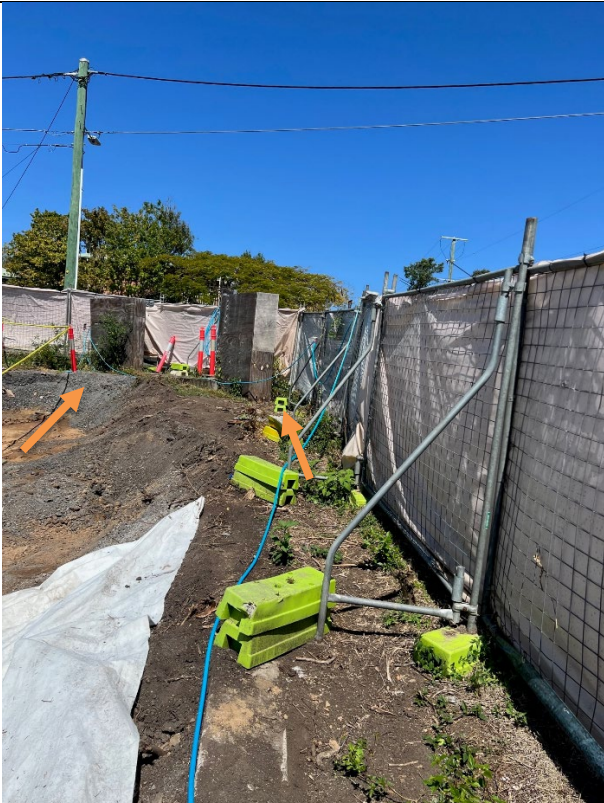
2	<p>View of natural soils and fill material in south-west of site (Area 2)</p> <p>Orange arrows indicate location of heritage listed pillars</p>

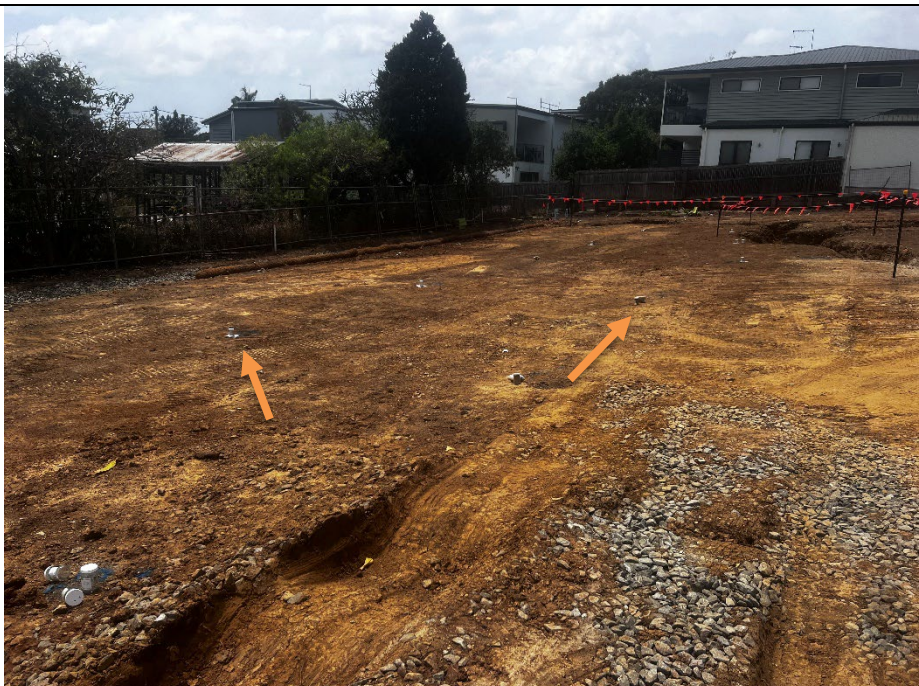
4	<p>View towards center-north of the site</p> <p>Natural soils visible throughout.</p> <p>Sample jars placed at locations of systematic gridded validation locations (orange arrows)</p>

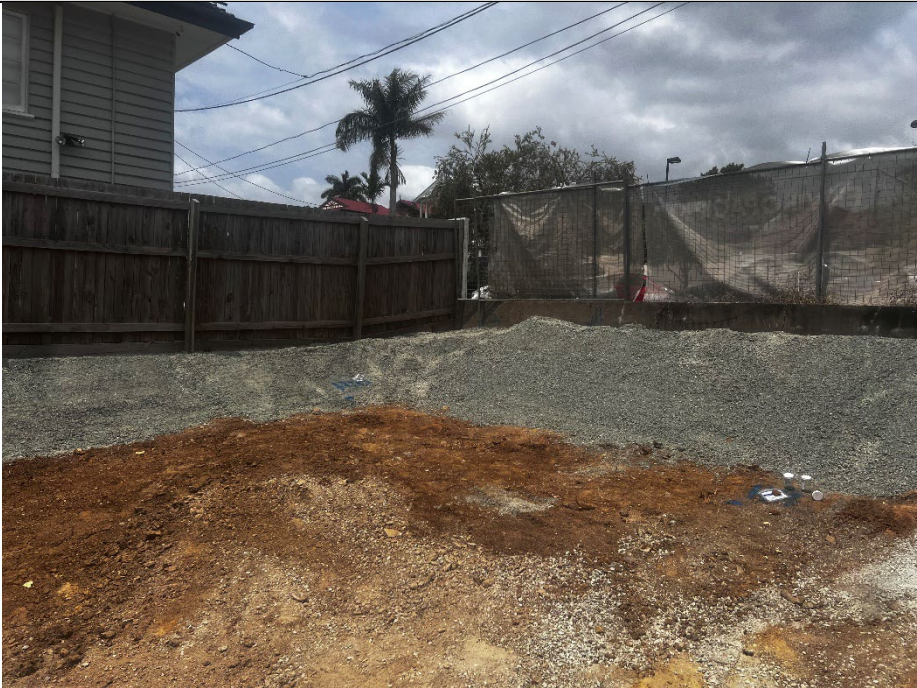
Photograph	Description	Image
5	<p>View of south-east corner of site.</p> <p>Natural soils and imported fill material visible.</p>

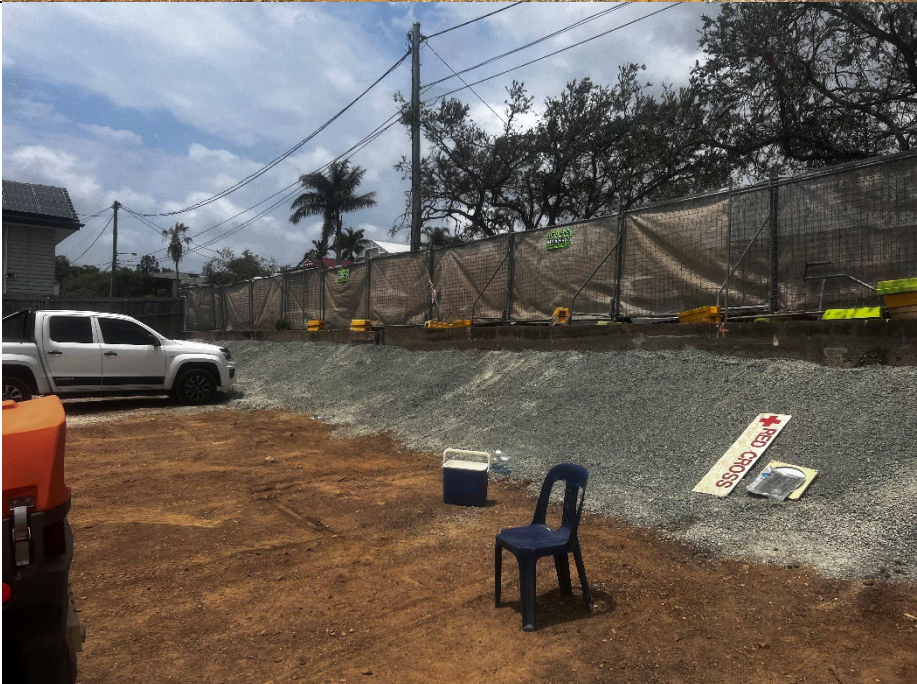
6	<p>View of southern boundary of site</p> <p>Natural soils and imported fill material visible.</p>
