# Validation Report

## 51, 53 and 55 Headfort Street, Greenslopes Queensland

Department of Veteran Affairs

**Reference: 784-BNEEN282781 Validation Report**

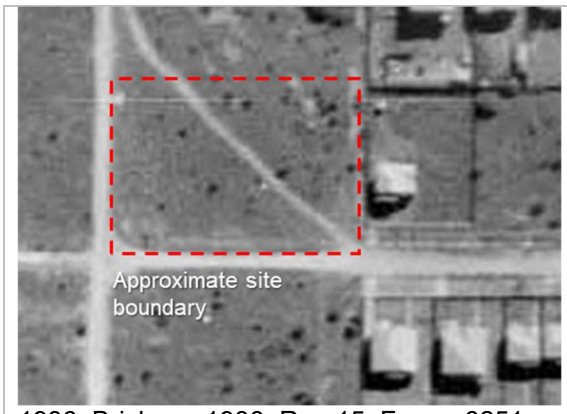
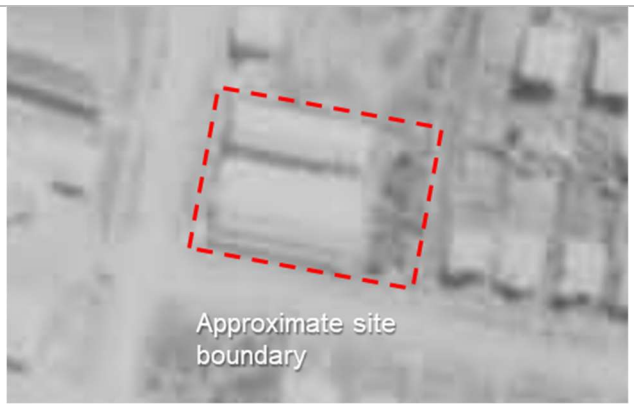
**Figure B: Historical Aerial Images (source: QImagery)**

Historical aerial photography of the Site and surrounding land is provided in the LotSearch Report included in Appendix K.2. Historical aerial imagery shows the land was cleared land in 1936 and 1941, and potentially in use for rural purposes (see image below for 1936). The site was acquired by the Commonwealth of Australia in 1920 and the Site was developed as the Australian Red Cross Centre (ARCC) between 1941 and 1946 (refer to Appendix K.2). Historical images of the Site from 1936 and 1946 are shown in Figure B below.

1936: Brisbane 1936, Run 15, Frame 6251

1946: Brisbane 1946, Run 11A, Frame 34654

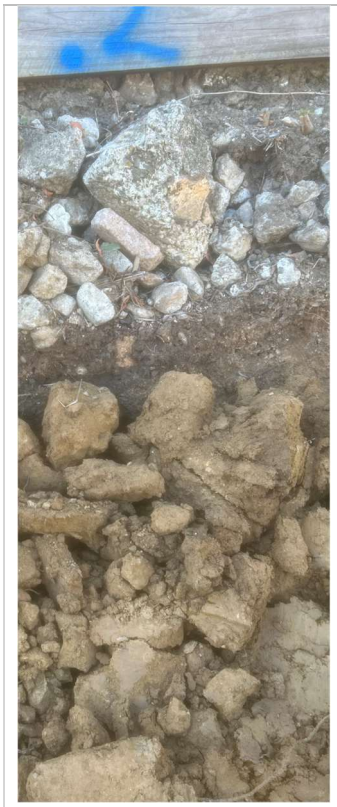
Example of excavation to Eastern Boundary Fence

Eastern Boundary Fence with boundary fence. Imported material was place along the boundary fence following excavation and validation.

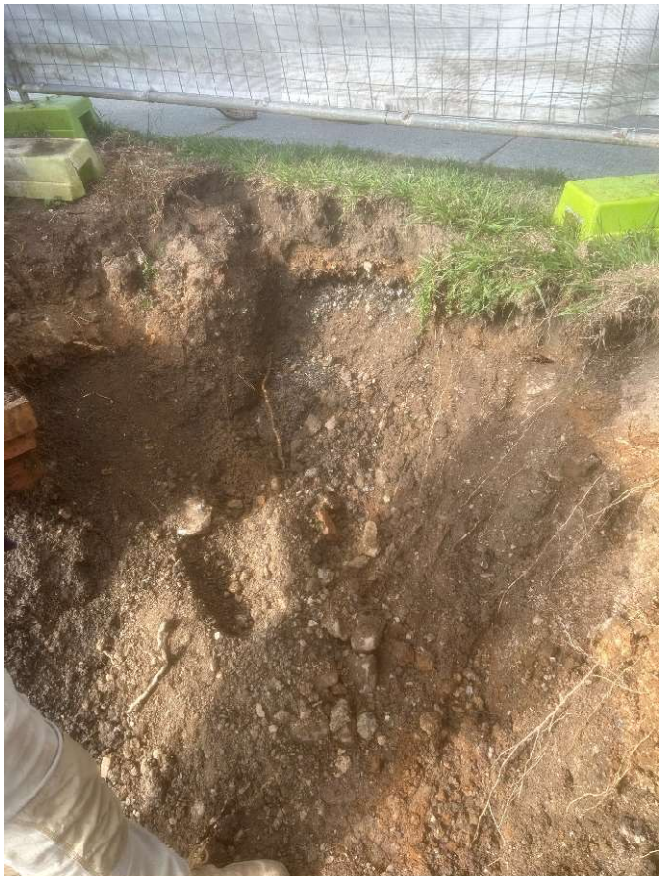
Excavation along the south western boundary of the Site with the footings of the heritage wall exposed. The footings of the heritage wall extended to natural ground

Excavation in the south western corner of the Site extended beyond the boundary of the Site into the Road Reserve. The photograph shows the excavation taking place past the footings of the heritage wall.
