# Validation Report

51, 53 and 55 Headfort Street, Greenslopes Queensland

Department of Veteran Affairs

Reference: 784-BNEEN282781 Validation Report

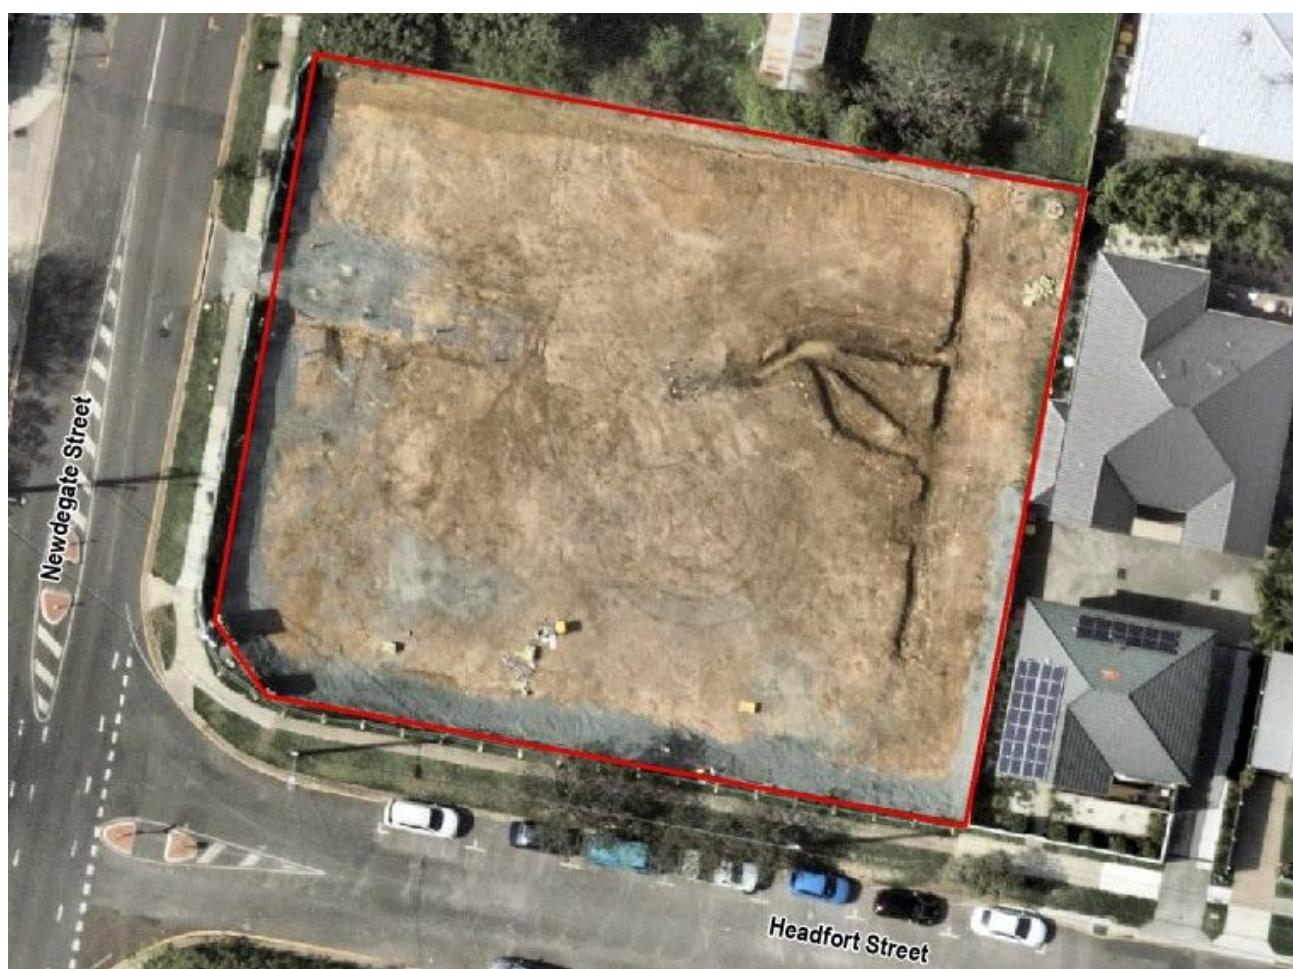
The Site is currently comprised of cleared land following the completion of the remediation works undertaken in 2023. An aerial photograph of the Site from the 31 October 2023 is shown in Figure 11, Appendix A and in Figure A below.

**Figure A Aerial Photograph of the Site During Remediation (source Nearmap, 13/11/23)**

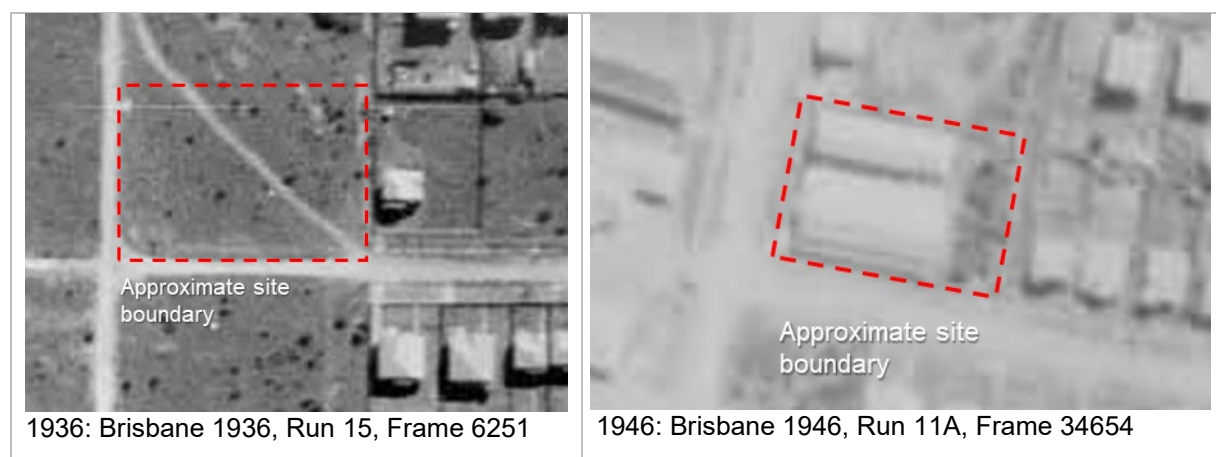
**Figure B: Historical Aerial Images (source: QImagery)**

The historical aerial photograph of the Site in 1946 shows the accommodation building in the north and the main hall building in the south. The location of these buildings is shown in Figure 2, Appendix A, and in Figure

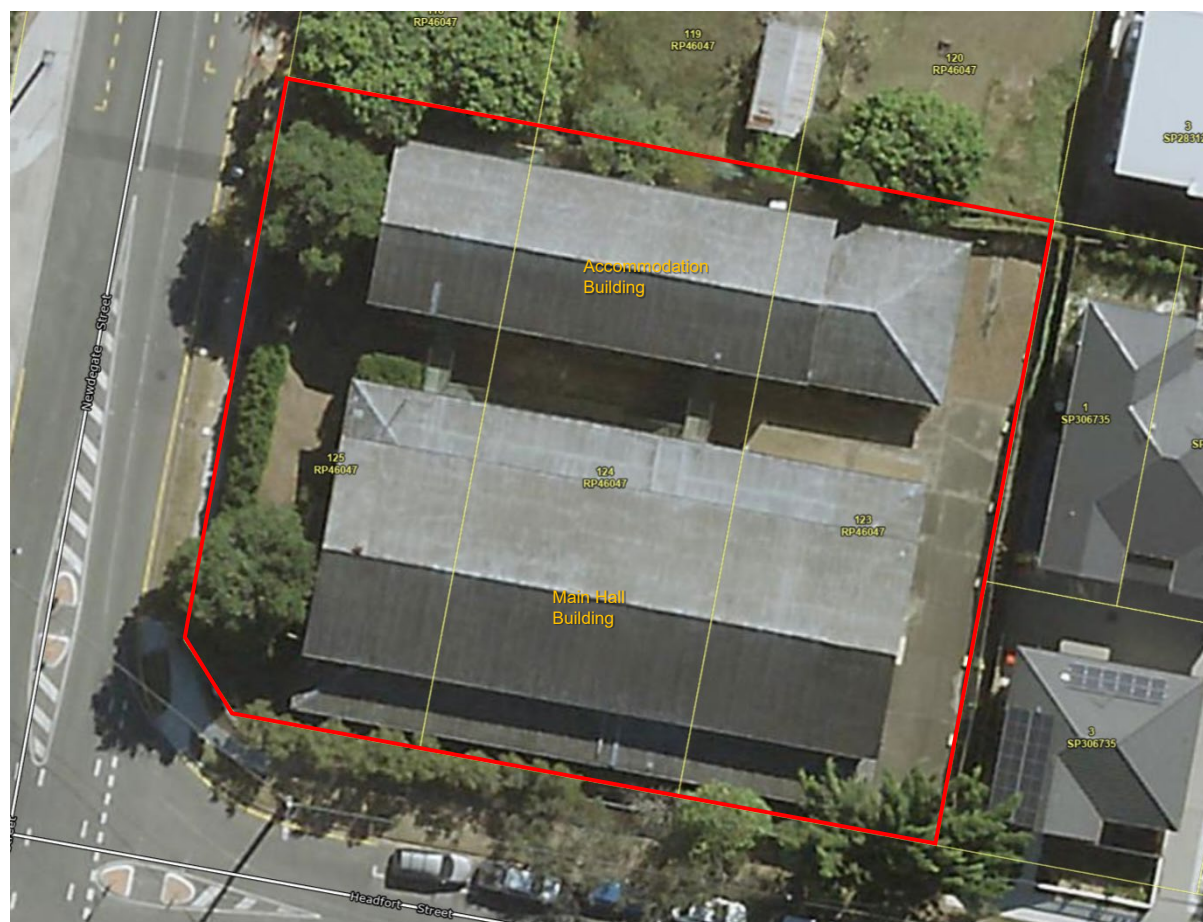
C on the following page. The configuration of buildings on the Site therefore remained the same over this time period until the buildings were demolished in 2023.

**Figure C Historical Aerial Image of the Site 2021 (Image source: Queensland Globe, 2021)**

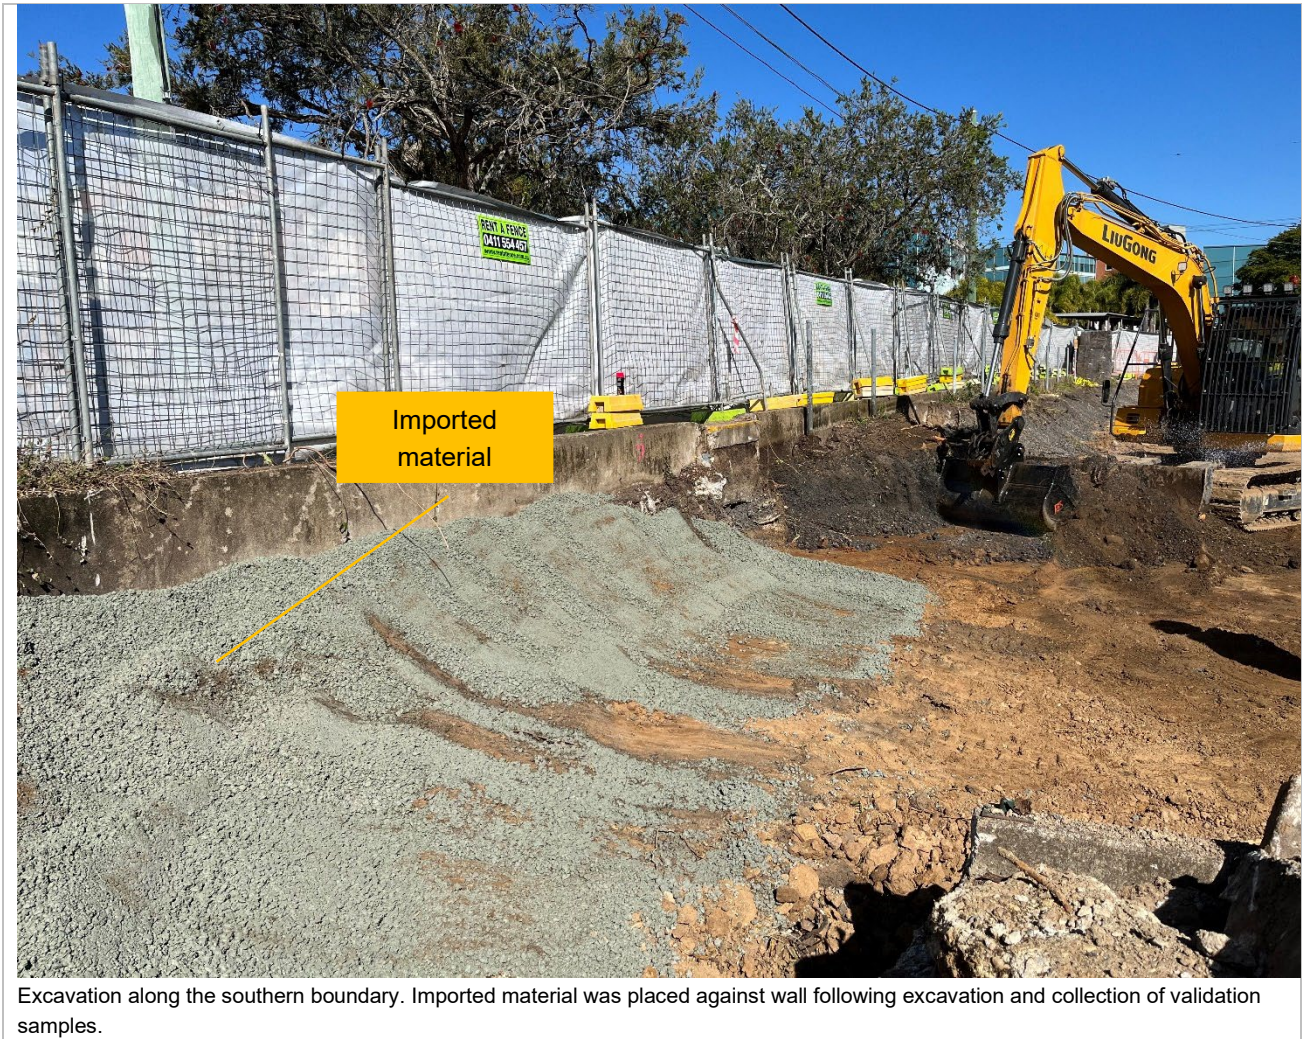
Excavation along the southern boundary was undertaken to the retaining wall which was the practicable limit of excavation.

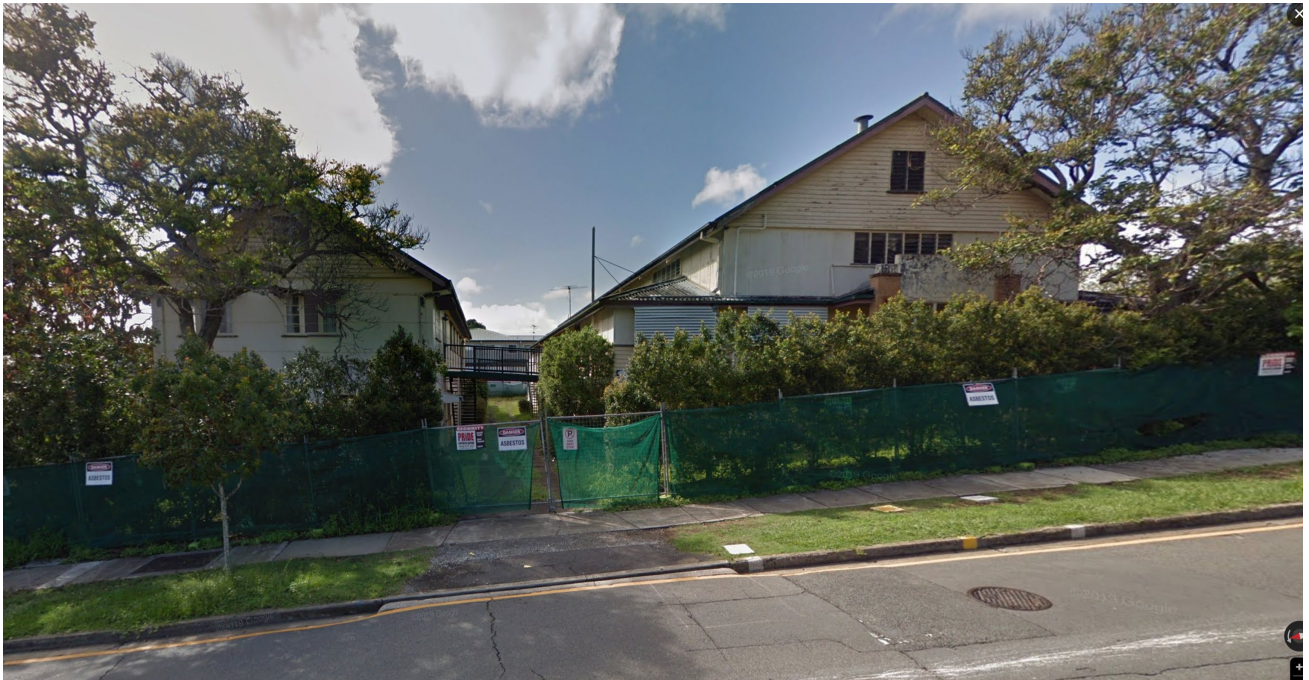
Pre-Remediation: Photograph of the Site in 2019 (source: Google Street View)

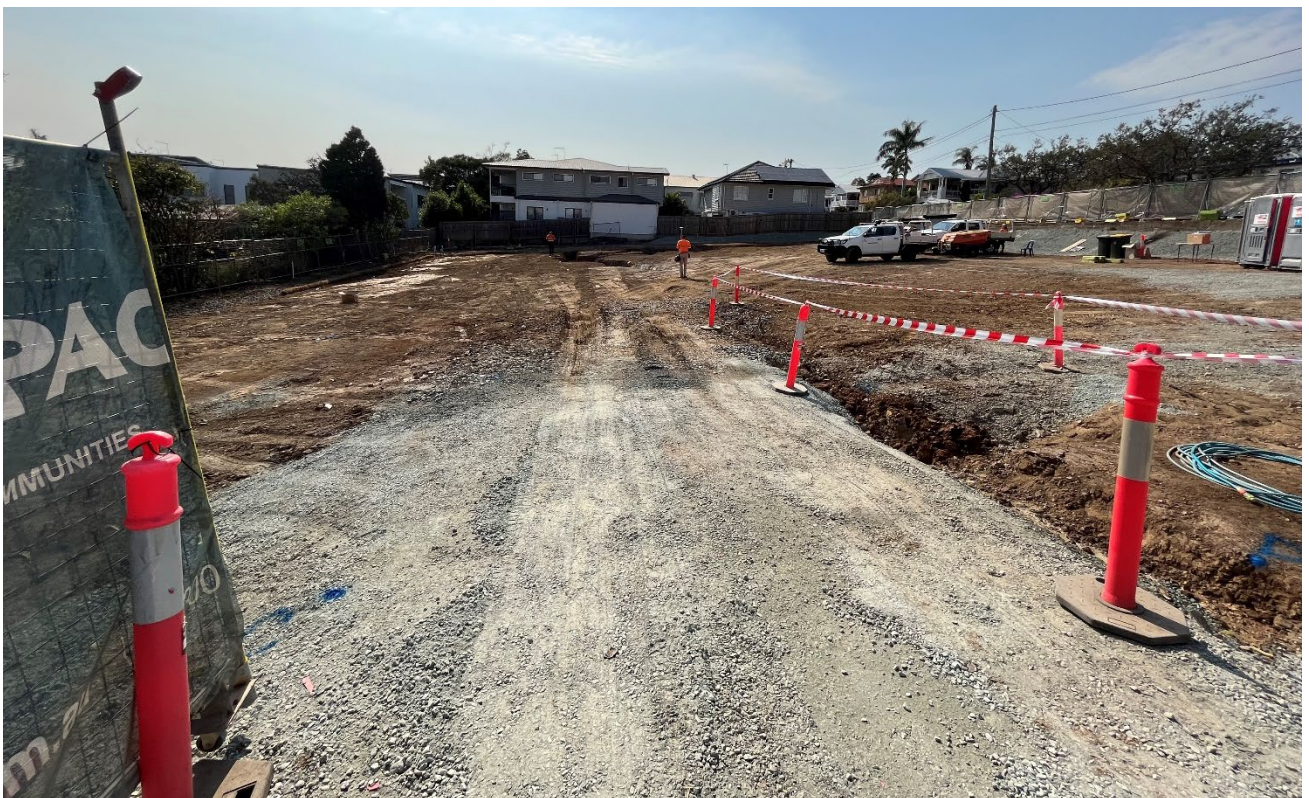
Post-Remediation: Photograph of the Site on the 26 October 2023

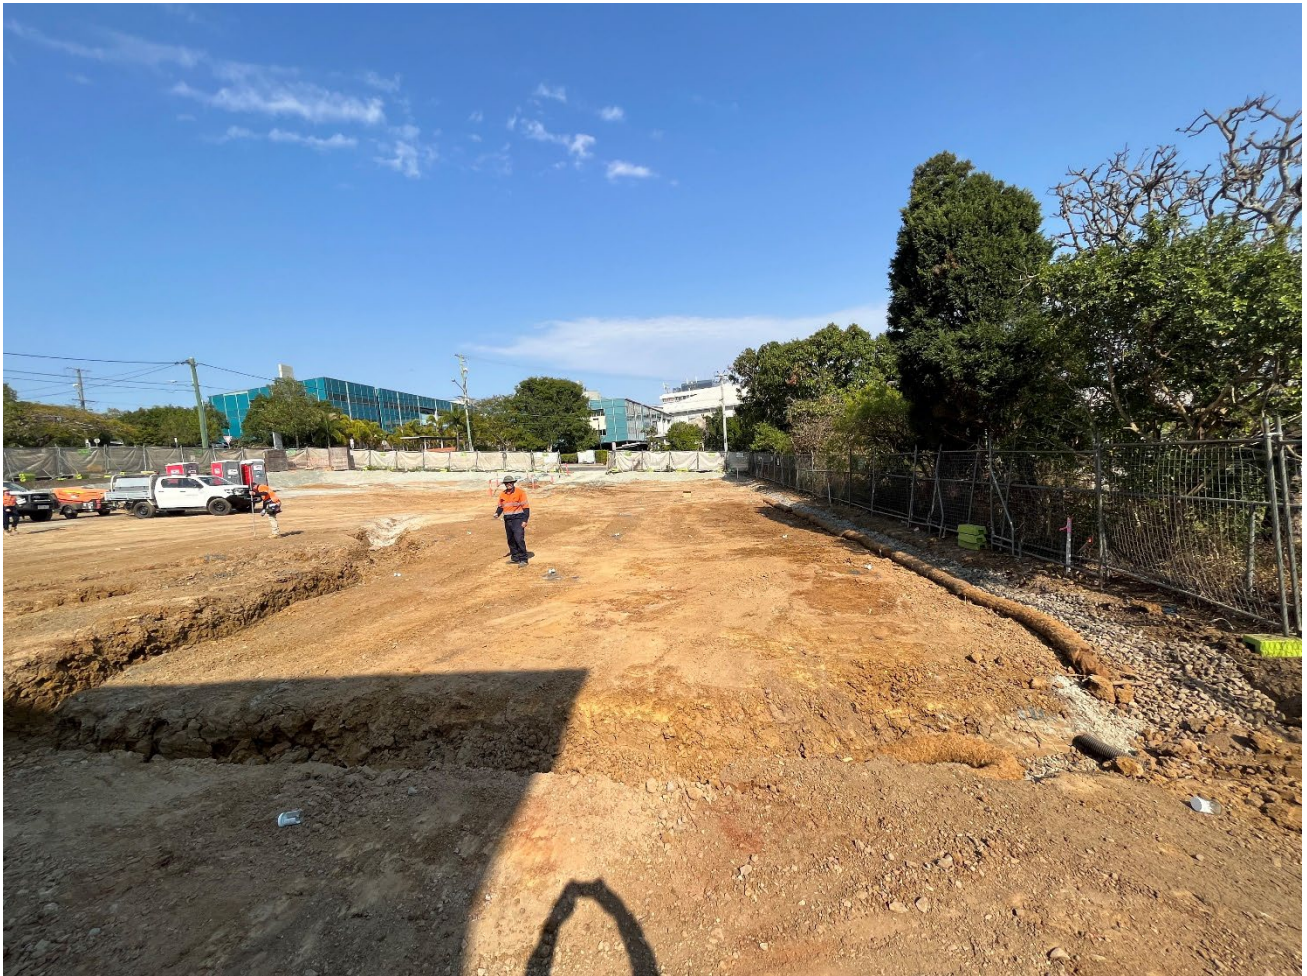
Post-Remediation: Photograph of the Site on the 26 October 2023
